SUSTAINABLE FISHERIES MANAGEMENT PROJECT (SFMP)

Shama Disaster Management Committee Meeting and Field Work To Plan Anlo Beach Resettlement

April, 2016

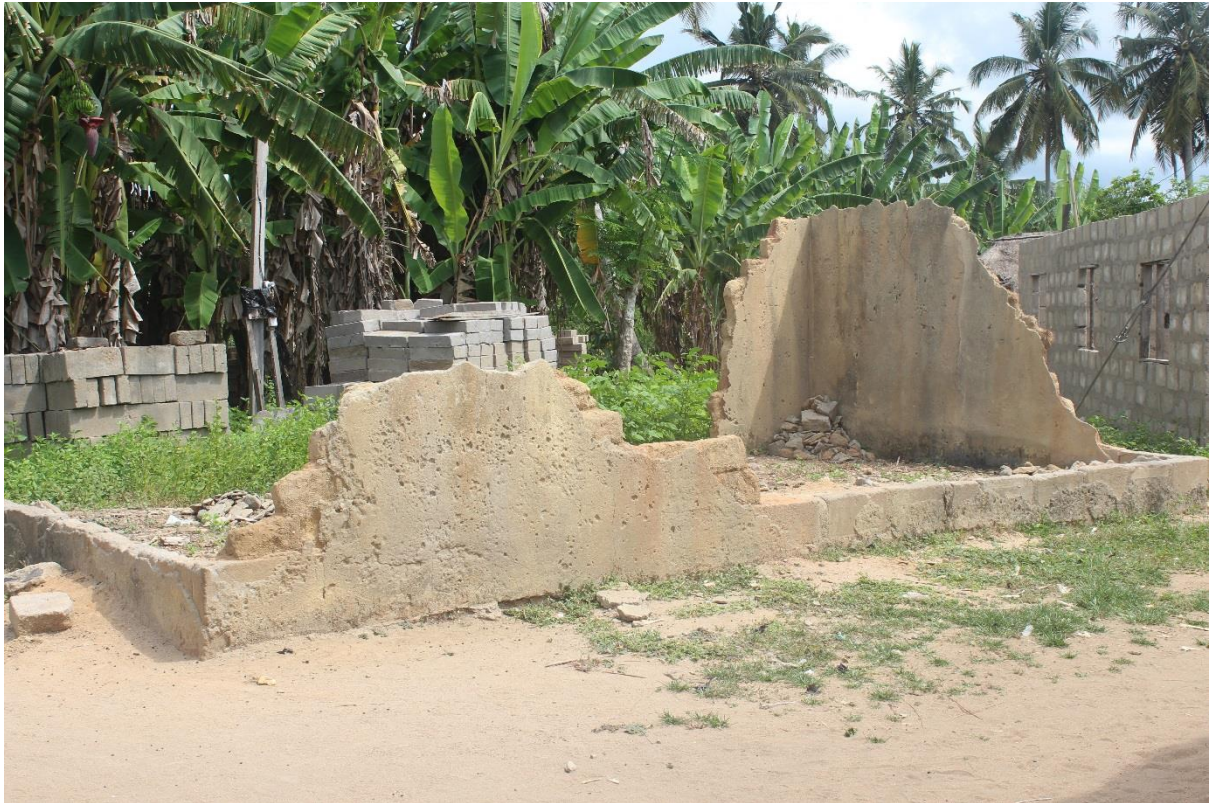
Figure 5 A collapsed structure due to effects of coastal erosion

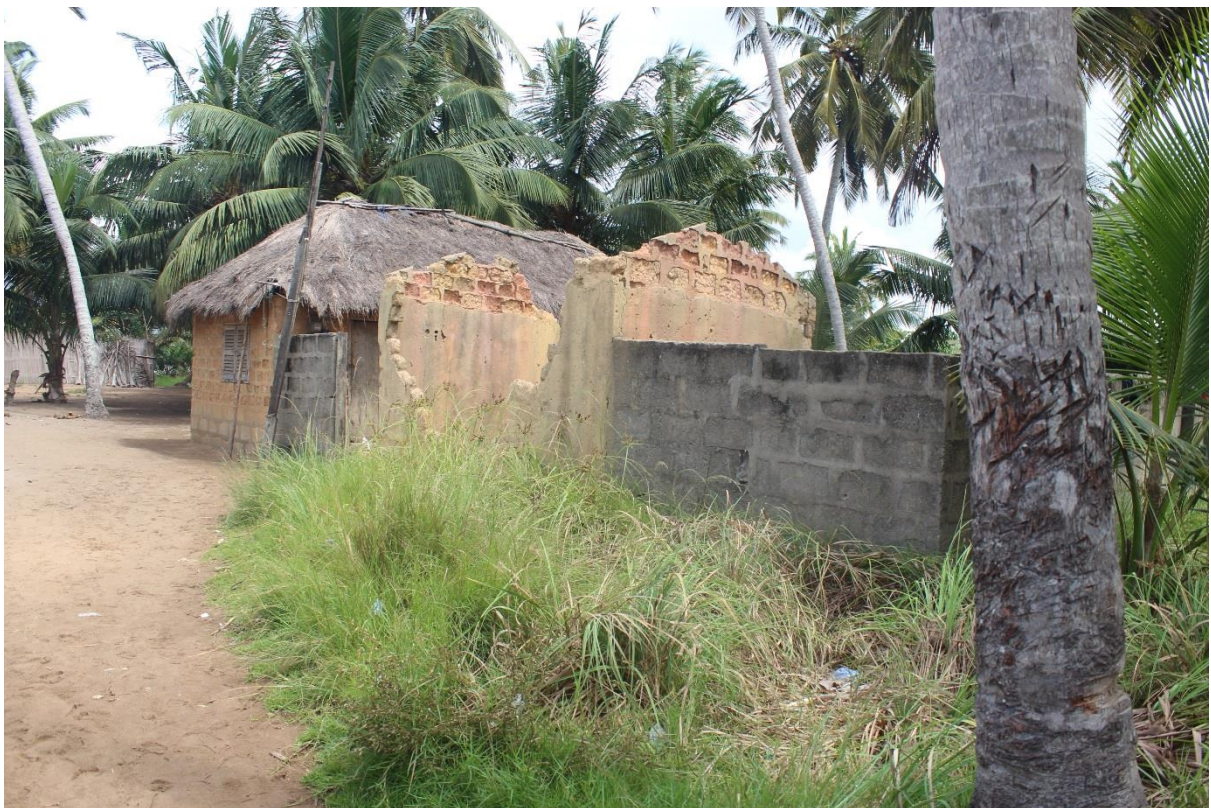
Figure 6 A collapsed structure due to effects of flooding
