Results of a Preliminary Shoreline Shellfish Sanitary Survey near Banjul, Gambia Conducted on 18 June 2011

**Gambia-Senegal Sustainable Fisheries Project
June, 2011**

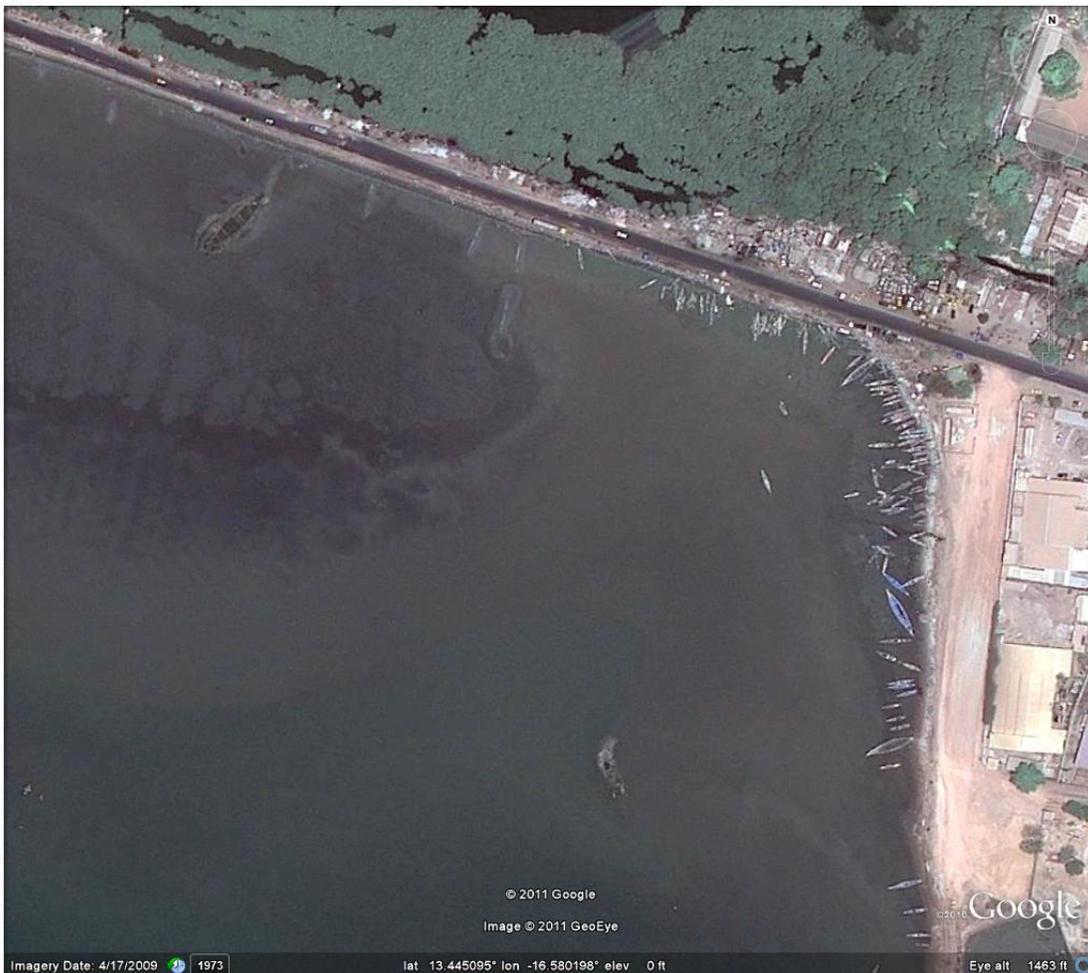
1. Fish landing area (13o 26.736'N, 16o 34.727'W). The Banjul Fish landing area is a location of considerable boat and shore activity (Figure 1). There is no evidence for adequate sanitary toilet facilities around the port for fishers and fish market personnel to use. Unless there is clear demonstration of control of sanitary wastes the Fish Landing Area should be best classified as a prohibited marina/port area under NSSP water quality classification definitions.

Figure 1. The Banjul fish landing area along the Bund Road Levee near the Port facilities. There is no evidence of adequate sewage disposal in this area despite large numbers of boats and fish buyers frequenting the area.

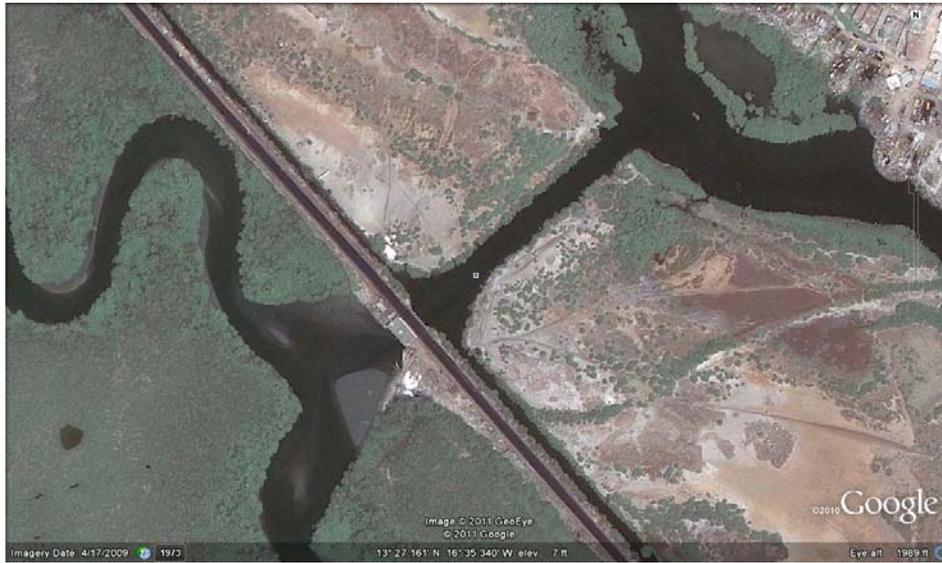
4. The floodgate and pumping station on Bund Road (13o 27.133’N, 16o 35.366’W) was first constructed in 1952 along with the levee after the Great Bathurst (Banjul) Floods of 1947 (according to a dedication plaque placed on the pump house building). The flood gates and pump house were refurbished in 1994 (according to a dedication plaque at the site) clearly to serve the dual purpose of flood control and use of constructed wetland technology for the treatment of drainage water and some sewage water from the City of Banjul prior to discharge into the northern part of the Tanbi Wetlands (Figure 2). The Bund Road Levee as constructed, walled off an area of the Tanbi Wetlands Complex such that the only drain from the walled off section and drainage from the city was through the floodgates in the levee. The area of the wetlands enclosed by the levee is approximately 110 hectares. During the dry season the floodgates would be raised periodically to flood the Banjul wetlands during an incoming tide. Drainage water from Banjul would drain into the wetland and be treated by natural wetland water and soil processes prior to discharge into the Tanbi by use of the pumps at the pump station or by raising the flood gates on an outgoing tide (Figure 3). During the wet season, the gates would remain closed keeping rainwater and drainage confined in the interior portion of the enclosed Banjul wetlands, and pumping out the treated water in a metered fashion.

At present, the flood gates at the pumping station are stuck in an open position and of the three pumps originally installed at the pumping station, two are missing and one is not operational. Without closed floodgates at the pumping station, all drain water with possible sewage contaminants coming from Banjul are free flowing through the wetland canals and rapidly discharged into the Tanbi Wetlands where oyster harvesting is occurring.

Figure 2. Bund Road Levee showing the Northern Tanbi Wetlands (lower left) and a portion of the Banjul wetlands enclosed by the levee (right) a portion of the urbanized portion of Banjul is visible at the upper right. The drain canal passing under a bridge and the pumping station is the sole normal discharge point of drainage water from Banjul.

It is recommended that Mr. Foday Konteh of the Gambian Water Resources Agency who is undertaking a study of bacterial water quality (total coliform and fecal coliform) in the Tanbi Wetlands add the discharge canal of the pumping station to his standard stations so that dry season and wet season discharges coming from Banjul can be assessed. This spot is potentially the single greatest point source of fecal coliforms entering the Tanbi Wetlands complex.

It is further recommended that attention be given to upgrading and maintaining the floodgates and pumps at the Bund Road pumping station as well as raising the Bund Road Levee for the sake of water quality maintenance and flood control (see further comments in section 6 below).

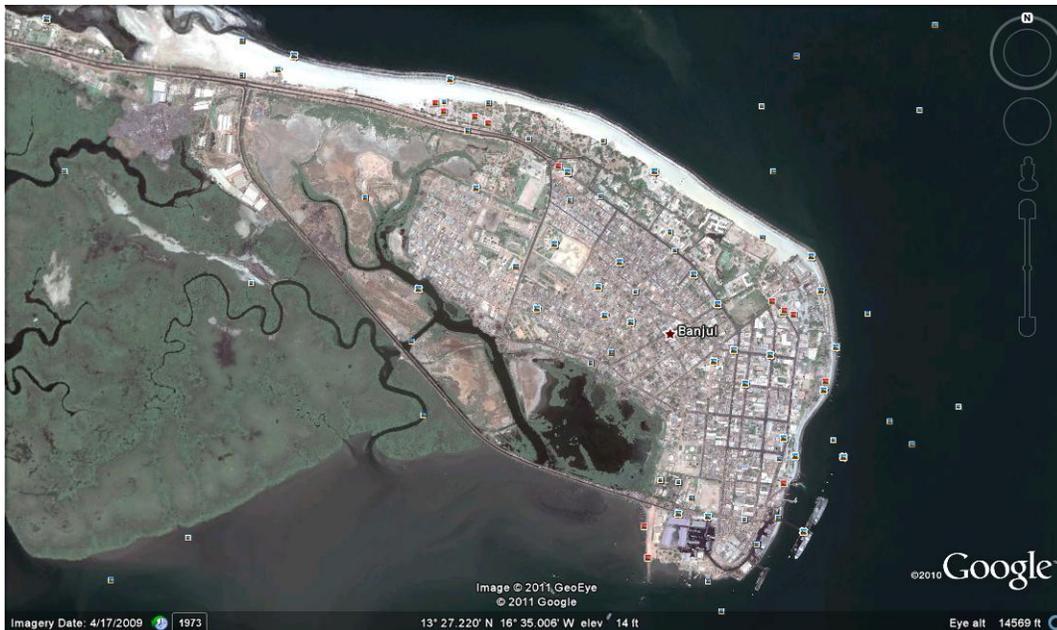
conditions or during exceptionally high tides or high water in the Gambia River, water would be spilling over Bund Road in several locations. It seems that when the levee was designed after the 1947 floods, there was enough freeboard to accommodate expected high water from the river. Since the levee completion in 1952, it is unclear if the levee has been maintained or “topped off” during the intervening 59 years. Undoubtedly there has been settling and subsidence of the levee over the years. It is recommended that attention to raising the height of the freeboard of Bund Road Levee be given priority, not only for sanitary water quality considerations, but for flood control purposes as well. This is particularly true since the recent construction of the new National Assembly Building at 13o 27.717’N, 16o 36.046’W falls within the drained area of the Tanbi Estuary that is enclosed by the Bund Road Levee (Figure 3).

Figure 3. Satellite imagery of Banjul showing the Bund Road Levee and associated drainage area in metropolitan Banjul.

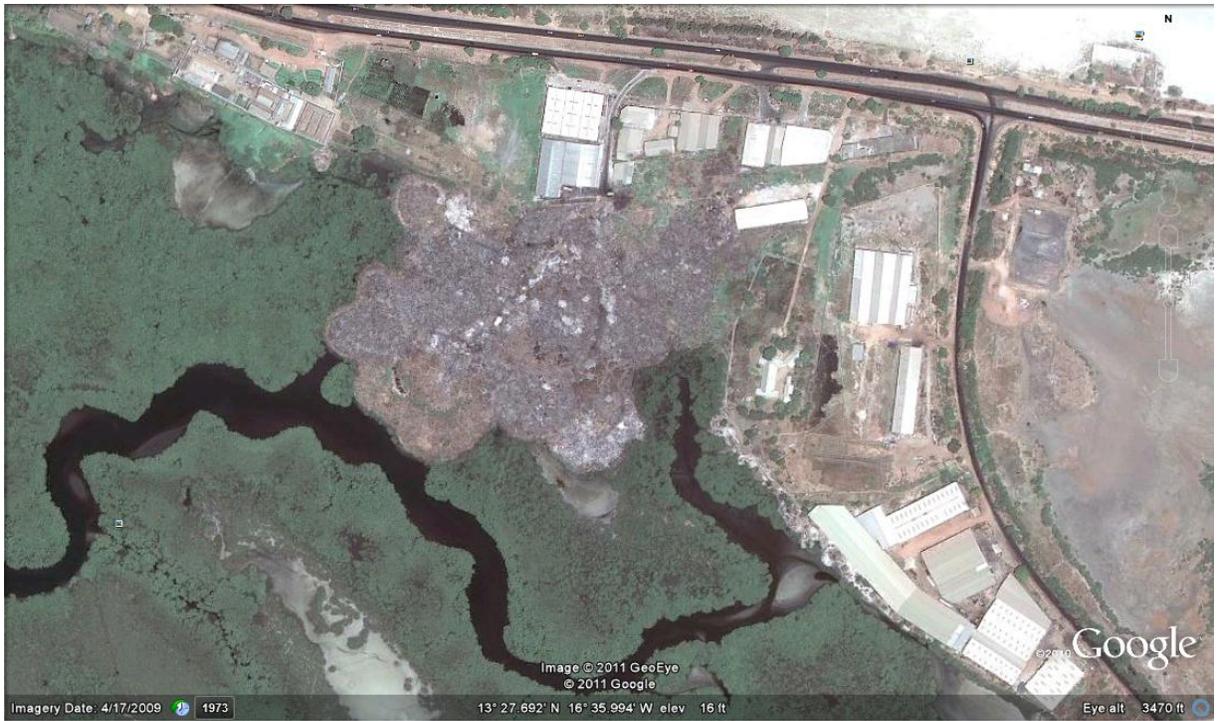
5. Examining Google Earth images in proximity to Bund Road and the Banjul-Serrekunda Highway is a possible rubbish dump of approximately 7 hectares in area centered at 13o 27.717’N, 16o 36.046’W (Figure 4). This may be a substantial source of contamination to the estuary.
6. In addition to observations related to sources of contamination along the Bund Road Levee, we also offer some observation as to flood control in the context of rising sea levels and global climate change. While traveling on Bund Road near high tide in the Gambia River, it was not difficult to notice that the height of the water in comparison to the top of the levee or roadway (the freeboard of the levee) was only a few centimeters. Clearly during storm

Figure 4. Rubbish dumping area in the Tanbi Wetlands area (center) near the intersection of Bund Road (right) and the Banjul-Serrekunda Highway (top).
