# The Beginnings of Shellfish Aquaculture and Water Quality Certifications in The Gambia, West Africa

Michael A. Rice, *University of Rhode Island*  
Foday Conteh, *Dept of Water Resources, Gambia*  
Ousman Drammeh, *USAID-URI/Ba-Nafaa Project*

# Summary

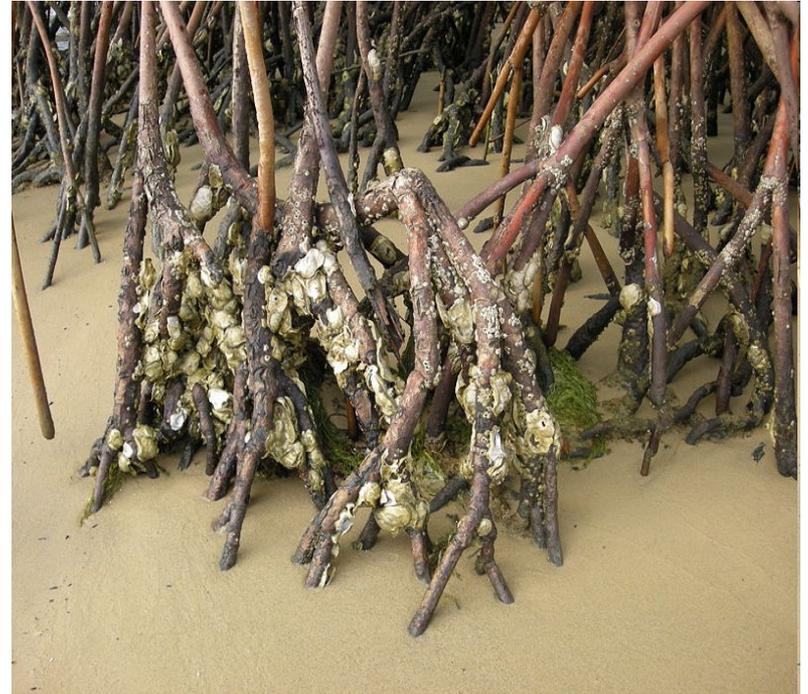
*Crassostrea tulipa* (Lamarck 1819)

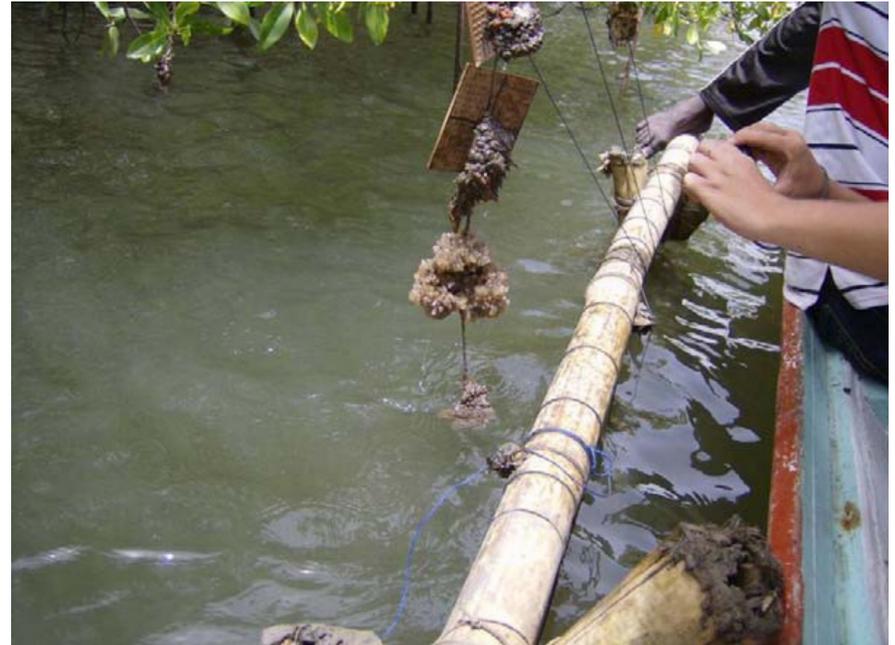
# Oyster Spat Collection Studies

- 10 tile spat collectors 15cm x 15cm placed at each site May 2011
- Checked monthly, cleaned & replaced
- Oyster spatfall & nature of fouling data collected until Dec 2011

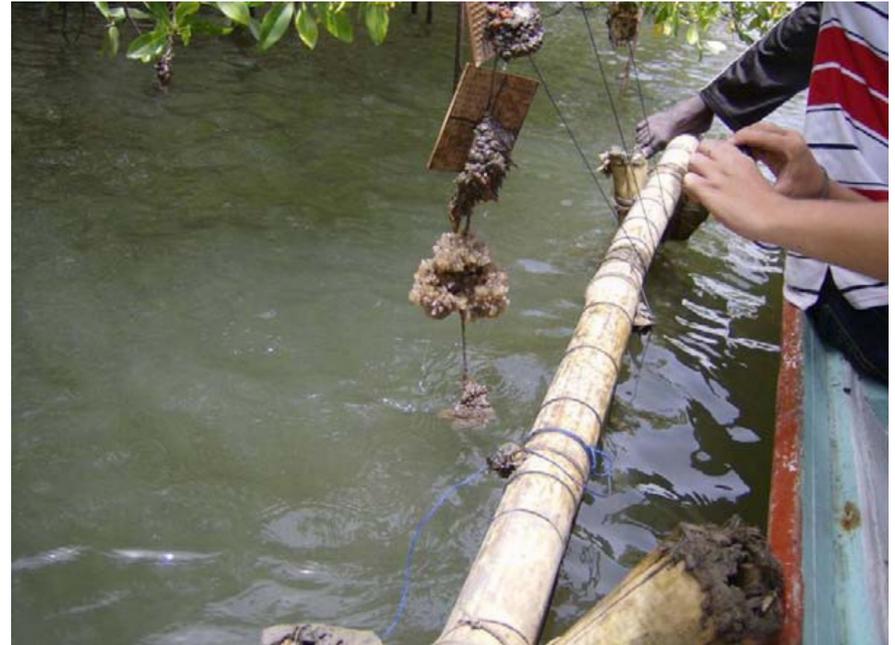
# Oyster Spat Collection Studies

- 10 tile spat collectors 15cm x 15cm placed at each site May 2011
- Checked monthly, cleaned & replaced
- Oyster spatfall & nature of fouling data collected until Dec 2011

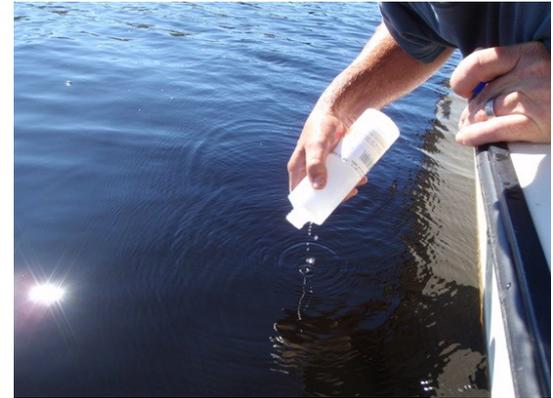
# Steps to establish water quality classifications

- Baseline testing of coliform bacteria in Tanbi estuary begun October 2010 & ongoing
- Monthly water sampling at 15 sites, parameters measured include temp, salinity, TC by filtration and m-Endo broth incubation method, and FC by filtration and LTB at 44.5°C
- Survey data is multipurpose
  - Prioritization for remediation
  - Establishing water quality classification zones for shellfisheries

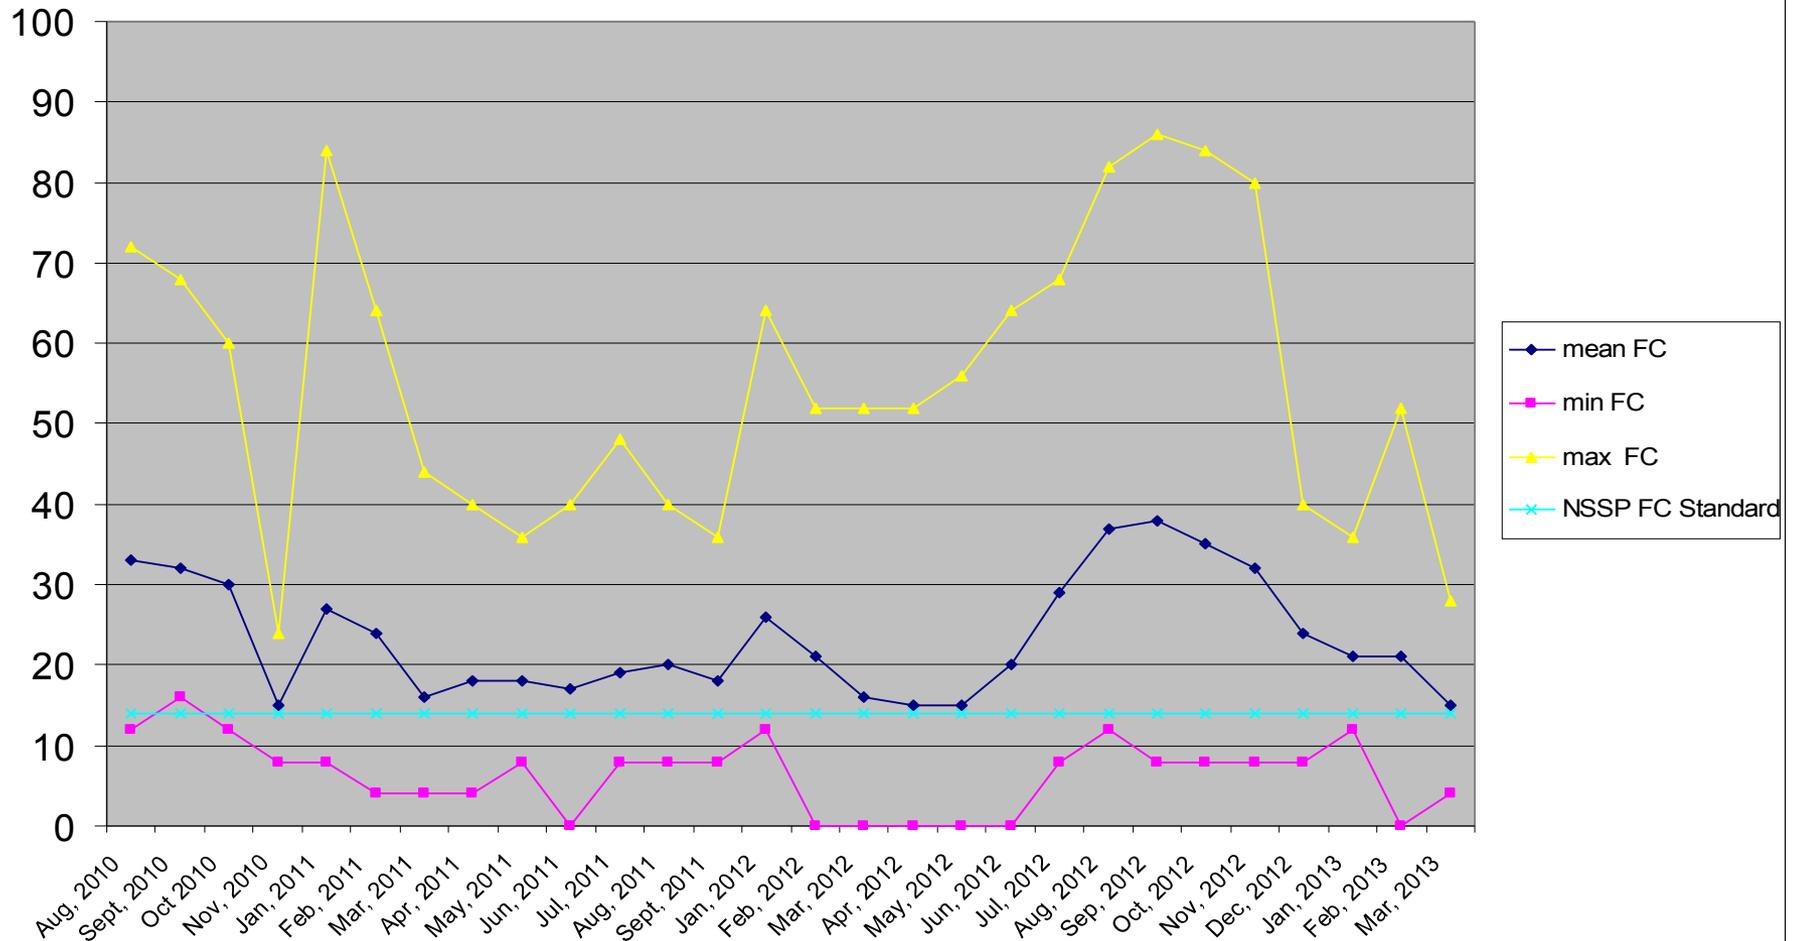
# Summary Fecal Coliforms in Tanbi

Mean, Maximum & Minimum Fecal Coliforms

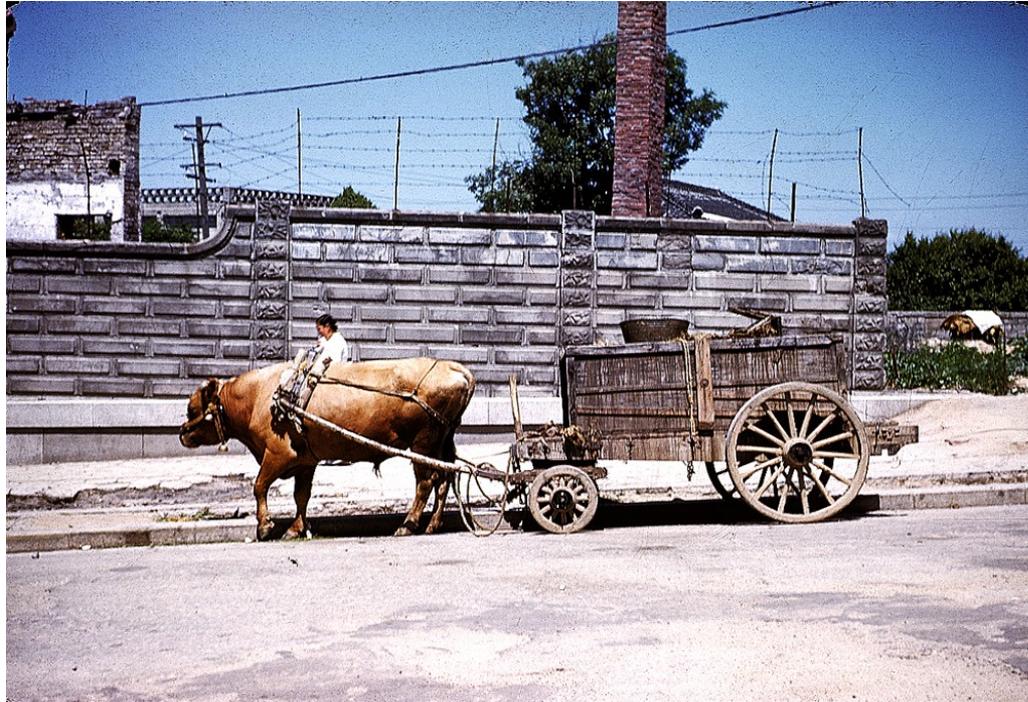
Manure cleanout “honey wagon” in Thailand;  
Similar system used in US cities pre-20<sup>th</sup> Century

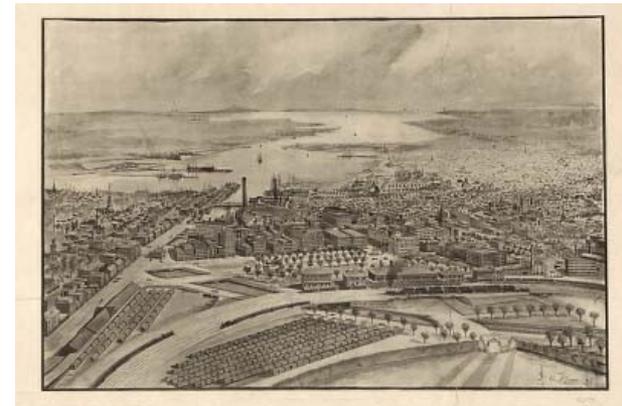
- **1901**  
The Providence Sewage Treatment System is put into operation. The chemical precipitation plant, the third of its kind in the United States, is the largest of its type ever built. The system consists of a pumping station at Ernest Street to lift sewage to Field's Point for treatment.

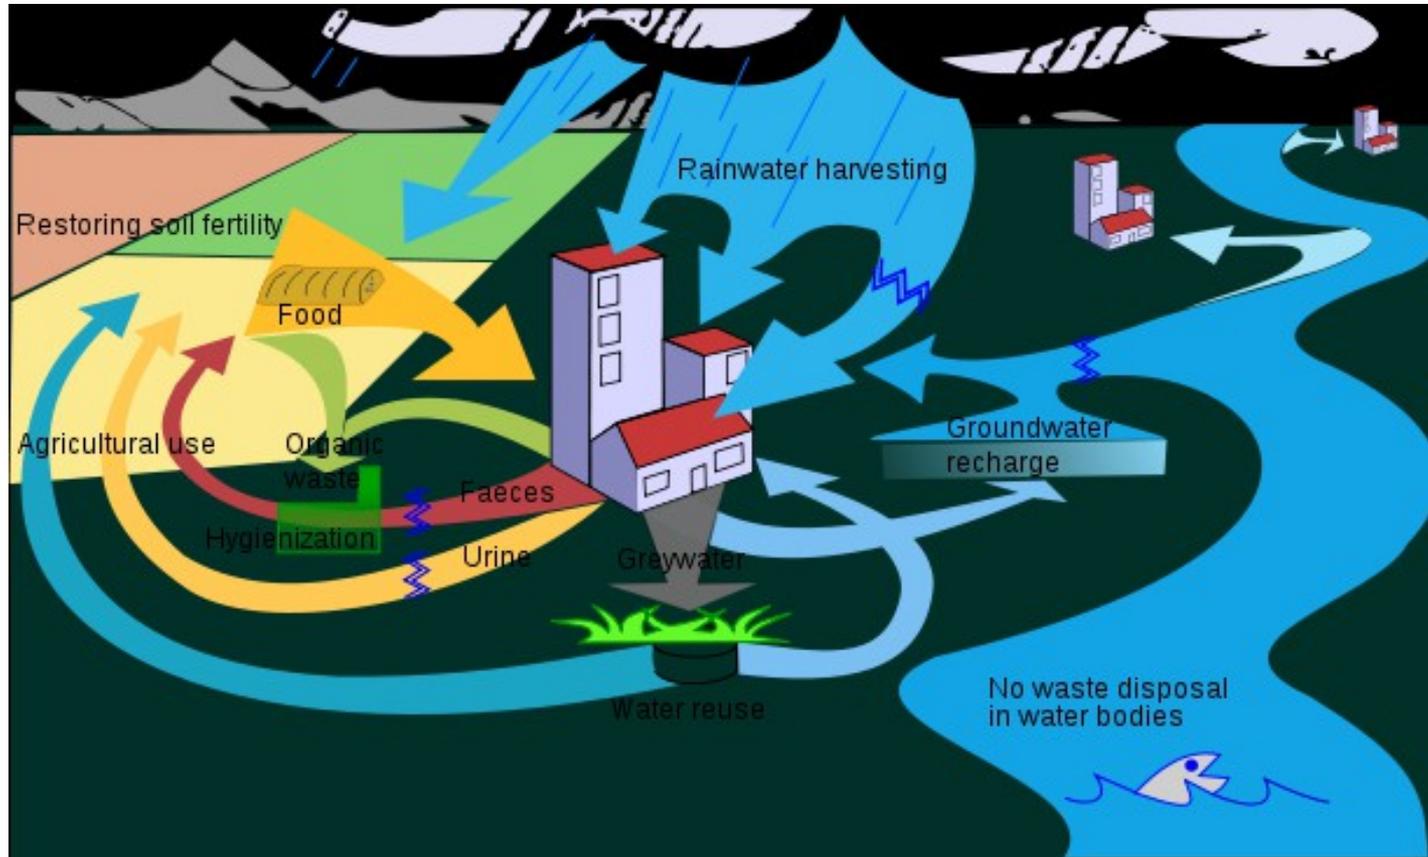
# Ecological Recycling of Wastes

Gambia may be closer to ideal of recycling than we are in New England --- Tech leapfrogging?

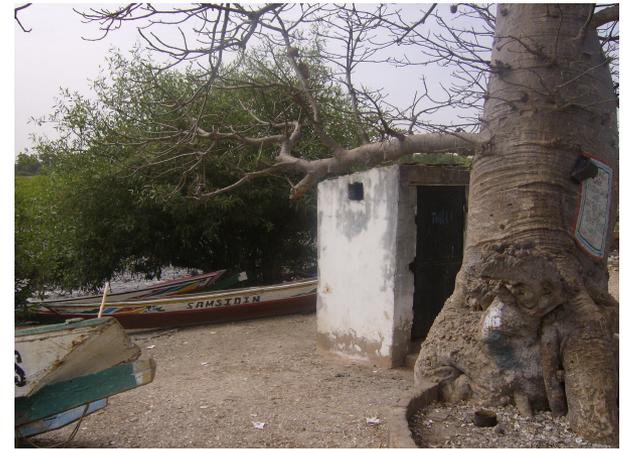
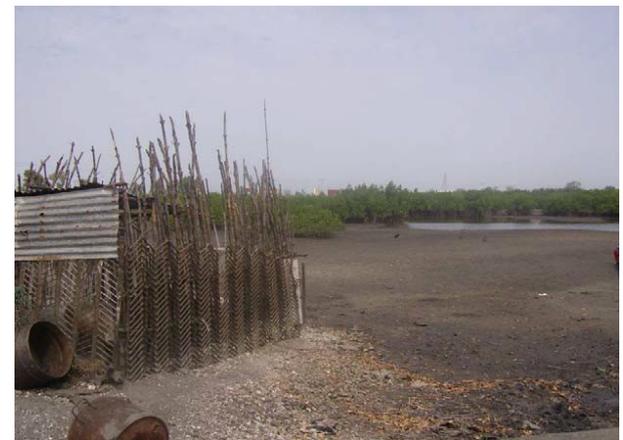
# Identification and remediation of known fecal contamination

- First, identify, define & map shellfish growing waters
- Pre-identify potential sources of contaminants
  - Google Earth to locate major problem areas
  - Use of local knowledge and public records
- Establish baseline conditions in pre-defined areas by walking the shoreline – pinpoint location by simple GPS device
- Use spreadsheet to establish database of problem areas

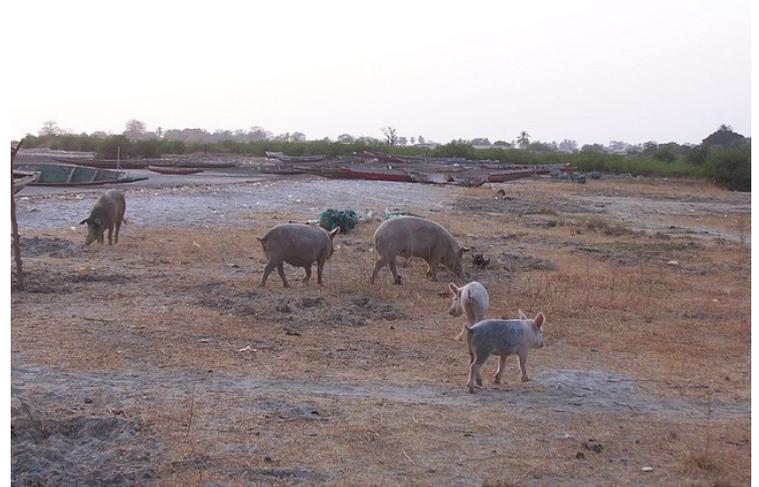
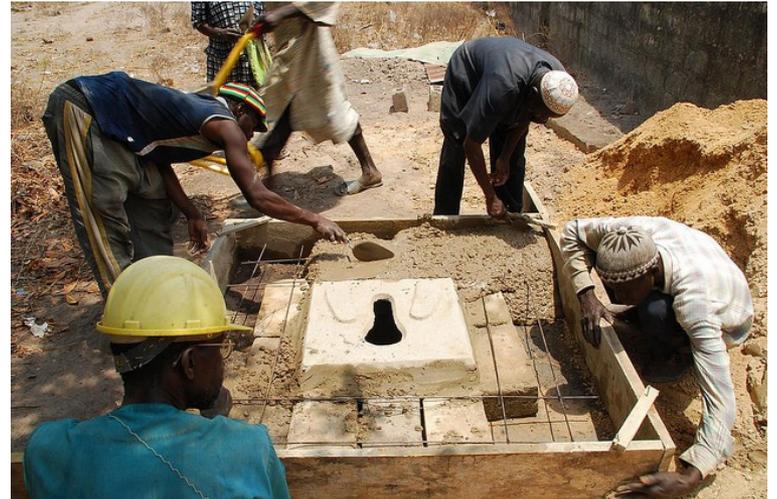
# Implementing Sanitary Shoreline Surveys

- Make sure defined survey areas sized to be able to complete survey in about 4 hours
- Conduct baseline survey and record results in spreadsheet
- Update surveys periodically
- Survey data is multipurpose
  - Prioritization for remediation
  - Establishing water quality classification zones
