SUSTAINABLE FISHERIES MANAGEMENT PROJECT (SFMP)

Progress Report For The Rehabilitation Of The CEWEFIA Fish Processing Center

SEPTEMBER 18, 2017

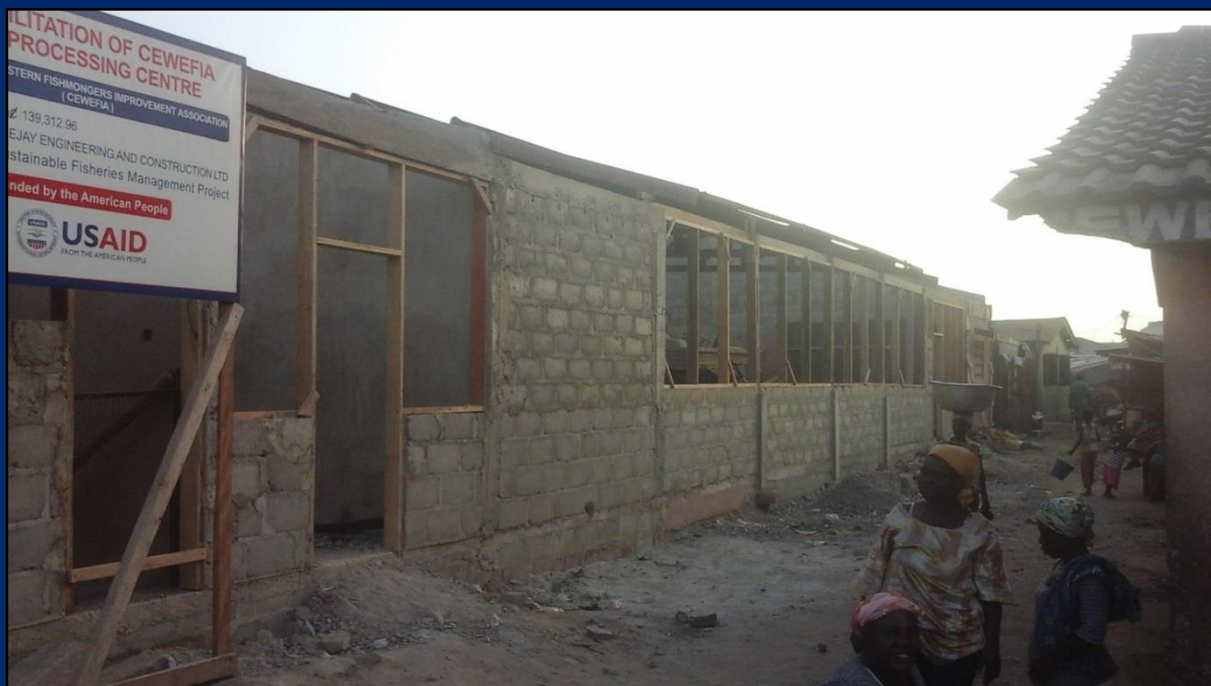
Cover photo: A picture showing progress of work at CEWEFIA Processing center. (Photo by Michael Takyi)

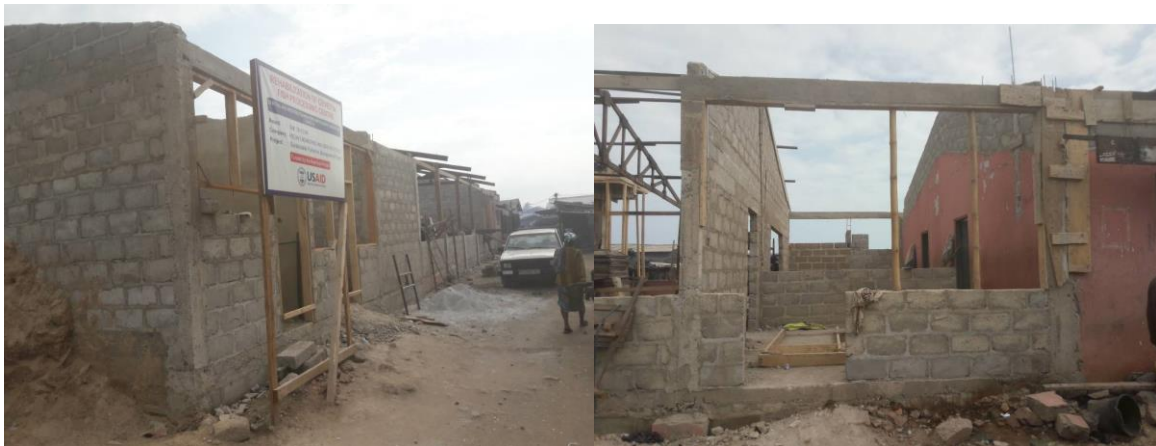
Figure 6 Outside Structure on September 9, 2017

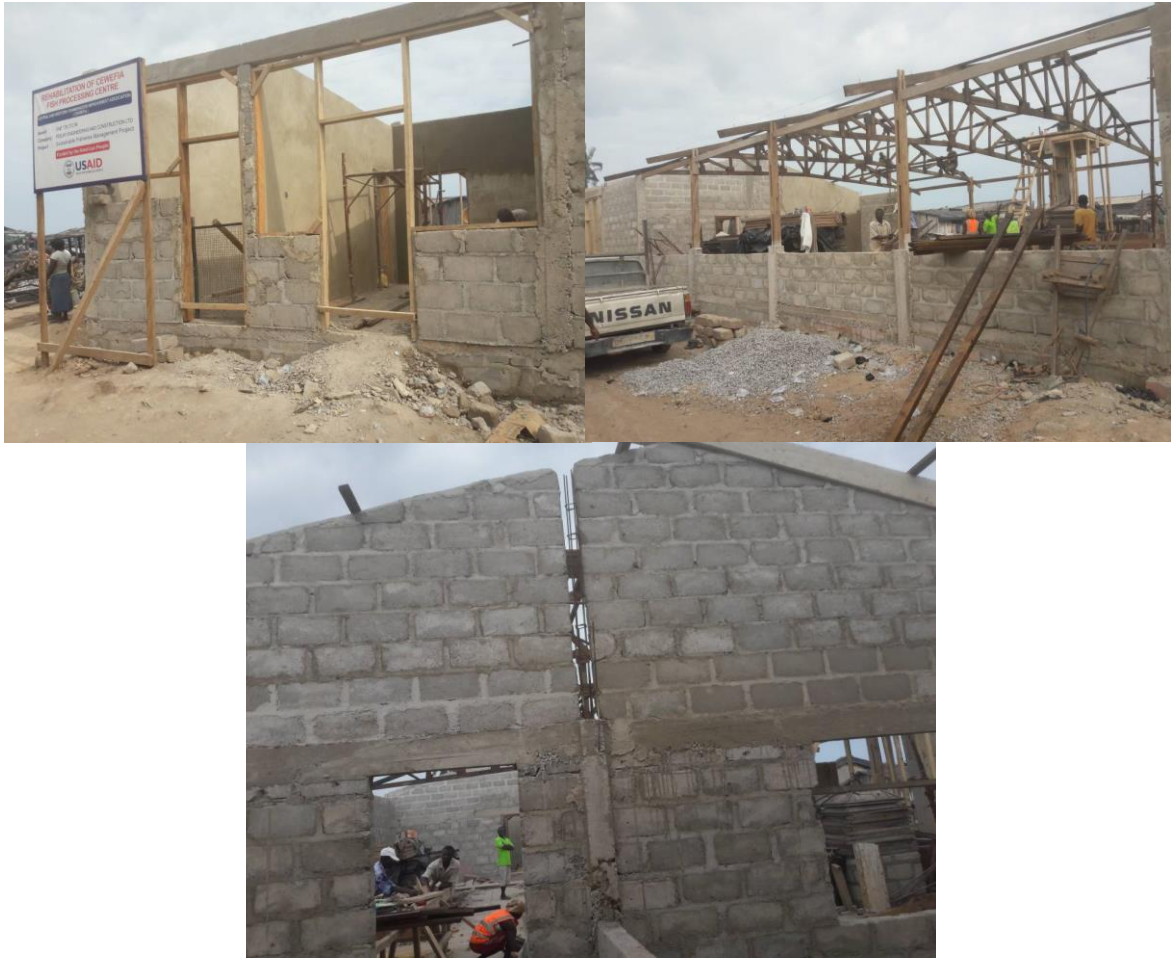
Figure 7 Structure on September 18, 2017
