Report on Sanitary Shoreline Survey within the Tanbi Wetlands National Park and Other Shellfish Harvesting Communities, The Gambia

By: Gambia-Senegal Sustainable Fisheries Project (USAID/Ba Nafaa)

June, 2012

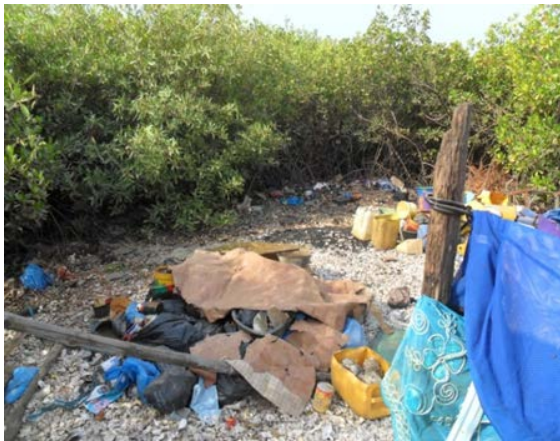
In Wencho (Code 001), the population of the settlement is approximately 120 individuals, comprising five families. The community is mainly engaged in oyster harvesting, fishing and subsistence agriculture. There are no toilets and sanitary facilities and the community is predominantly exposed to open defecation. The rubbish is indiscriminately dumped in the settlement. There are several poultry houses and nine pig pens located in the intertidal zone. A small drainage outlet is located in the settlement that collects effluent from the nearby stores and pig pens and drains into the river. Another drainage channel collects and directs rainwater to the river from the nearby storage facilities. There is no potable water supply present and the residents get water from either the stores, Royal Victoria Teaching Hospital (RVTH) Sanatorium or from the National Water and Electricity Company (NAWEC) water tanks opposite Mile Two central prison. The photographs taken at this site are shown in Figure 4.1.

Figure 4. 1 (a): Dumping of litter in the intertidal zone

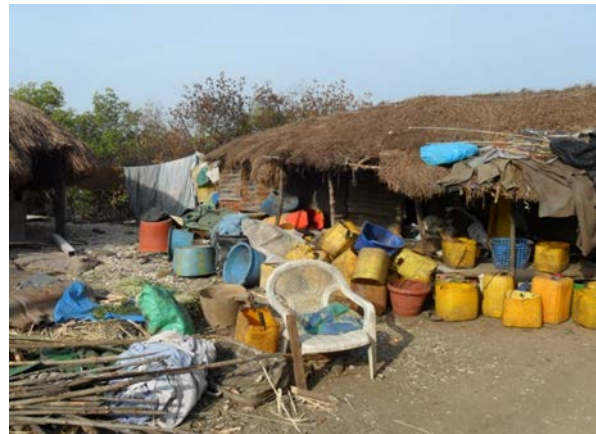
Figure 4. 2 (b): Human settlement at the intertidal zone

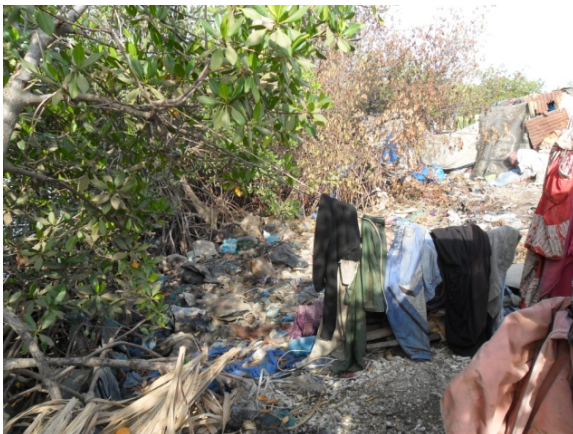
Figure 4. 3 (c): Waste in the intertidal zone

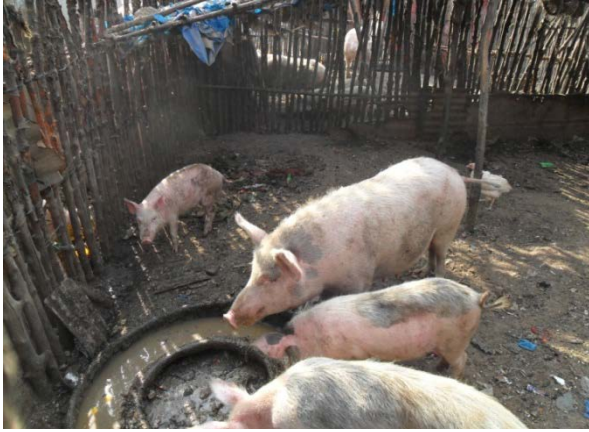
Figure 4. 5 (e): One of the nine pig pens near the intertidal zone

Some sites, especially next to urban settlements have indiscriminate waste dumping next to the estuary. Pig pens located in or near the intertidal zone pollute the water and are the cause of observed elevated coliform bacterial counts in adjacent waters. The water quality data show that the oyster harvesting areas near urban settlements have larger numbers of fecal (FC) and total coliforms (TC) in the water than the sites that are located further from the villages. However it should be noted that in many of the oyster producing sites, water quality based on coliform counts is frequently below the 70 TC/100mL standard of the U.S. NSSP, albeit less frequently below the 14 FC/100 mL standard. These relatively low coliform counts may be explained by the relatively low human population densities in areas directly adjacent to the estuary, and as a result of the lack of the widespread use of urban sewage disposal systems with central collection sewerage and discharge into the waterway. Most toilet facilities in Gambia, when they exist, consist of upland pit latrines that allow for collection, retention and some soil treatment of human fecal wastes, thus minimizing likelihood of contaminants reaching the river or estuary (as discussed by Rice et al., 2012). These findings suggest that attention to improvements to sanitary toilet systems in the upland that focus on technologies for the collection, retention, composting and recycling of fecal wastes may be a highly effective means to achieve goals of public health, but sanitation of shellfish-producing waterways as well.

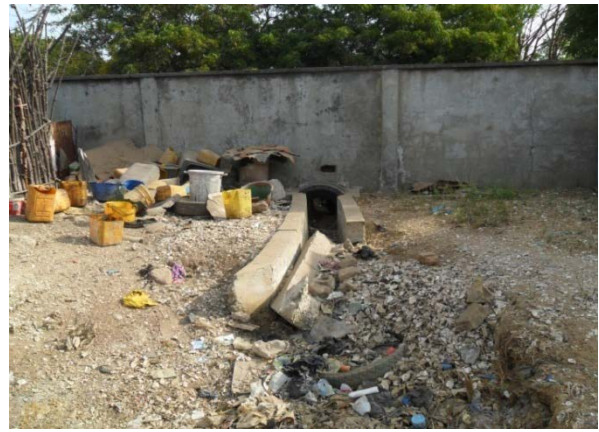
Figure 4. 6 (f): Drainage channel emptying into the river from nearby facility

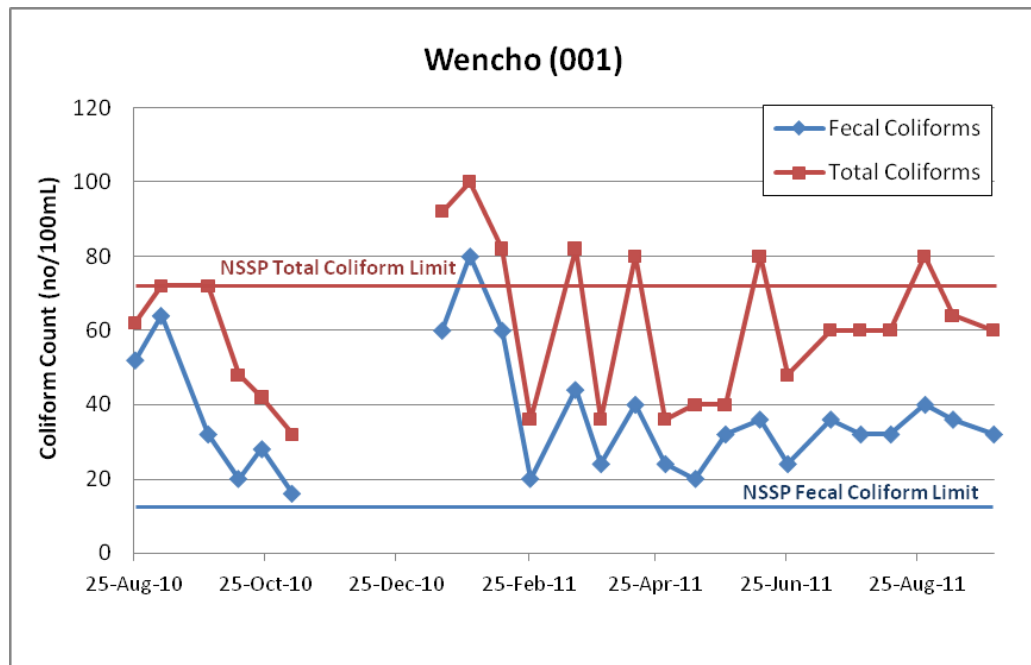
Figure 4.1 (g) shows that measured Fecal Coliforms at this site are above the established NSSP Fecal Coliform limit (14 MPN/100mL). Total Coliforms also exceeded the limit for Total Coliforms (70 MPN/100mL) set by NSSP.

Figure 4. 7 (g): Fecal and Total Coliforms for Wencho site.

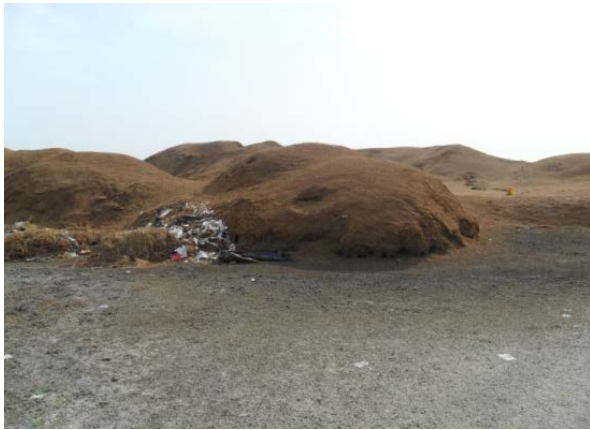
Heaps of groundnut shells present on the side of the wetland. A rubbish heap is obstructing the stream water flow and contributing to the contamination of the aquatic environment. There are no toilets and sanitary facilities available and the place has an illegal waste dumping site. At the time of the survey, there was no oyster harvesting activity taking place

Figure 4.2 (a): Heaps of groundnut shell and a rubbish dumping site

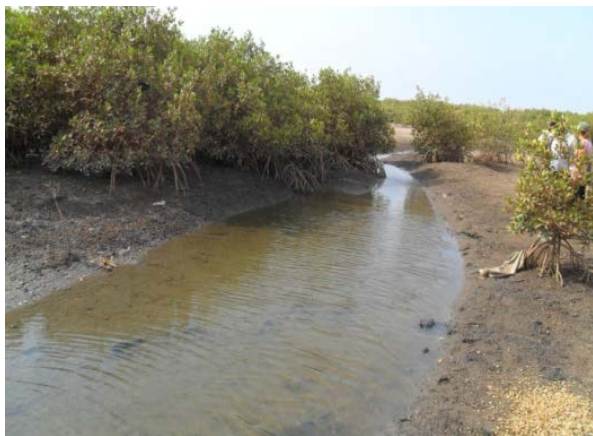
Figure 4.2 (c): Potentially contaminated stream flowing into mangroves

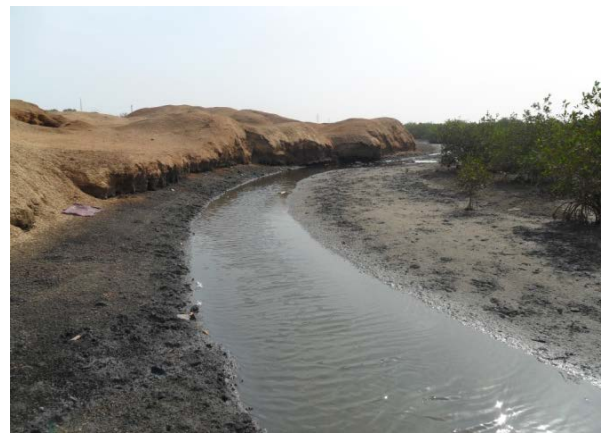
Figure 4.2 (d): Heaps of ground nut shells obstructing stream water flowing into the mangroves

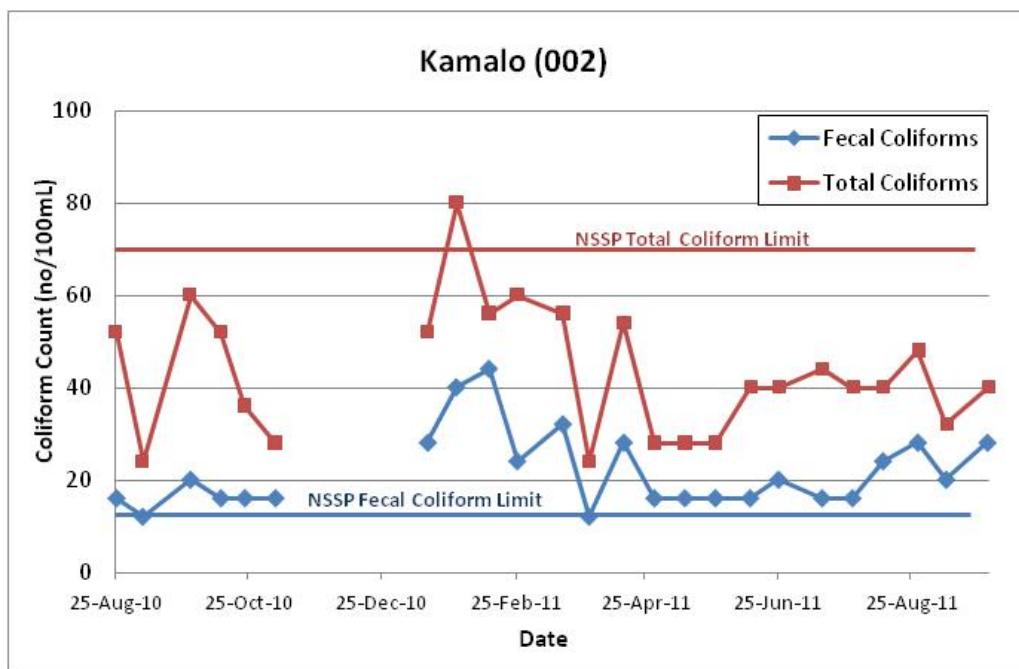
Figure 4.2 (e) shows that measured Fecal Coliforms at this site are above the NSSP limit. Total Coliforms exceeded the limit for Total Coliforms set by NSSP only once during the data collection period.

Figure 4.2 (e): Fecal and Total Coliforms for Kamalo site.

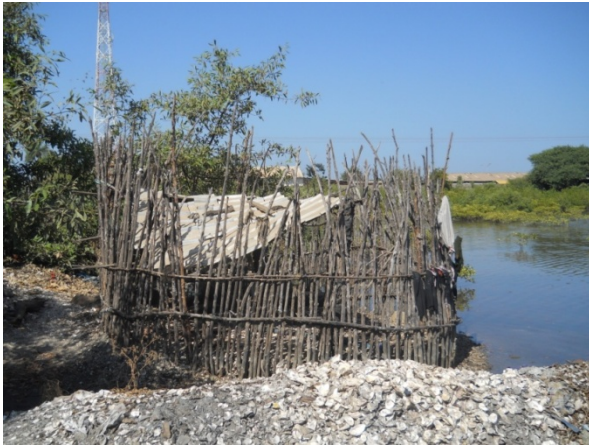
There are no toilets and sanitary facilities available at the landing site. As can be seen from Figure 4.3 (a), there is a pig pen located at the intertidal zone. At the time of the survey, there was no oyster harvesting activity. The site is used for dumping of human and other wastes and trash scattered over the place as shown in Figure 4.3 (b). A woman fish smoker was resting (Figure 4.3 (c)) and waiting for the arrival of fishermen from the sea. The fact that fisheries activities are happening at the landing without a specified dumping and sanitary facilities are a cause for concern.

Figure 4.3 (a): A pig pen located in the inter-tidal zone

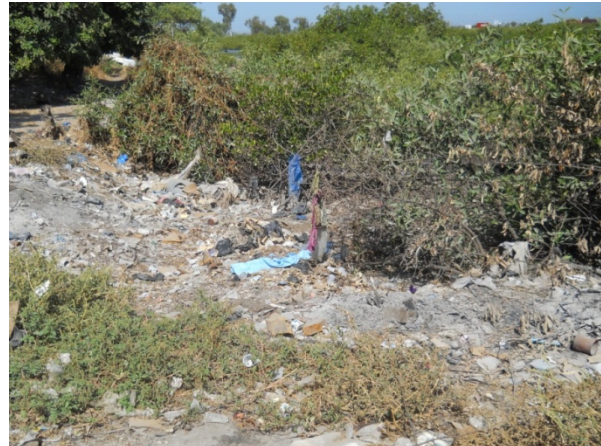
Figure 4.3 (b): Trash scattered over the inter-tidal zone

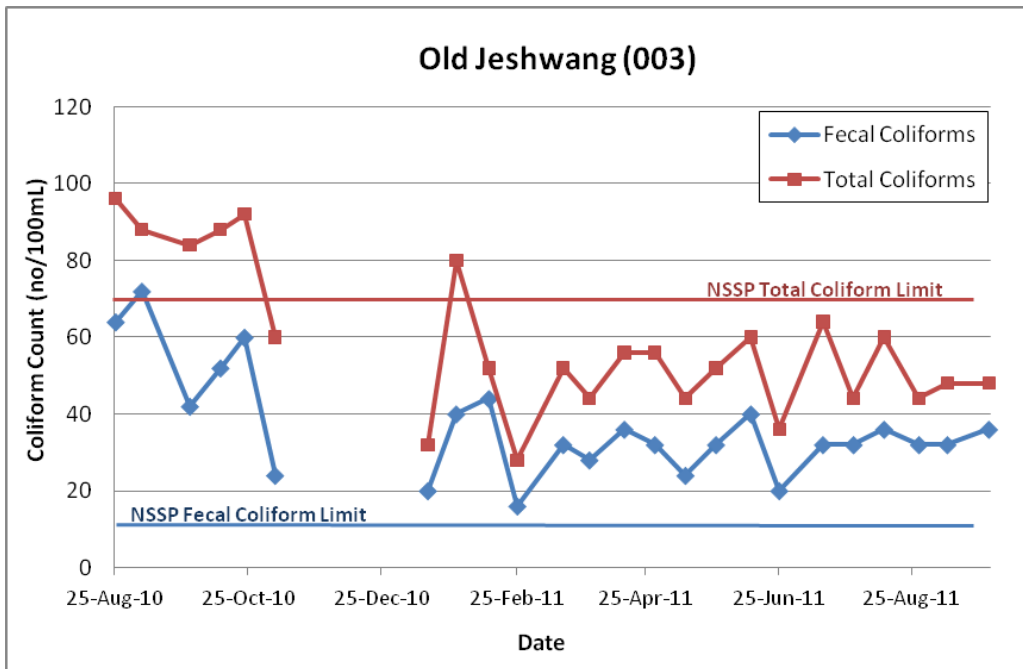
Figure 4.3 (d) shows that measured Fecal Coliforms at this site are above the NSSP limit. Total Coliforms exceeded the limit for Total Coliforms set by NSSP during data collection in 2010.

Figure 4.3 (d): Fecal and Total Coliforms for Old Jeshhwang site.

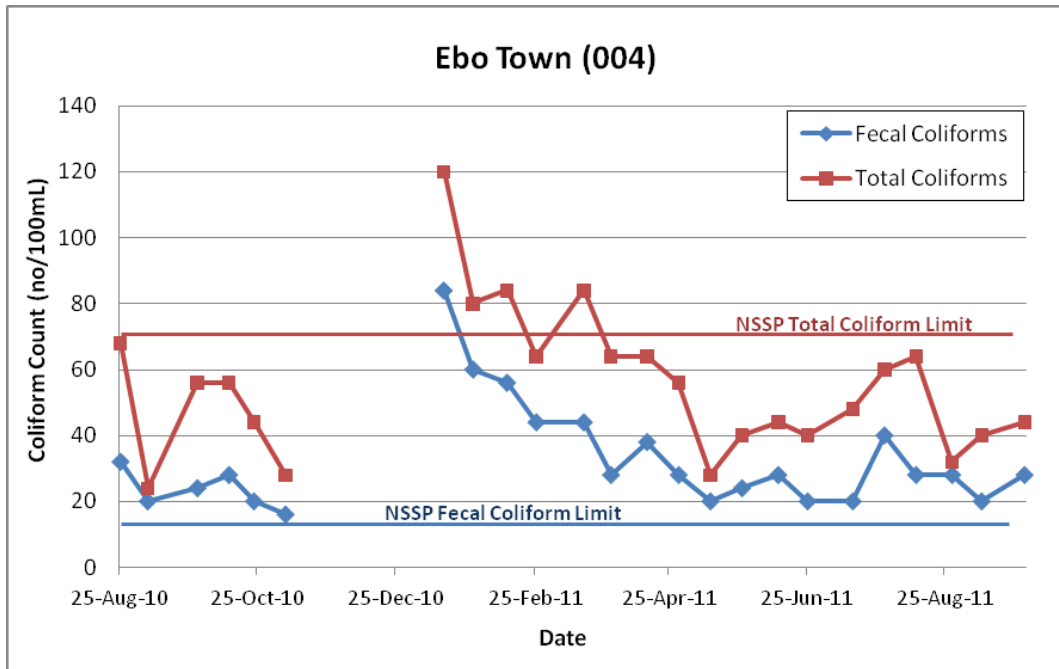
Figure 4.4 (d) shows that measured Fecal Coliforms at this site are above the NSSP limit. Total Coliforms exceeded the limit for Total Coliforms set by NSSP during data collection in 2010 and beginning of 2011.

Figure 4.4 (d): Fecal and Total Coliforms for Ebo Town site.

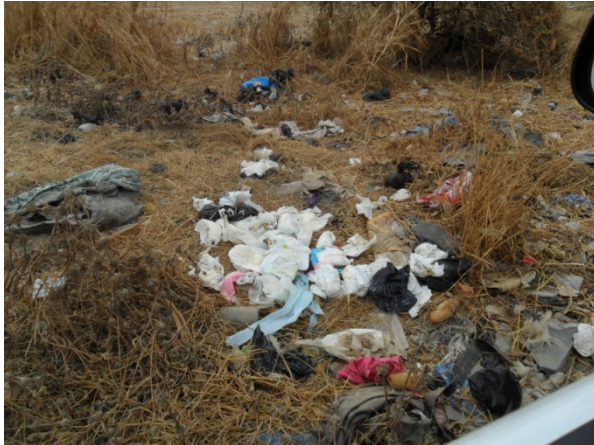
There are no toilets and sanitary facilities available at the site. The team observed indiscriminate dumping of wastes and non-biodegradable substances near the intertidal zone as can be seen in Figure 4.5.

Figure 4.5 (a): Indiscriminate dumping site close to the mangroves

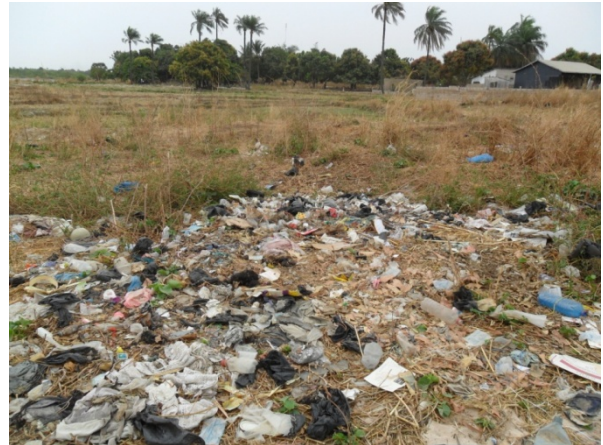
Figure 4.5 (b): A dumping site

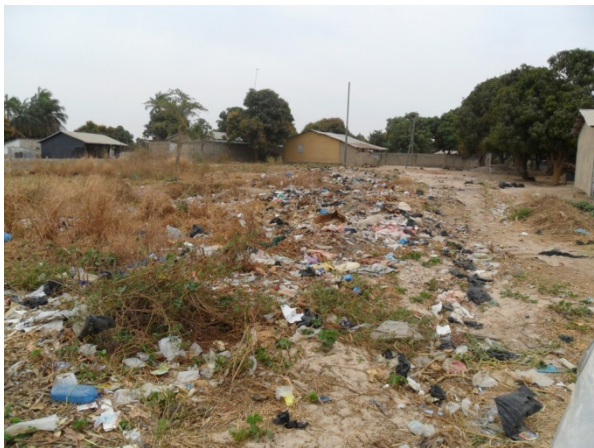
Figure 4.5 (c): Settlements and rubbish dumping site along the storm runoff path

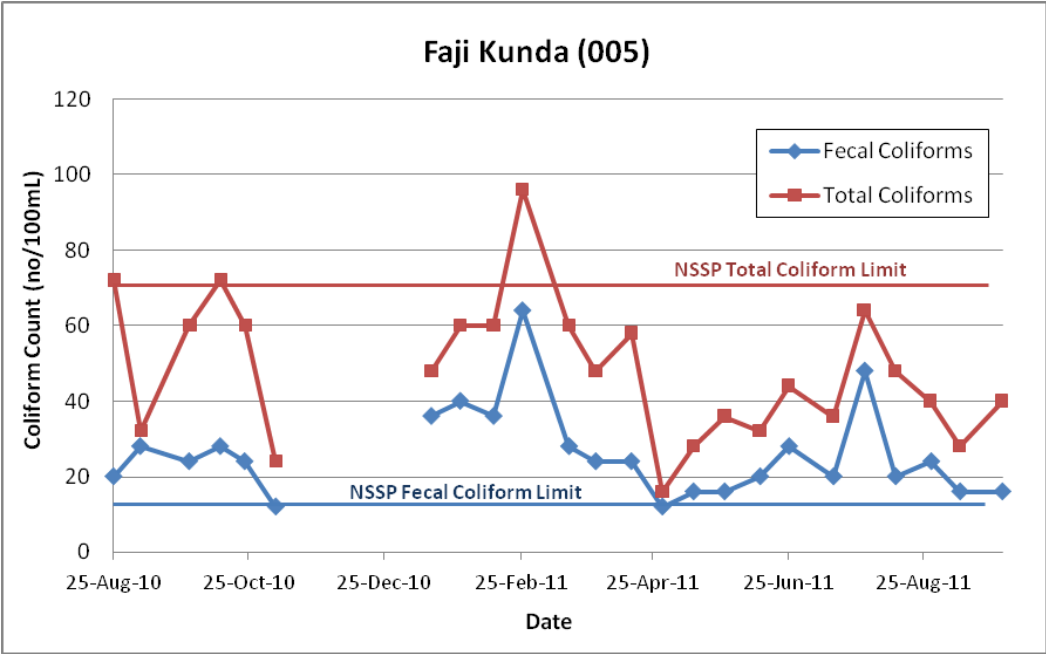
Figure 4.5 (d) shows that measured Fecal Coliforms at this site are above the NSSP limit. Total Coliforms exceeded the limit for Total Coliforms set by NSSP during data collection in February 2011.

Figure 4.5 (d): Fecal and Total Coliforms for Faji Kunda site.

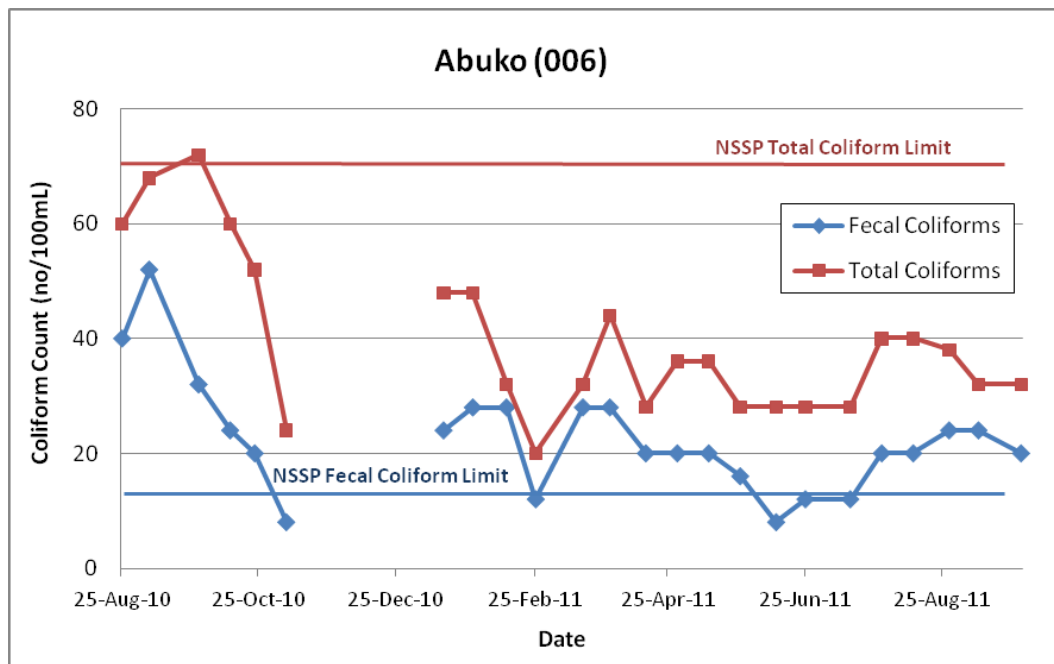
Figure 4.6 (c) shows that measured Fecal Coliforms at this site are above the NSSP limit. Total Coliforms exceeded the limit for Total Coliforms set by NSSP during data collection in September 2010.

Figure 4.6 (c): Fecal and Total Coliforms for Abuko site.

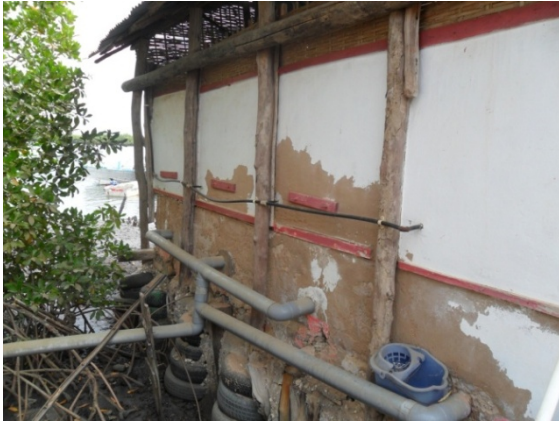
Lamin Lodge is located at the intertidal zone and it is a very important tourist centre. It is one of the sites within TWNP that has toilet facilities. However, the toilets are located in the intertidal zone near the fish landing site and un-treated human waste is directly emptied into the river through drainage pipes from Lamin Lodge itself. Waste dumps, tourist boats and fishing/oyster harvesting boats are present at the site (see Figure 4.7).

Figure 4.7 (a): Drain pipes from Lamin Lodge toilets emptying directly into the estuary

It is evident that only Lamin Lodge (Code 007) and Kartong (Code 015) have sanitary facilities with water seal toilets, but these facilities are designed to discharge directly into the adjacent waterways. The rest of the oyster harvesting and processing sites lack any facilities. The sites also do not have water supply and water is usually carried from the nearby villages and/or compounds.

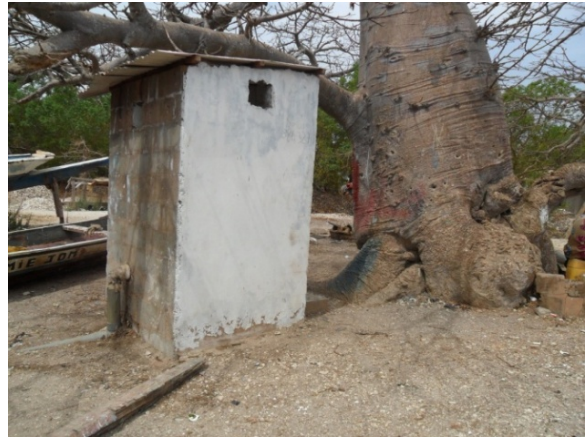
Figure 4.7 (b): An outside toilet which empties directly into the estuary

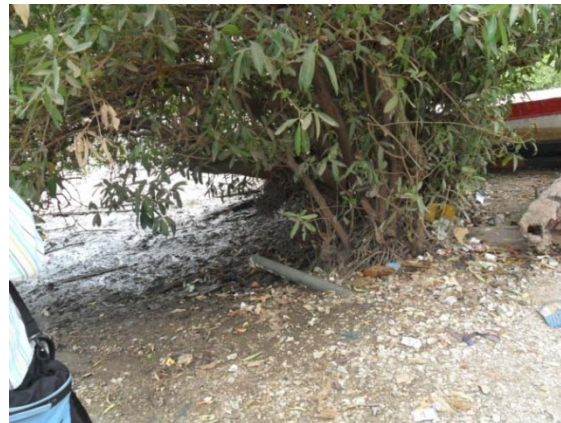
Figure 4.7 (d): Drain pipe from the outside toilet emptying into the estuary

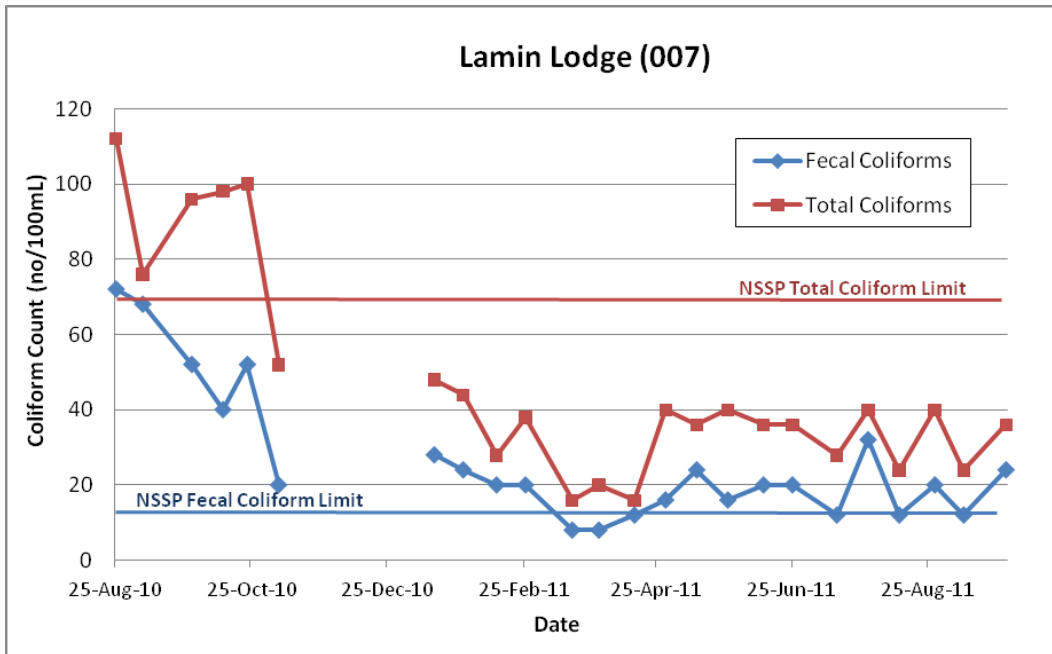
Figure 4.7 (e) shows that measured Fecal Coliforms at this site are on the lower side but still above the NSSP limit. Total Coliforms exceeded the limit for Total Coliforms set by NSSP during data collection in 2010.

Figure 4.7(e): Fecal and Total Coliforms for Lamin Lodge site

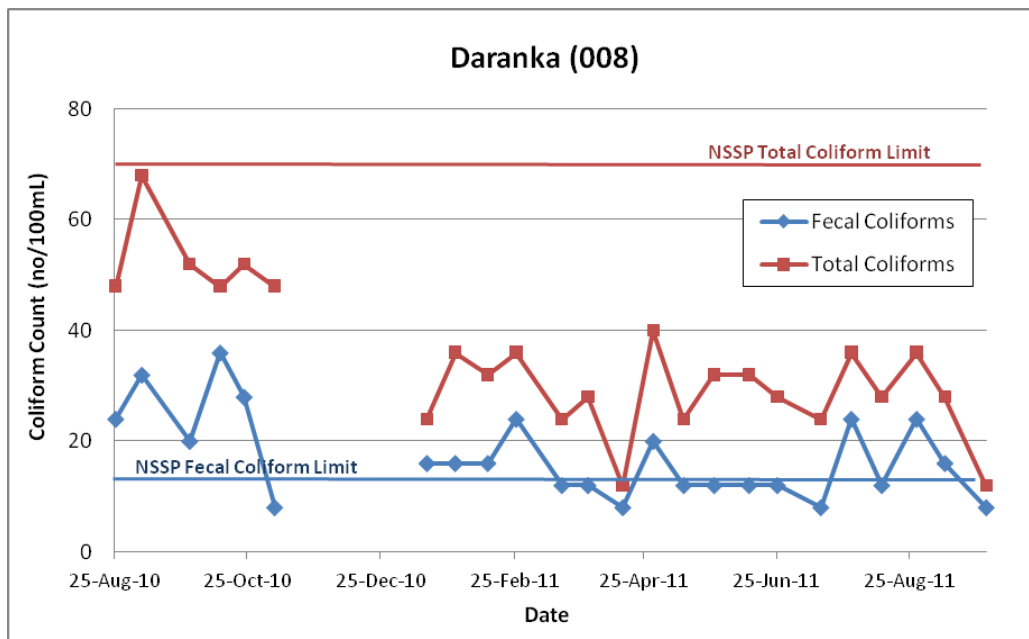
Figures 4.8 (c) and (d) show that measured Fecal Coliforms at this site are on the lower side but still above the NSSP limit. For both, Daranka and Kerewan, sites Total Coliform count is below the limit for Total Coliforms set by NSSP.

Figure 4.8(c): Fecal and Total Coliforms for Daranka site.

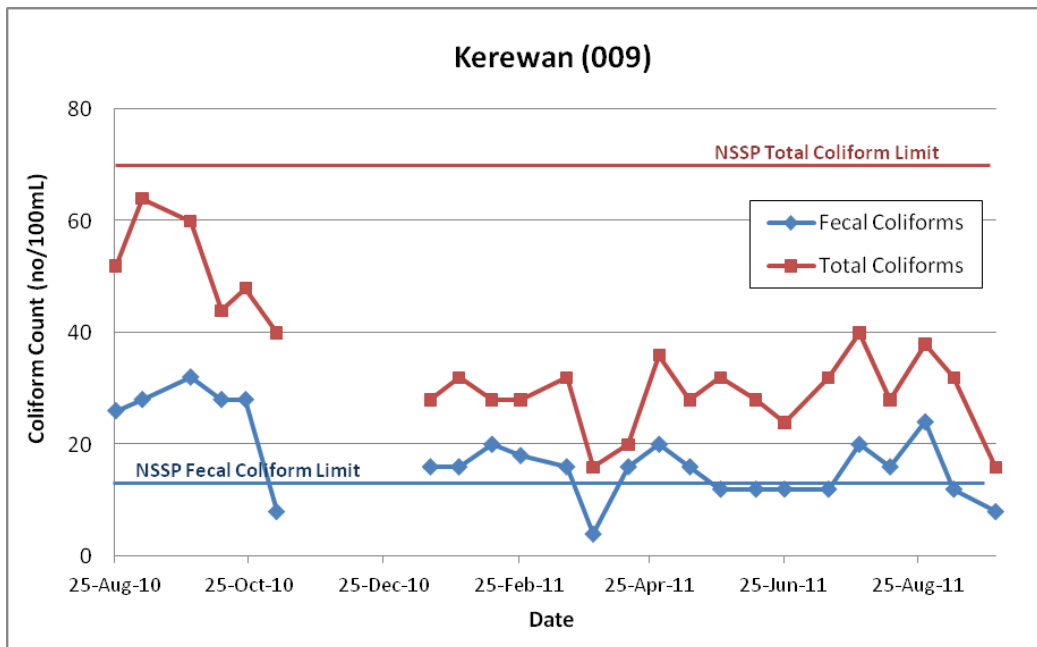
Figure 4.8(d): Fecal and Total Coliforms for Kerewan site.

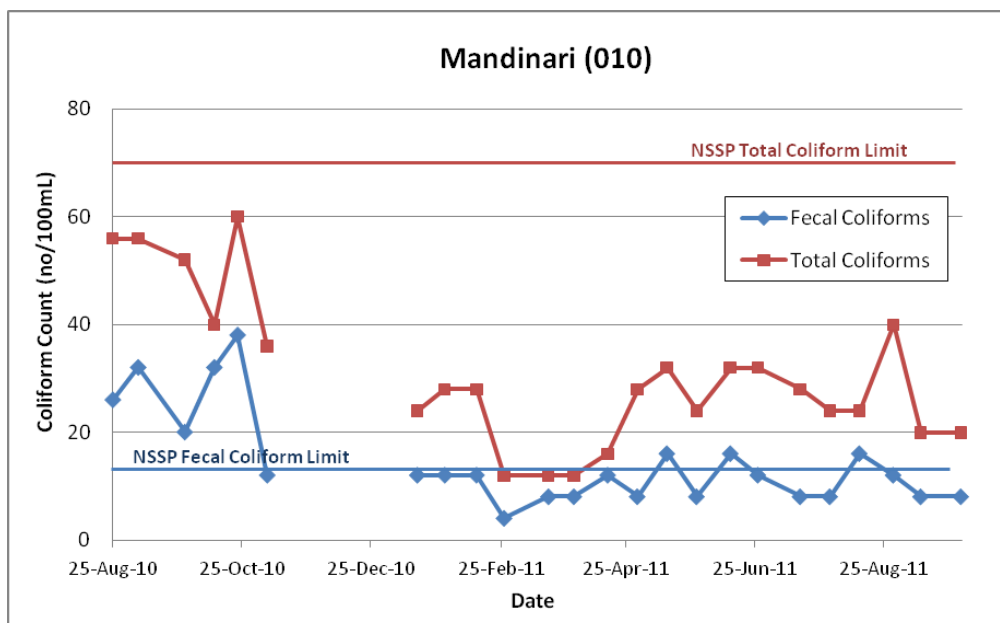
Figure 4.9 (d) shows that measured Fecal Coliforms at this site are near the NSSP limit and Total Coliform count is below the limit for Total Coliforms set by NSSP.

Figure 4.9(d): Fecal and Total Coliforms for Mandinari site.

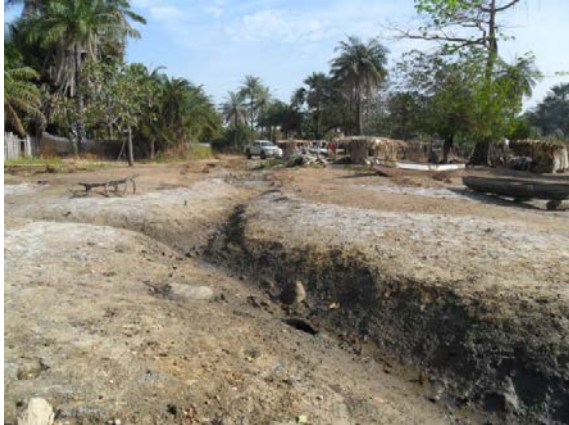
There are no water and sanitary facilities provided at the site. Moderate erosion as a consequence of storm water runoff into the mangroves is shown in Figure 4.10 (a). The women oyster harvesters were found processing and grading oysters into the different sizes (see Figure 4.10 (b)). The site is also used for washing of animals, boat landing, drying of mangrove logs and orchards are located not far from the estuary.

Figure 4.10 (a): Erosion of the water way leading to the estuary

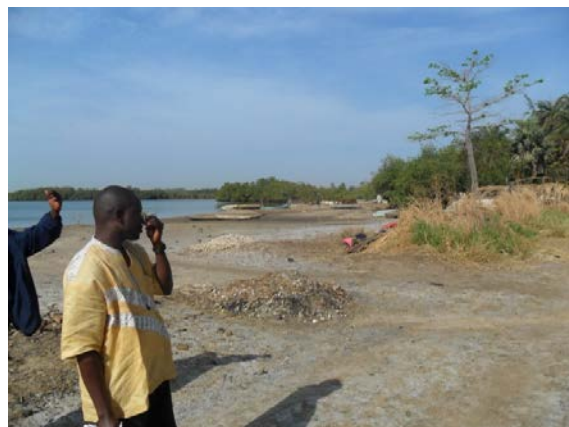
Figure 4.10 (c): Rubbish heap near the intertidal zone

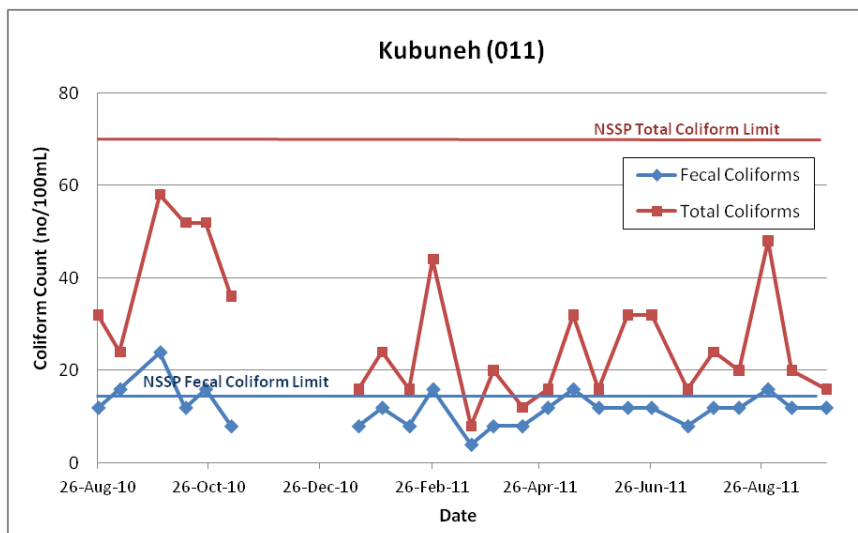
Figure 4.10 (d) shows that measured Fecal Coliforms at this site are below the NSSP limit (most measurements) and Total Coliform count is below the limit for Total Coliforms set by NSSP. The water quality monitoring results shows that the sanitation conditions at this site are nearly acceptable.

Figure 4.10 (d): Fecal and Total Coliforms for Kubuneh site.

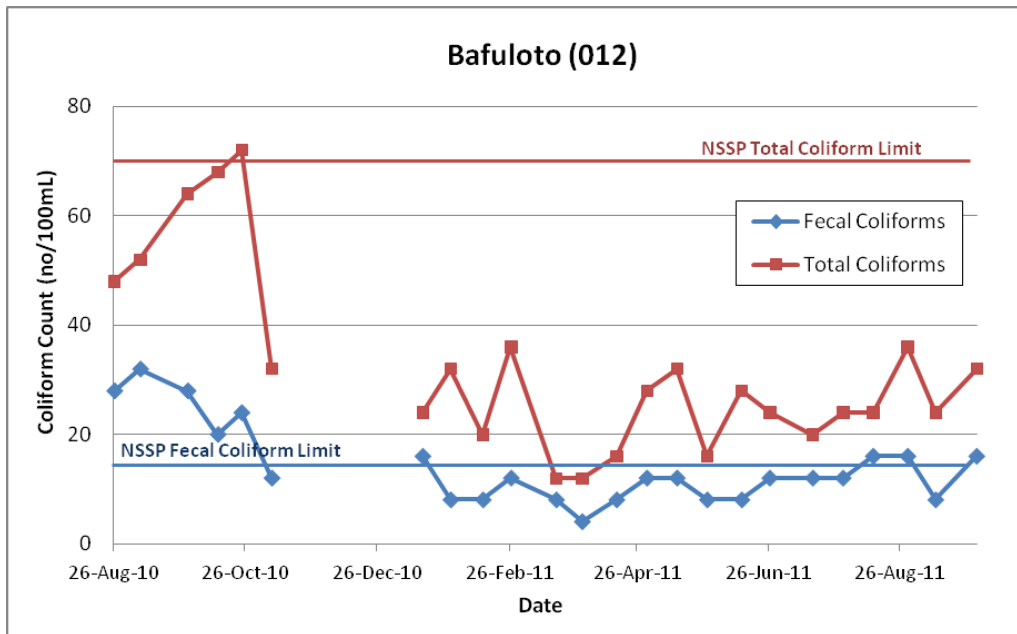
Figure 4.11 (d) shows that measured Fecal Coliforms at this site are below the NSSP limit (most measurements) and Total Coliform count is below the limit for Total Coliforms set by NSSP, except for October 2010 data. The water quality monitoring results shows that the sanitation conditions at this site, like Kubuneh, are nearly acceptable.

Figure 4.11 (d): Fecal and Total Coliforms for Bafuloto site.

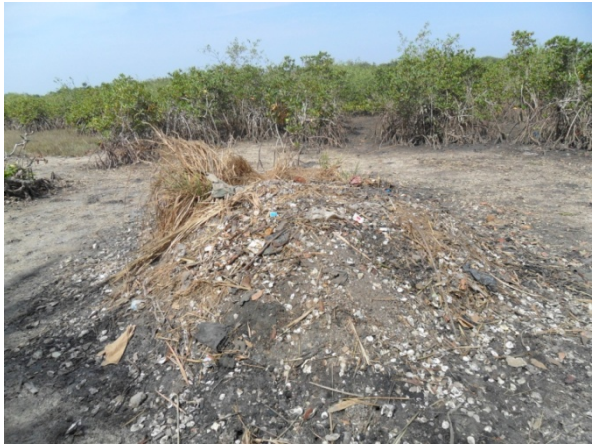
Figure 4.12 (c): Dump site near the intertidal zone

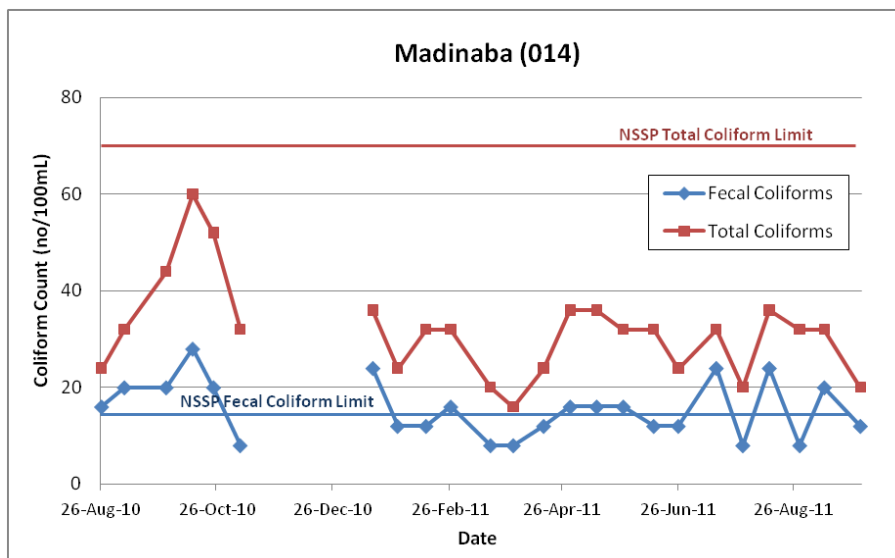
Figure 4.13 (d) shows that measured Fecal Coliforms at this site are on the lower side but still above the NSSP limit. However, Total Coliforms have not exceeded the limit for Total Coliforms set by NSSP.

Figure 4.13 (d): Fecal and Total Coliforms for Mandinaba site.

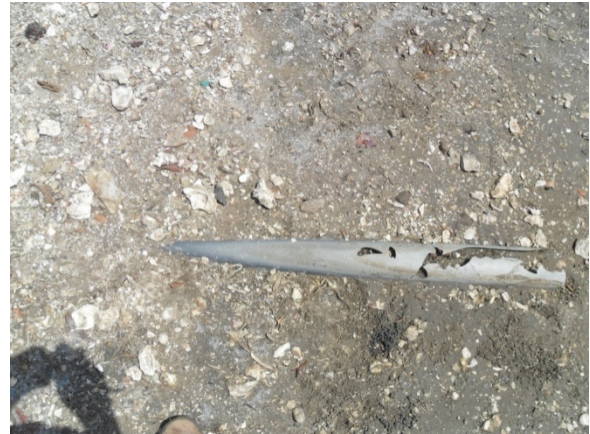
The oyster processing/boat landing site is located approximately 2.5 kilometers from the Kartong village. There are two bars and restaurants and one of them has toilet facilities, but the effluent drain pipe leads to the estuary. Sanitary facilities for oyster harvesters and fishermen are not available. Water supply is not available and water used for fisheries and other related activities is brought from the village. The site is rarely used for recreational swimming purposes due to strong currents (Figure 4.14).

Figure 4.14 (b): Drain pipe from restaurant's toilet discharging directly into the stream

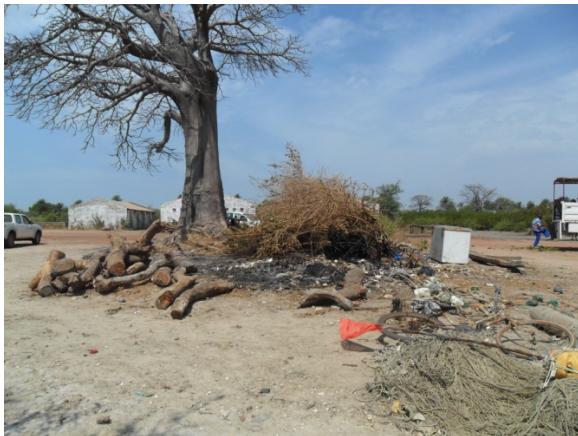
Figure 4.14 (c): Trash burning site near the stream

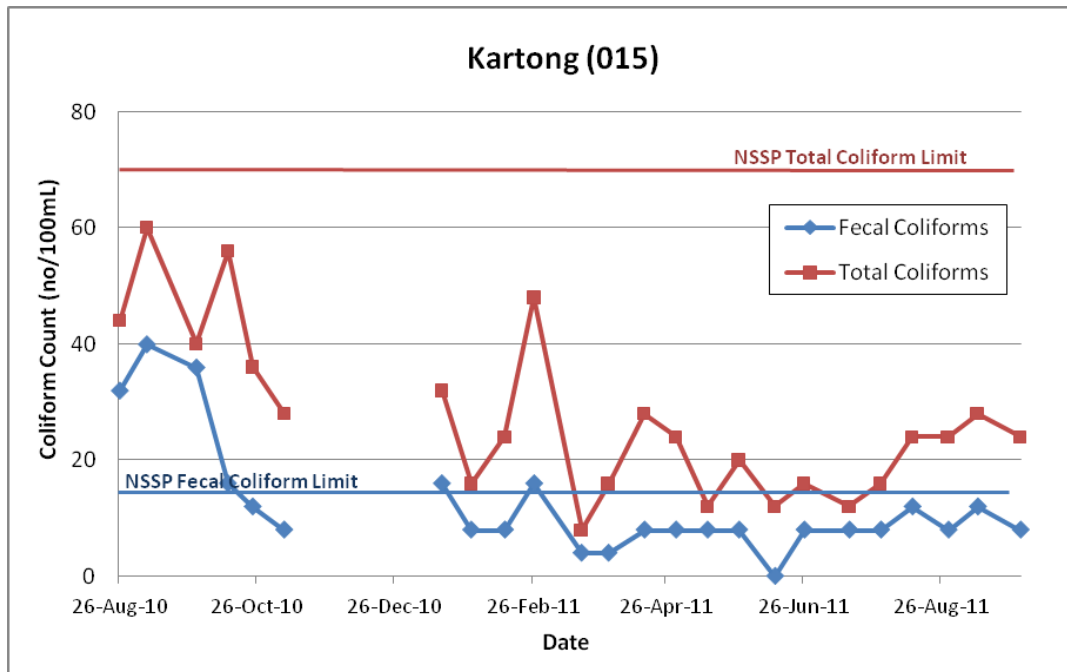
Figure 4.14 (e) shows that measured Fecal Coliforms at this site are below the NSSP limit during most of the data collection period. Total Coliforms have not exceeded the limit for Total Coliforms set by NSSP.

Figure 4.14 (e) : Fecal and Total Coliforms for Kartong site.
