USDA Forest Service Technical Assistance Trip

Wami River Resource Assessment

Rapid Assessment of the Interdependence of the Wami River to the Ecosystems and Biodiversity of Saadani National Park, United Republic of Tanzania

Mission Dates: January 27 – February 10, 2007

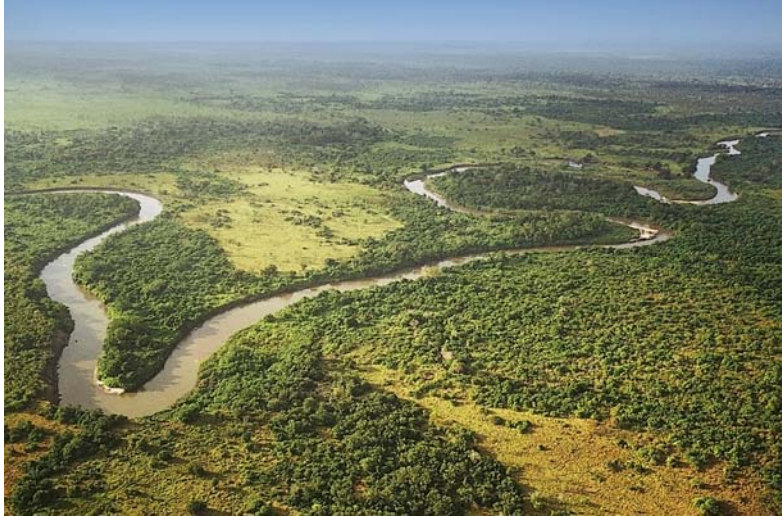
Figure 2. Wami River in Saadani National Park.

Wami River Hydrology: The lower reaches of the Wami River in the vicinity of the park are classified as a C5 and C6 stream types (Figure 2). These stream types are slightly entrenched, meandering, sand (C5) or silt (C6) dominated, riffle/pool channels with cutbanks and pointbars, and a well-developed floodplain (Rosgen, 1996). These stream types are very dynamic and have a very high sediment supply. They are generally very sensitive to disturbance and have high to very high potential for stream bank erosion. On the other hand they also have fair to good potential for recovery when there is adequate vegetation providing bank stabilization (Rosgen, 1996).

A rapid resource assessment of the lower Wami River basin indicates that the river is functioning at risk. Currently the river has access to its floodplain, with decent riparian vegetation grading from good and recovering within the park to poor in isolated areas of active agriculture just outside of the park. The river is not fully supporting beneficial uses of drinking water and a freshwater fishery, but still supports viable populations of wildlife that depend upon it to some extent all year.

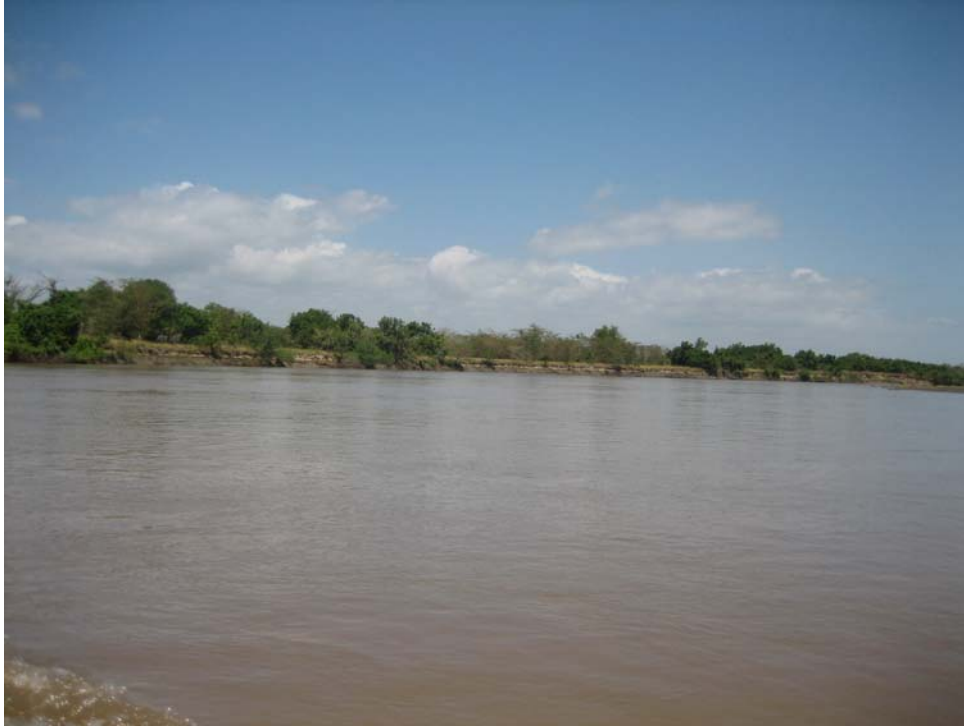
Figure 4. Vegetation transition riparian gallery forest to open woodland with increased bank height. Site of vegetation transect.

Findings and Concerns: During field investigations, especially along the lower reaches of the Wami River, we found several instances where even slight increases in bank height (vertical departures from bank full, or flood stage) gave rise to an entirely different community of riparian vegetation (Figures 3 and 4). The normally dense riparian (or riverine/gallery) forest that benefit from regular inundation and an influx of sediment and nutrients growing on the active floodplain would transition to a more open grassland/acacia woodland vegetation type with an increase in bank height. On the floodplain of the lower Wami River, these forest assemblages include an array of mangrove and palm species (*Nypa fruticans* – also known as a mangrove palm) that transition to species compositions included in closed deciduous, ground water, or riverine forest types (Mugasha et al. 2004) as salinity decreases away from the zone of tidal influence (Figure 3). Besides relying on regular periods of inundation, these species all require a high water table (Mugasha et al. 2004). In-stream flow reductions and the depression of groundwater levels have contributed to the decline or alteration of riparian ecosystems throughout the world (Stromberg et al. 1996).

To demonstrate how vegetation reacts to increases in bank height on the lower Wami, we carried out a 2100 foot (640 meters) transect along the bank pictured above (Figure 4) that measured the vertical separation from the active floodplain (bank height) and ground cover in a 10 foot by 10 foot (3x3 meter) square adjacent to the bank. Ground cover was broken down into categories of bare ground, herbaceous species, shrubs, and trees. Tree species were also categorized and grouped into palm, mangrove, acacia, or “other.” Our general findings showed that as bank height increased, ground cover shifted from an almost 100 percent tree cover composition with some recently deposited silts to a ground cover that consisted of a somewhat more xeric composition of herbaceous species, bare ground, and sparse trees or shrubs (Appendix G). The intercepts that had sparser tree compositions were generally composed of acacia species – mostly *Acacia zanzibarica* (Figure 5).

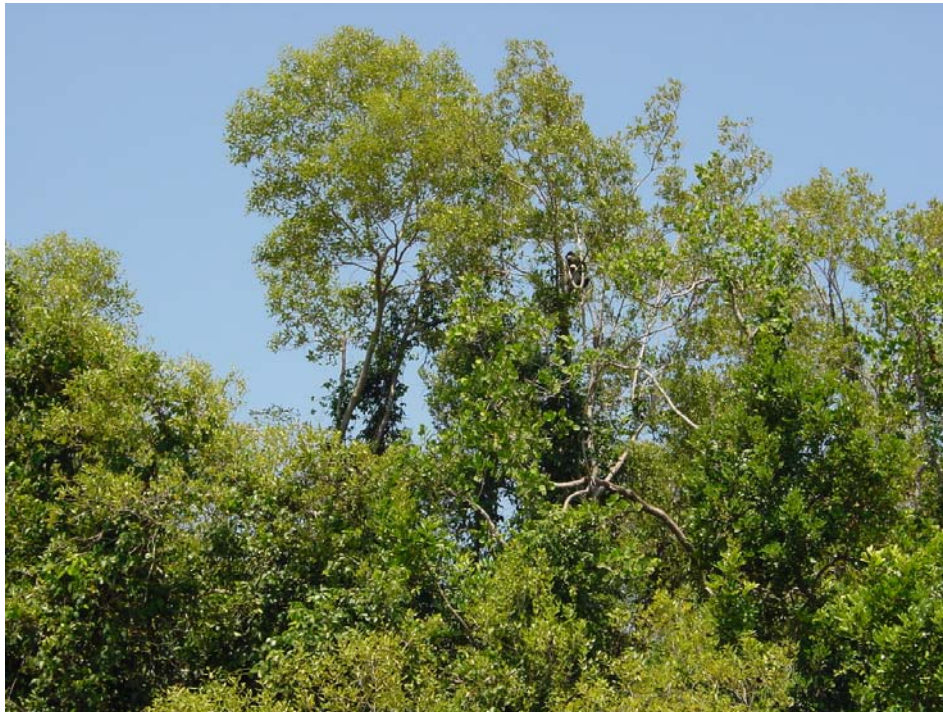
Figure 6. Black and white colobus monkeys in riparian gallery forest.

Riparian gallery forests along the Wami River are critical habitats for black and white colobus monkeys in Saadani National Park (Figure 6). Their only other disjunct occurrence is in the Zaraninge Forest. A variety of birds also rely on these areas for fruits, night roosts, hunting perches and nesting habitat. Dense riparian forests provide important hiding cover for ambush predators. Hippopotamus and crocodiles rely on this vegetation to provide cover while outside of the water and as hippopotamus travel corridors to upland feeding sites. A decline or collapse of this vegetation community compromises the viability of these species along the Wami River.

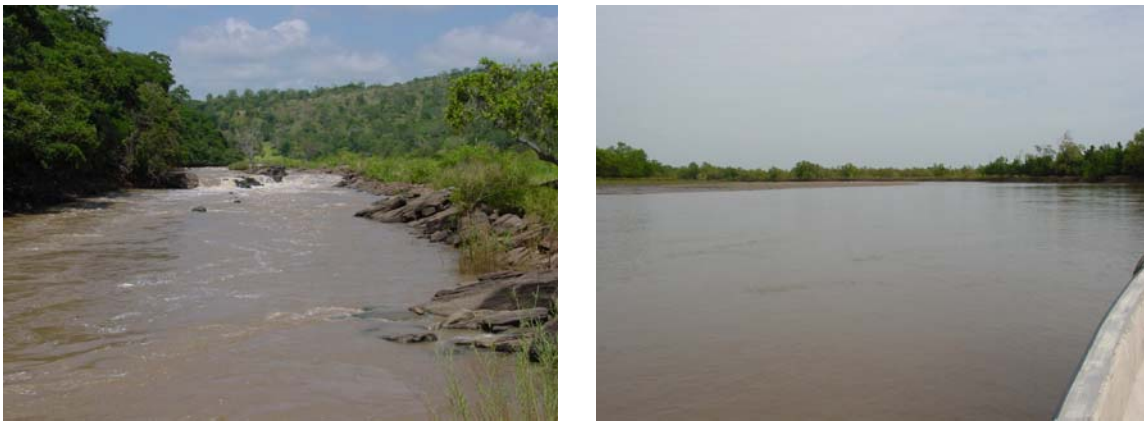
Figure 7. Wami River in a zone of bedrock control (left) and on the coastal plain (right).

This anecdotal information in combination with information we received during discussions with officials at the Chalinze water pumping station increased our concern regarding low flow periods. Pasco Hamuli, Engineer and Project Manager (pers comm. 2007), said that the lowest flows ever recorded at their gauge were $80 \text{ m}^3/\text{sec}$ ($2,825 \text{ ft}^3/\text{sec}$). These flows do not match the physical description of residual pools linked by shallow streams during low flows in the lowest reach of the Wami River. This information indicates that the lower Wami River is losing surface water as it emerges from of the more bedrock controlled uplands onto the coastal plain, which consists mostly of unconsolidated sands and silt. This phenomenon would be more pronounced at times when ground water levels are low. Increases in water withdrawal in the upper reaches of the Wami could further exacerbate problems of low flows in the lower reaches.

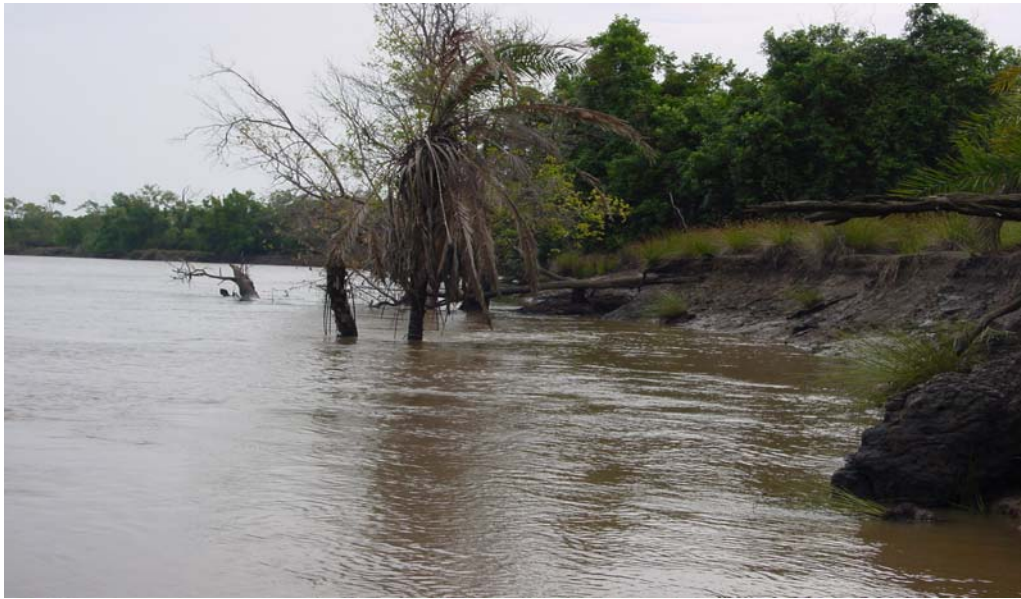
Figure 8. Trees recruited to the active channel through bank erosion.

In our observations, active bank erosion is evidenced by sloughing banks and recruited trees within the active channel (Figure 8). Erosion may be accelerated during periods of widening, channel incision, or channel migration. In the reach of river west of the park closer to Matipwili, the elders observed bank erosion as a process of channel migration (as opposed to incision or widening). Since the time of the grandparents of these elders, the river has migrated approximately four miles (6.5 km.) to the north, with rapid periods of migration taking place at least three times. These migrations have consumed cropland and forced people to change the location of their village to a high terrace above the river. One of the primary livelihood strategies of the people in Matipwili is agriculture – both cultivating the uplands and the floodplain (Figure 9). The elders did verify that bank

Whatever the mechanism, accelerated bank erosion will cause sedimentation and aggradation in alluvial reaches. Aggradation will normally contribute to channel instability by increasing the width-to-depth ratio (as observed in the lowest reaches), further accelerating bank erosion (Brooks et al., 1997). Should this process be exacerbated by degradation in the upper watershed, the riparian gallery forests that support so much diversity along the Wami could be consumed and the Wami River would go through a major period of instability, degradation, and morphological change before reestablishing its equilibrium. Excessive bank erosion would not only compromise the integrity of riparian ecosystems and the stability of the channel, but would have a

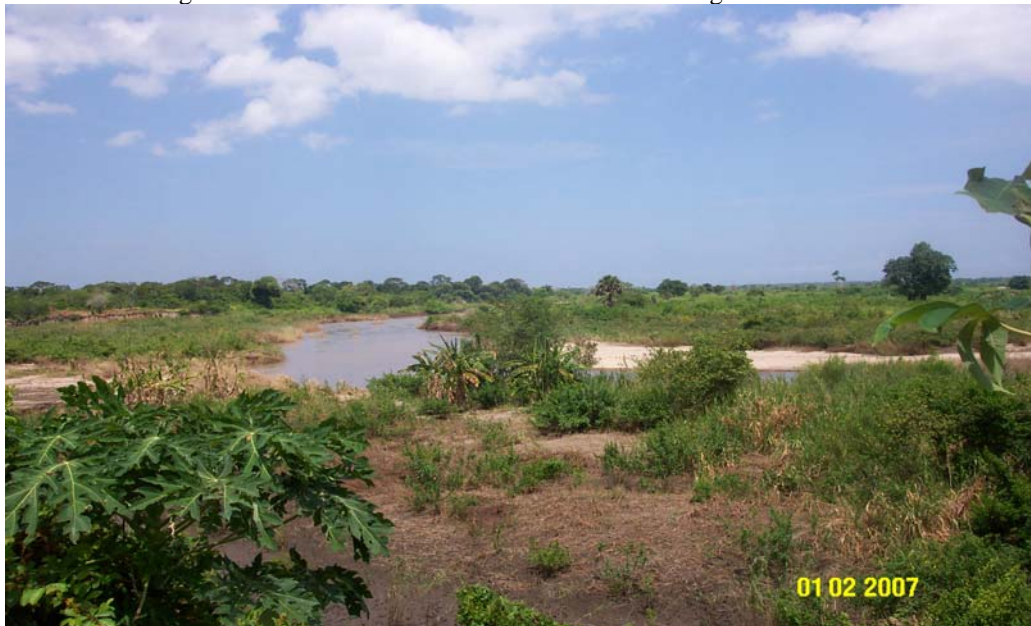
Figure 9. Floodplain agriculture near Matipwili.

erosion and channel migration is occurring more rapidly in areas where the floodplain is cultivated to the river's edge.

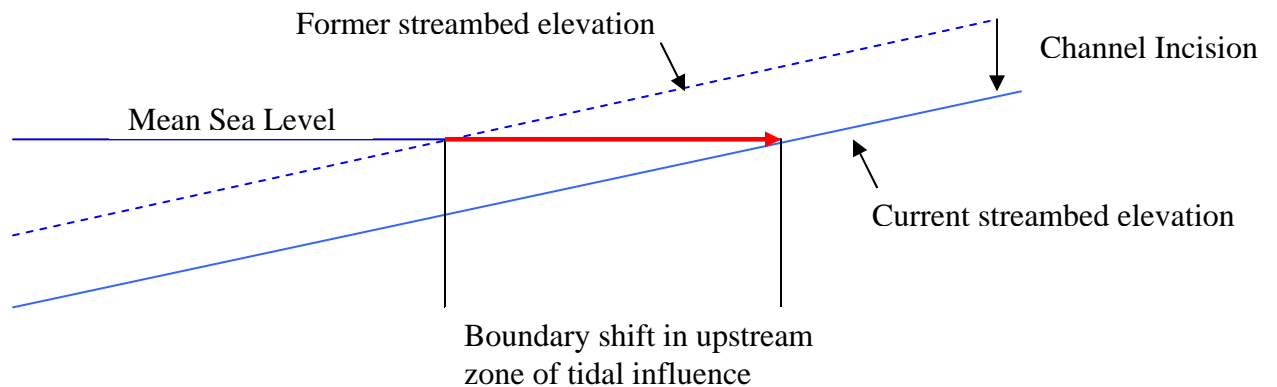
Figure 10. Schematic of the effect of channel incision on upstream zone of tidal influence.

The process of channel incision in the lowest reaches of the Wami was verified by members of both communities and best described in terms of an increase in the upstream distribution of brackish water through tidal influence. As a vertical degradation (incision) of the riverbed occurs near the mouth of a river flowing to the sea, there is an increase in potential for horizontal or inland movement of sea water upriver (Figure 10).

The zone of tidal influence was reported by elders to have moved from the area of the Kinyonga Camp, to Gama Gate (Figure 3) [A more thorough discussion regarding the upstream distribution of brackish water is found in the water quality section below.]

- b. Inventory and monitoring of the upstream extent of tidal influence (or brackish water). Such an inventory would help to anticipate ecological changes that might be expected along the river and its floodplain, and to point to changes in channel morphology. Long-term monitoring would be low-cost and repeated every two to five years depending on available resources and other indications of changing conditions.

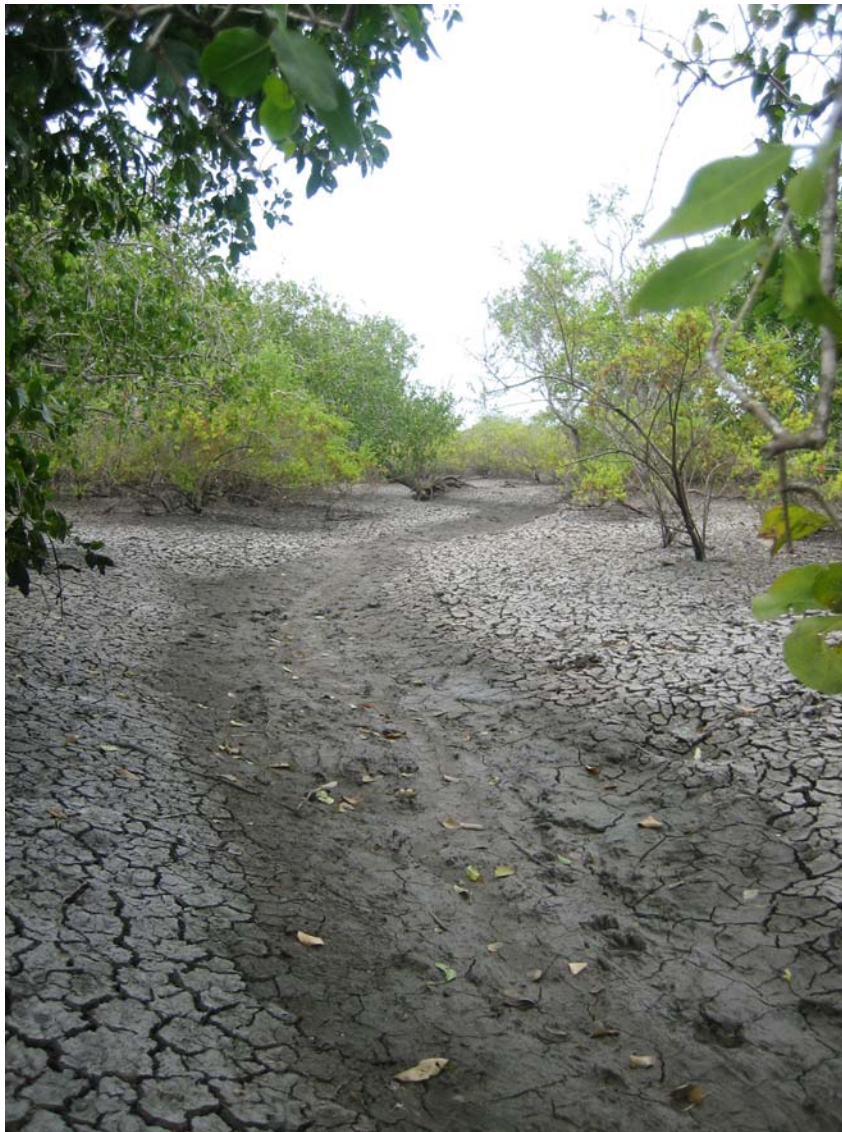
Figure 11. Kinyonga wetland.

We first observed physical evidence of increased salinity in the Wami River in the Kinyonga wetland. The dominant floral composition area of the Kinyonga wetland presently consists of mangrove species that are more tolerant of high ranges in salinity and varied flood regimes (Figure 11). Historically, land-cover in this area was not a mangrove assemblage. Information gathered from a SANAPA ranger and other members of local communities describe the area as having once been under a grassland land-cover type before the area was converted to a sisal plantation. Following the sisal plantation, vegetation succession changed to a mangrove assemblage. It is unclear if one of the components of this vegetation succession could have been land/soil degradation, but the maintenance of the current land-cover type would require periodic inundation with saline or brackish water. This change in vegetation would indicate that the degree of salinity in floodwaters being delivered to the area in the past was not as great as current levels since grasslands and agricultural crops are not tolerant of a high degree of salinity in their soils and floodwaters.

Bare, mud-cracked ground (Figure 11) provided physical evidence that the area is periodically inundated by water. Flood cycles in the Kinyonga are dominated primarily by spring tides. Even during low flow periods in the Wami River, the area will become inundated by a mixture of sea water and river water. During flood stage on the Wami River, the concentration of salinity will be reduced to the point that water is palatable by

animals using the area, but there is always some degree of brackishness (Baraka Kalangahe, pers comm.). As described earlier, through channel incision there is a greater upstream distribution of brackish water from tidal influence. The effects of channel incision in the location of the Kinyonga wetland, where flood waters may have always been somewhat brackish, is that a greater quantity of saline water would be in the floodwater mix during spring tides. In combination with decreased fresh water inputs from the Wami, the degree of salinity during these flood events could greatly increase.

An increase in salinity delivered to the floodplain in this area is a concern for two primary reasons. The Kinyonga wetland is a major migration corridor for animals in the southern part of the park during the dry season. Further change in vegetation composition from grassland to mangrove will limit forage for certain animals moving along this corridor. Also, with greater tidal influence and increased salinity, water remaining in residual pools following floods, as well as in the Wami River itself, is not palatable to animals, so they would have to travel greater distances to find fresh water in the dry

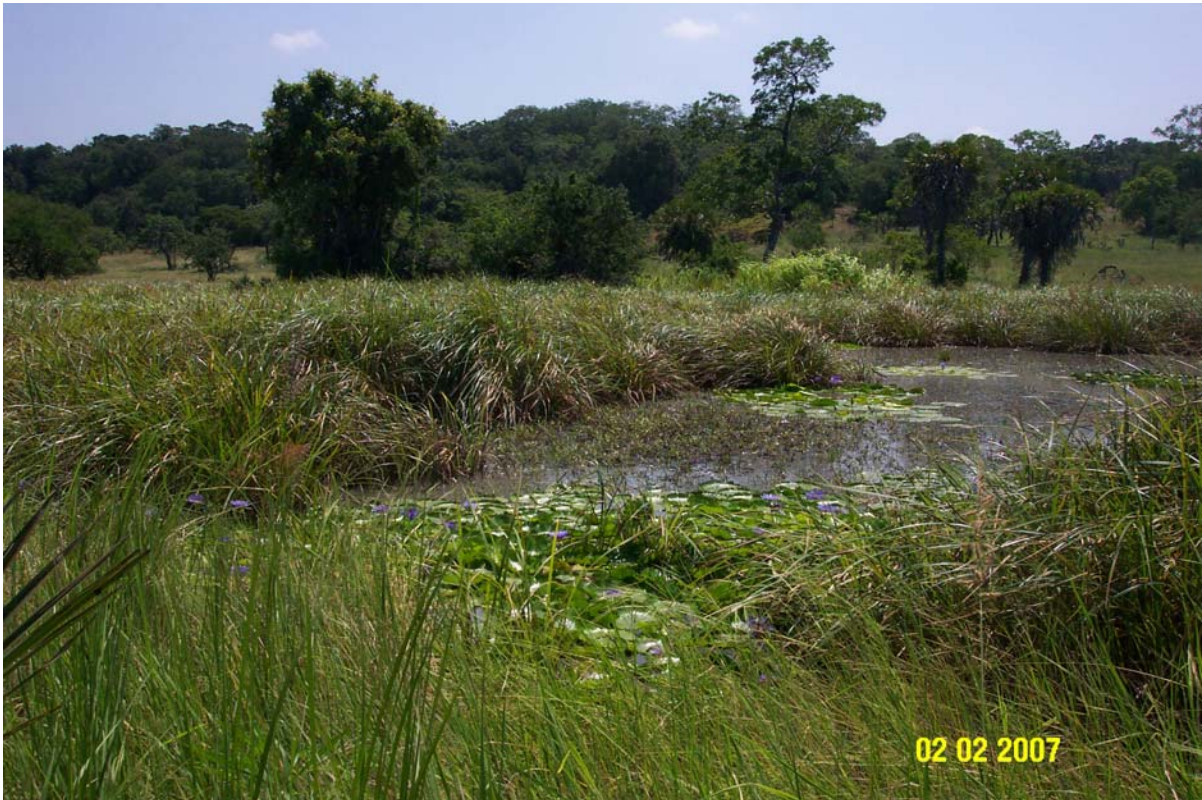
Figure 13. Mabumo wetland.

Two of the three groups of animals depend on the Wami River and adjacent creeks and wetlands for fresh drinking water and high quality forage during the dry season. The largest of these two groups (population 1: giraffe, kongoni, lions, wildebeest, zebra) moves south toward the Kinyonga wetland and the Wami River at the onset of the dry season. The smallest of these two groups (population 3: buffalo, kongoni, reedbuck, waterbuck, wildebeest, warthogs) moves south, at the onset of the dry season, to the Mabumo wetland (Figure 13), continuing on to the wetlands of the Zaraninge Forest, and follow several different routes to the Wami River in the vicinity of Matipwili village.

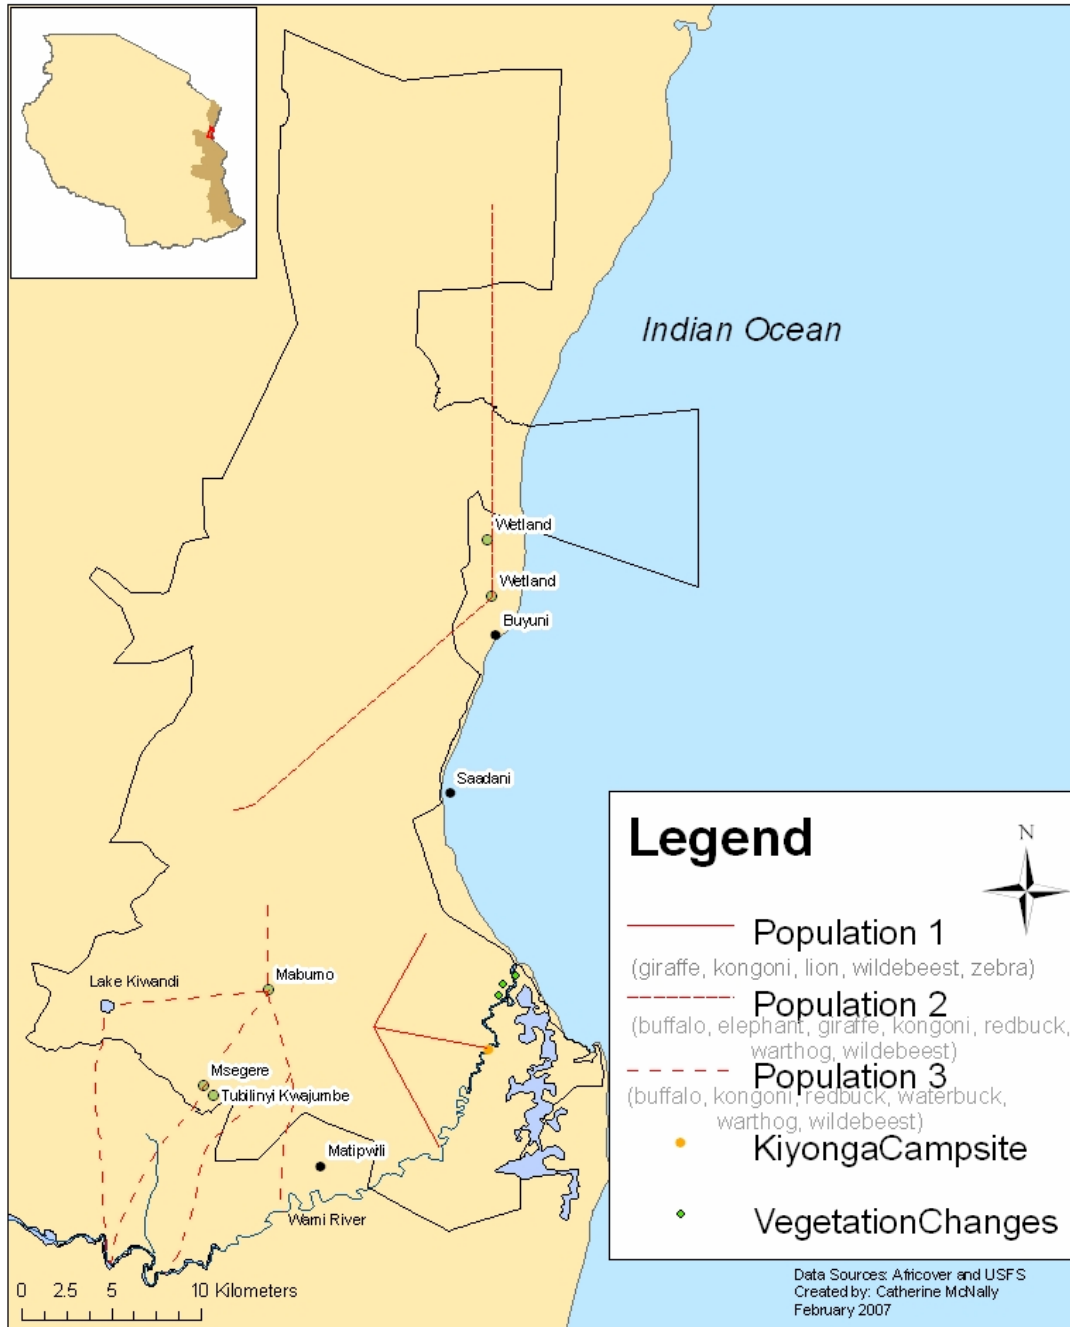
Figure 14. Wildlife migration corridors in Saadani National Park.

[The remaining group (population 2: buffalo, elephant, giraffe, kongoni, kudu, reedbuck, warthogs, wildebeest) is median in size to populations 1 and 3 and move north to the permanent wetlands near Buyuni and further north to the constructed water holes of the former Mkwaja cattle ranch in the north of SANAPA.]

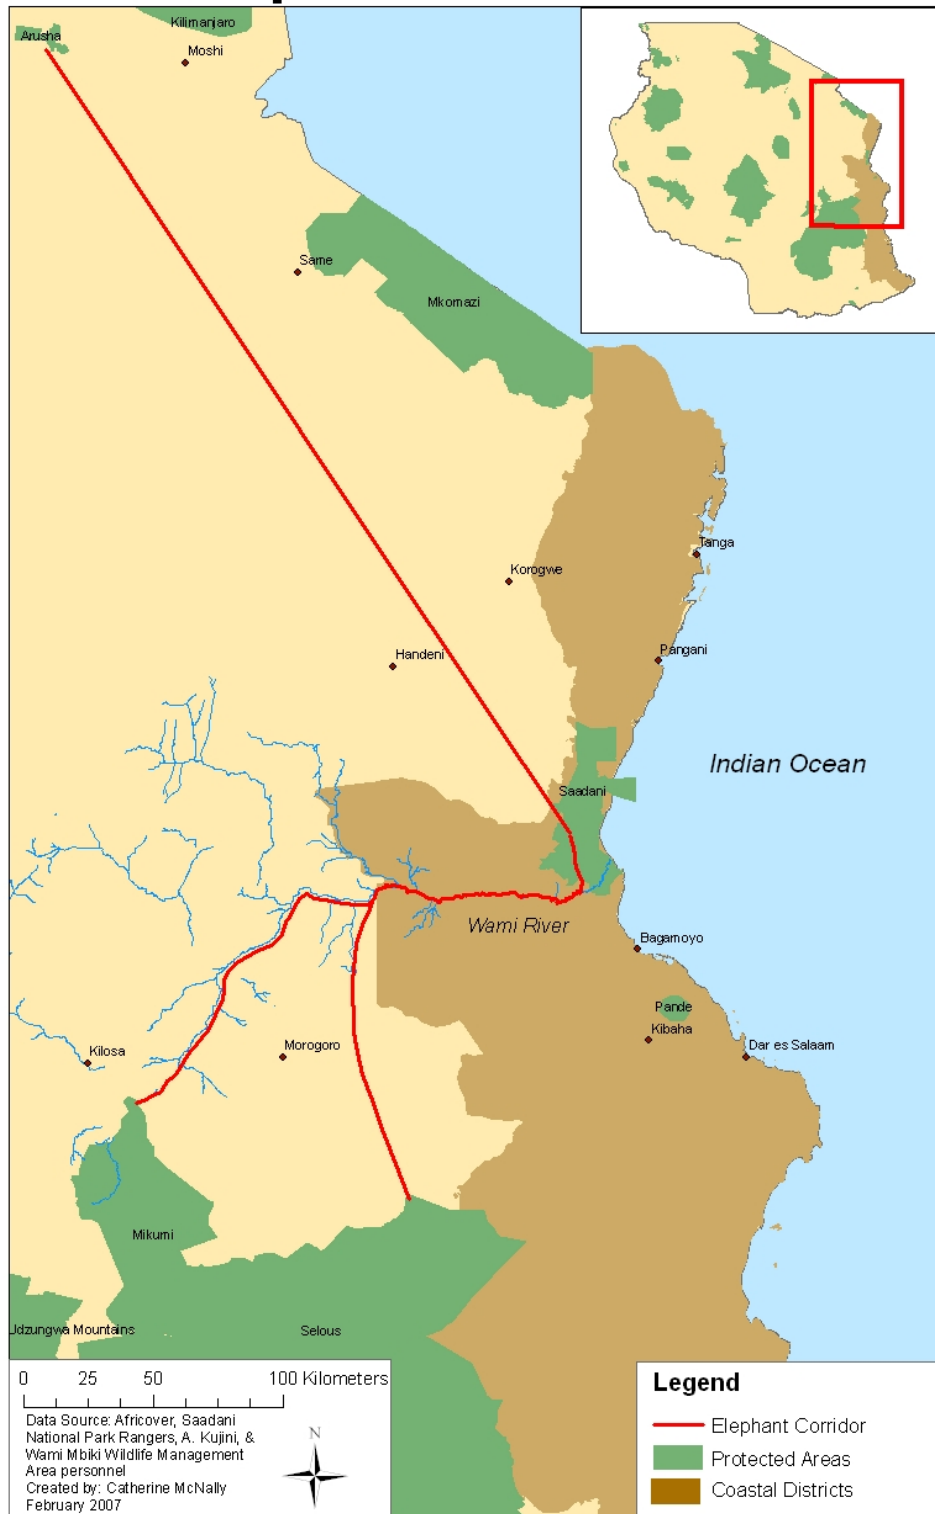
Figure 15. Elephant migration corridor in eastern Tanzania.

The Wami River and Saadani National Park also play a critical role in a larger scale elephant movement corridor. Park Rangers, village elders, and USAID and Wami-Mbiki Wildlife Management Area staff provided information on this corridor as it winds through eastern Tanzania (Figure 15).

Matipwili elders provided detailed information on elephant movements near their village and to the south and southwest in the direction of the Selous Game Reserve. Elephant use of this route, and resultant crop damage along the river, was emphasized as a source of frustration for some Matipwili elders. Matipwili elders described elephants moving from the Saadani village area to Makande and then to the Wami River and Mialeni. From there, the elephants split into two groups: one group continues to Rufuji and beyond; the other group moves upstream to Kisampa Camp, back to the Wami River, to the Wami-Mbiki and on to the Selous Game Reserve and back. SANAPA Ecologist, Halima Ramadhani, may be able to confirm and clarify this described route from her notes from the interview with Matipwili elders.

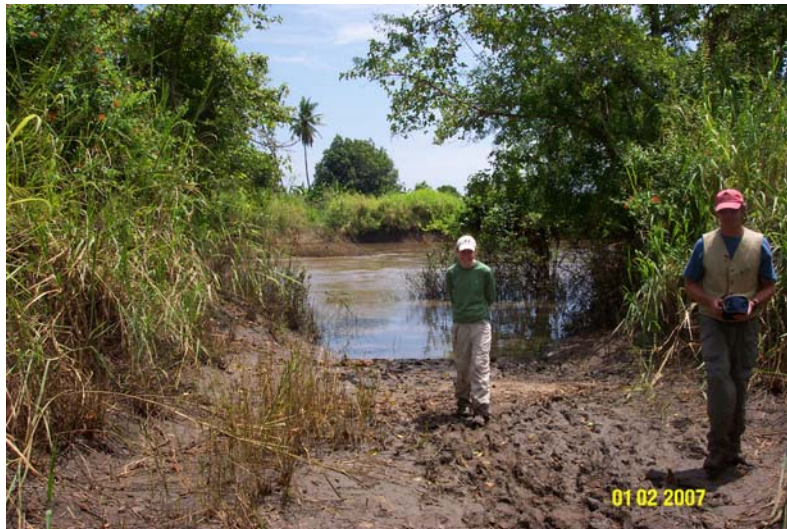
Figure 16. Old ferry crossing site at Gama Gate.

The location of finite, limited dry season habitats and the routes that animals travel to and from them are critical for maintaining these routes and habitats in the short and long term. Informal discussion with TANAPA planning staff and review of the Saadani National Park Management Zone Plan (TANAPA 2003) reveal numerous park infrastructure development projects to accommodate an anticipated rapid increase in tourism. Potential planned infrastructure includes a group campsite development at Mabumo wetland and re-construction and upgrade of the old Tonga Road. [The road has not been used since dereliction of the ferry in 1998. On the north side of the Wami River (Figure 16), this route parallels the river within the immediate riparian area and floodplain (including wetlands); hippopotamus and elephant tracks were abundant when we walked the route on February 1.]

Infrastructure development near any dry season fresh water source may cause alterations in migration patterns and consequent increased wildlife use at other scarce and finite fresh water sources. Degradation of water quality or water quantity at any of these locations would yield similar results. Any infrastructure development that could affect the water table and/or local hydrology will contribute to this potential degradation.

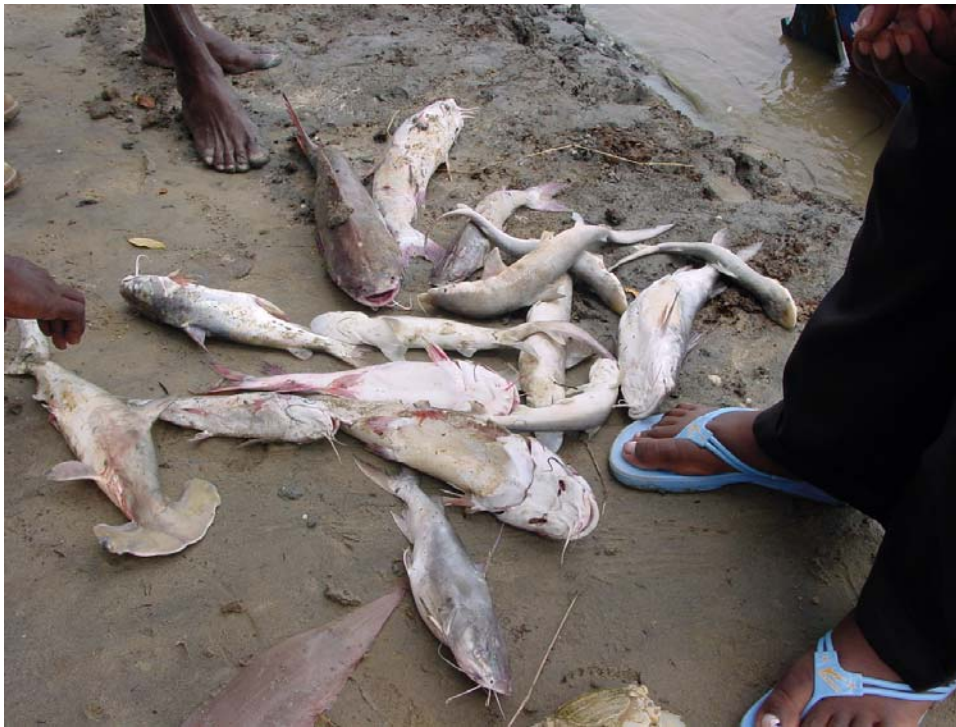
Figure 17. Fish catch at Saadani fish camp on Wami River.

Findings and Concerns: Team observations along the Wami River and interviews with the elders of Saadani village and Matipwili village documented the following conditions of fish populations in the river. Although Saadani villagers fish primarily in the sea, they also have a small fishing hamlet near the estuary of the Wami River. Matipwili villagers fish only from the river. Both sets of fisherman describe a change in fishing technology over the years: nets have doubled in length from 25 to 50 meters, and the mesh has become fine enough that no fish escape. The Executive Officer from Matipwili referred to ‘unsustainable’ fishing practices as all of the fish are now caught and no small fish escape to provide fish for the future. Indeed, fishermen from Matipwili, and as far as 50 kilometers (31 miles) upstream (separate opportunistic interview on February 7), describe fishing all day and catching very few fish (Figure 17).

3. A freshwater hatchery with a program that focuses on the propagation of native fish species for the Wami River (and adjacent basins) will be important for reestablishing this highly degraded fishery.

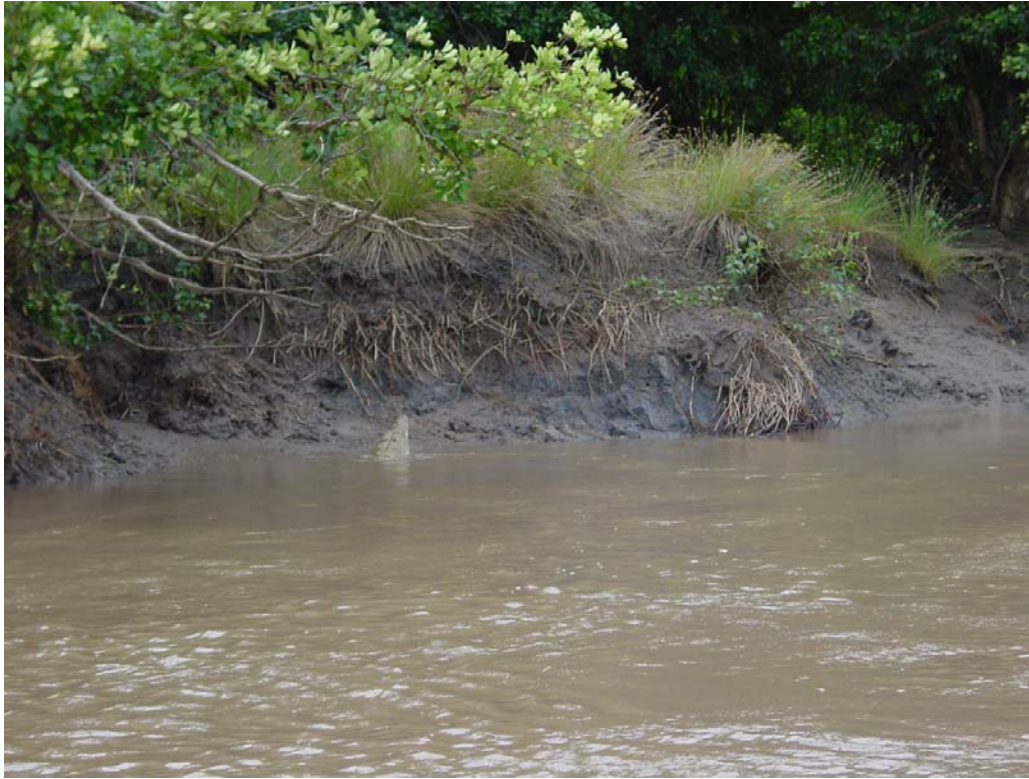
Figure 18. Nile crocodile hunting for prawns along the bank of the Wami River.

The elders of Saadani village describe an historic time of plentiful crocodiles in the Wami River; then an increase in poaching of crocodiles for skins in the 1950s; an end to poaching around 1965 with the establishment of the Game Reserve; then a recovering population of crocodiles to the present (Figure 18). Matipwili elders also notice a contemporary increase in crocodile populations. The Matipwili residents describe a dramatic decrease in the populations of catfish and tilapia in the river and feel that crocodiles no longer have enough to eat. The elders believe this is the reason that the

village is now losing at least one person per year to crocodile attack along the river as people are going for water during the months of November through January.

Anecdotal evidence suggests that current fish populations are not adequate to support current, and suspected increasing, populations of crocodiles in the Wami River. This may be the cause of increased crocodile predation on humans, especially in the vicinity of Matipwili.

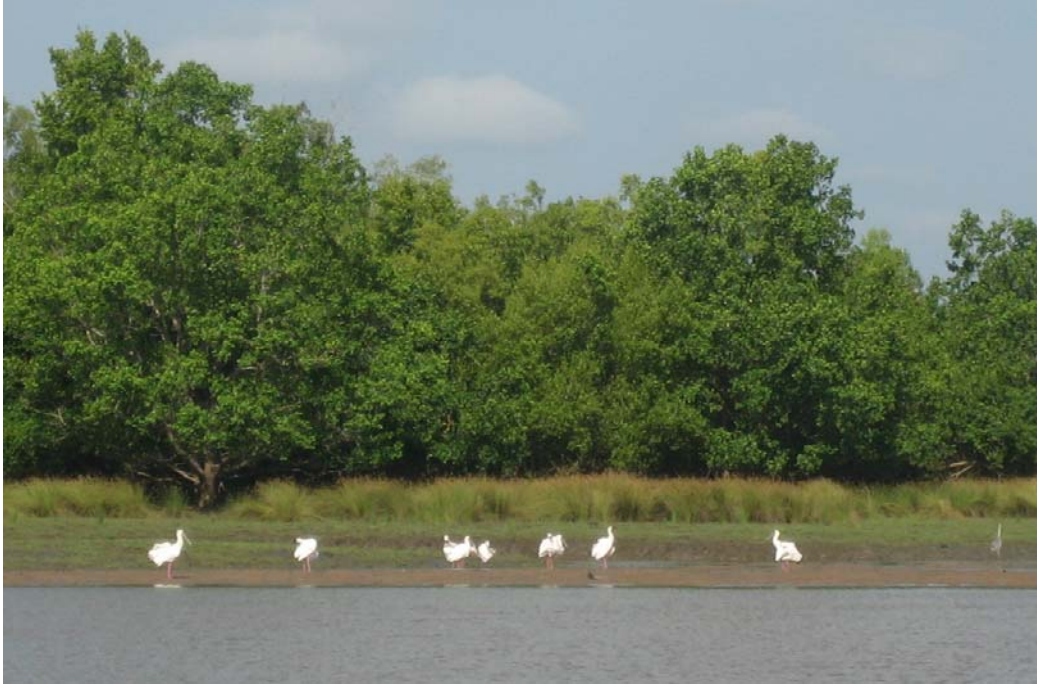
Figure 19. African spoonbills on a point bar on the Wami River.

After spending two days on the Wami River from the estuary to the approximate location of Gama Gate, the team observed only one fishing raptor (i.e. osprey). Although wading birds (e.g. storks, cranes, spoonbills, herons and egrets) capable of eating small fish were present, larger birds capable of eating one to two pound fish, or greater, were conspicuously absent (Figure 19). These observations may provide indirect evidence of the scarce fish stocks (especially in larger size classes) of fish in the Wami River.

Wami River fish populations do not appear to be adequate to support the expected abundance and diversity of raptor and wading bird species. Wading birds should be more abundant and diverse; raptors capable of exploiting fish as prey are nearly absent.

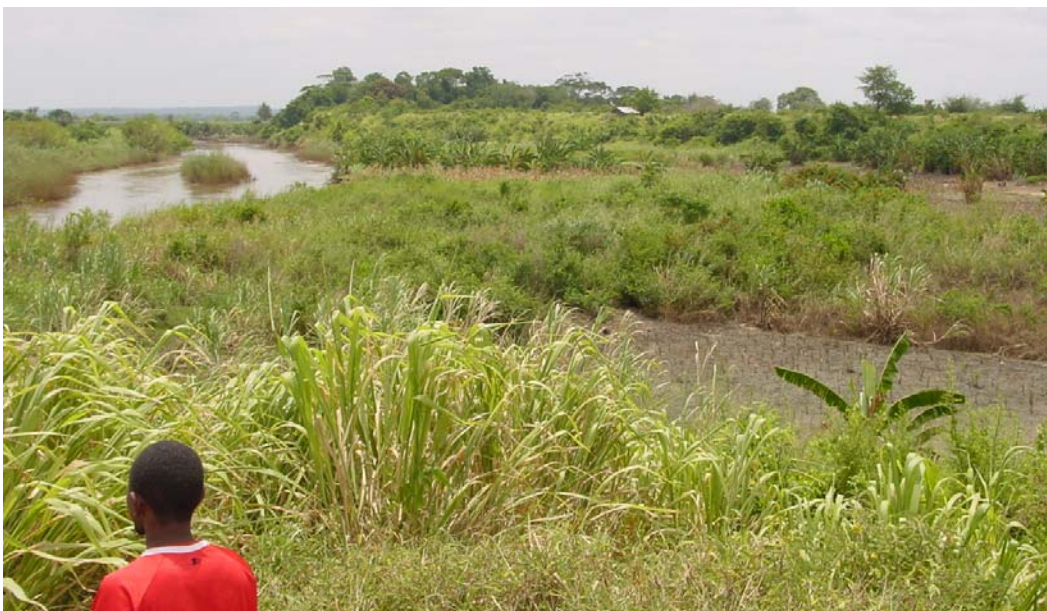
Figure 20. Floodplain agriculture near Matipwili.

Finally, declining fish stocks in the Wami River are forcing communities to find other sources of food. Matipwili, for example, has recently begun agricultural development within the Wami River floodplain to augment their diet. Such agricultural development along the river banks, and loss of native riparian vegetation, is contributing to changes in river morphology listed previously (Figure 20).

Fish populations in the Wami River are no longer adequate to support local populations. People are beginning agricultural conversion of native vegetation in floodplains and uplands, which accelerates the erosion of river banks, and may contribute to the brackish taste of water coming from uplands during and after the wet season.

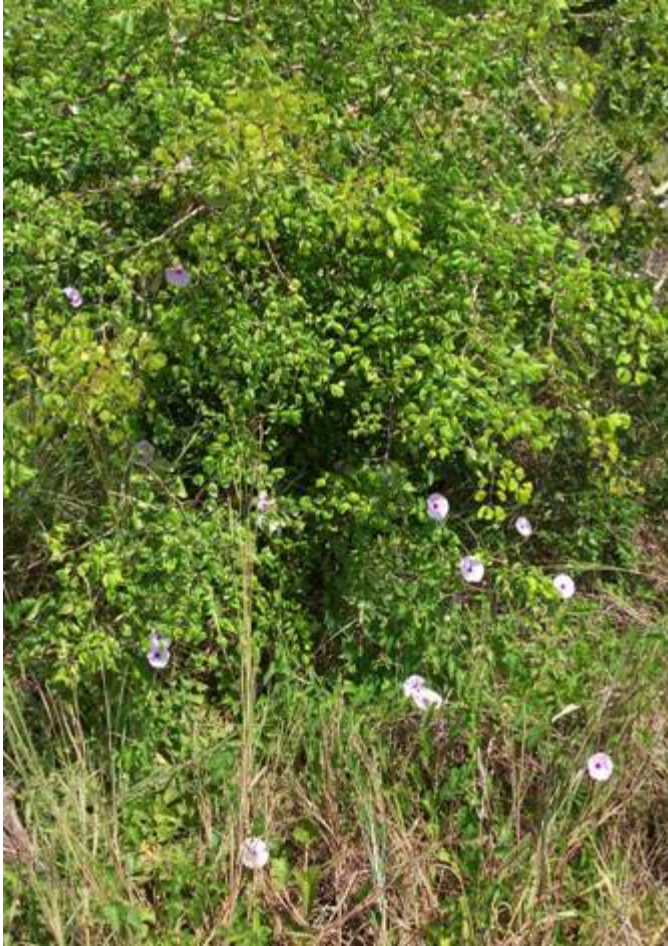
Figure 22. Bindweed found along road to SANAPA.

Noxious weeds– Despite the history of ecological disturbance in SANAPA (e.g. cattle ranching, sisal plantations) the literature points to very few occurrences of non-native plant species and these were found as landscaping relicts at the old Mkwaja Ranch headquarters. During this mission, noxious weeds within SANAPA were not apparent to the team, but verification from a local ecologist is needed. However, one apparent noxious weed species was observed in agricultural areas and along roadways in proximity to SANAPA (agricultural areas along the Wami River upstream of SANAPA; and along the access road from Mandela).

This species is abundant in disturbed areas, drapes over native vegetation, and appears to be a type of bindweed (Convolvulaceae: Morning glory family) (Figure 22). Species identification, verification of its threat to SANAPA biodiversity, a map of the existing infestation, and potential development of a weed management plan are needed to protect SANAPA from its invasion and establishment.
