Asian Institute of Technology

Field Observations on Water and Sanitation at Tsunami-affected villages, Kampan Sub-district, Ranong Province

22 June 2005

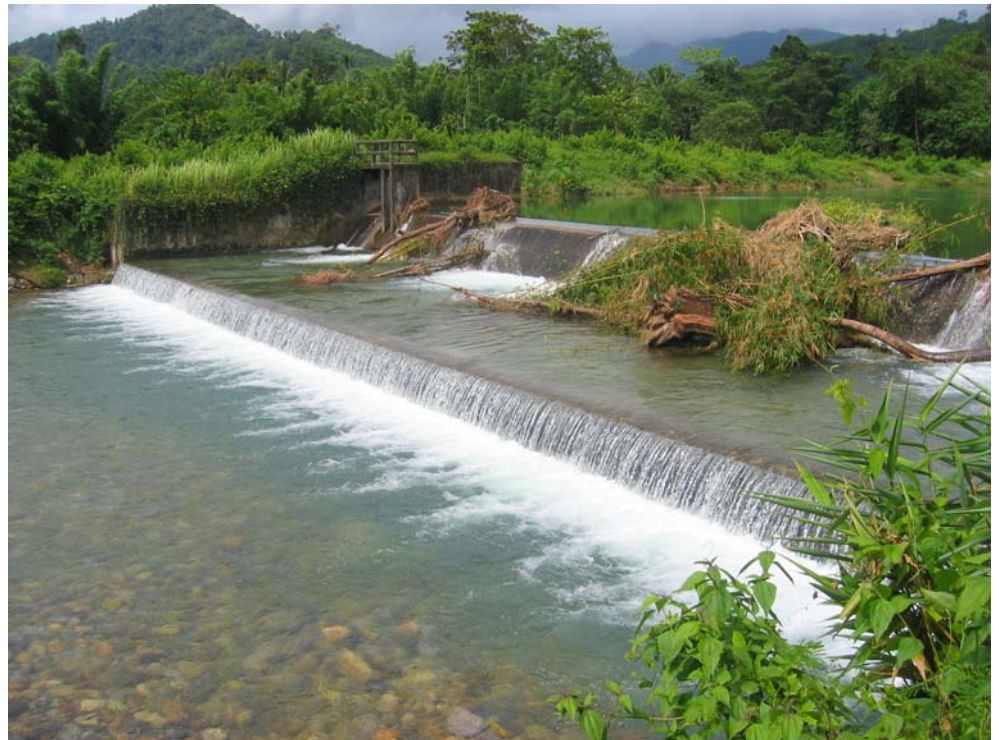
Figure 1. A small concrete dam at Kampuan creek

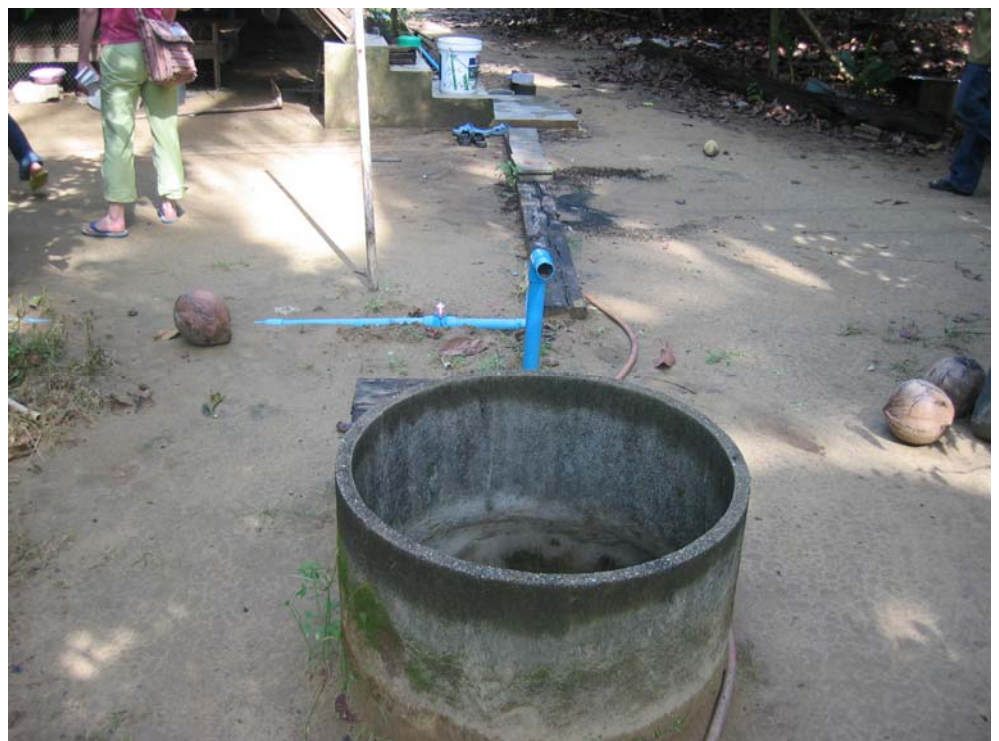
After catastrophic incident in December 2004, several villages in Ranong province were seriously demolished including the water supply systems, most of them were contaminated by saline water in the shallow wells. According to the discussions with villagers and TAO officers, those villages have faced the shortage of water supply especially in dry season where either surface or groundwater sources are diminished. This incidence is contradictory to the fact that Ranong province has the highest rainfall in Thailand at the rate of about 2,000 mm/year.

Figure 2. Typical shallow well in a village

With the fact that the highest precipitation rate occurs in Ranong province, the rainwater harvesting from roof and underground collection tanks should be an alternative for water supply system where either shallow wells were contami-

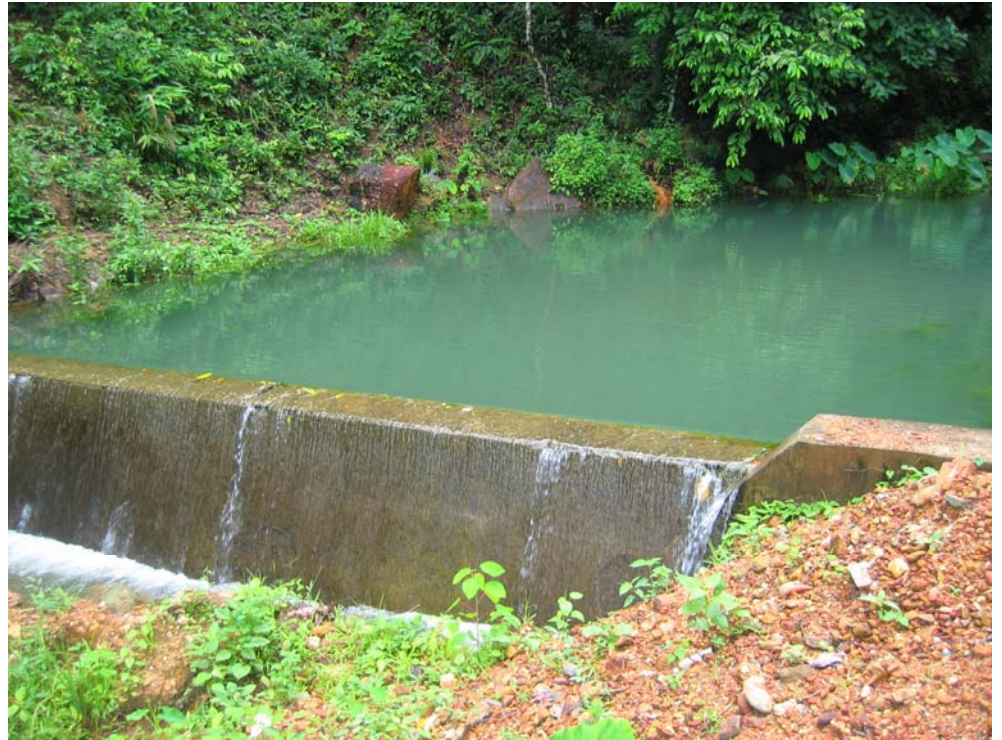
The newly-built housing estates in Ranong province for Tsunami-affected householders were mostly completed, but apparently lacking of water sources for their livelihoods. Based on the discussion with TAO officers, it was informed that there are 2 main sources for water supply in these villages: surface water from a small dam at Kampuan creek (Figure 1) and shallow well (Figure 2). However, at village no. 1 there is a small reservoir at waterfall nearby (Figure 3), but seems not adequate for the whole village.

Figure 3. A small reservoir at Village 1 waterfall

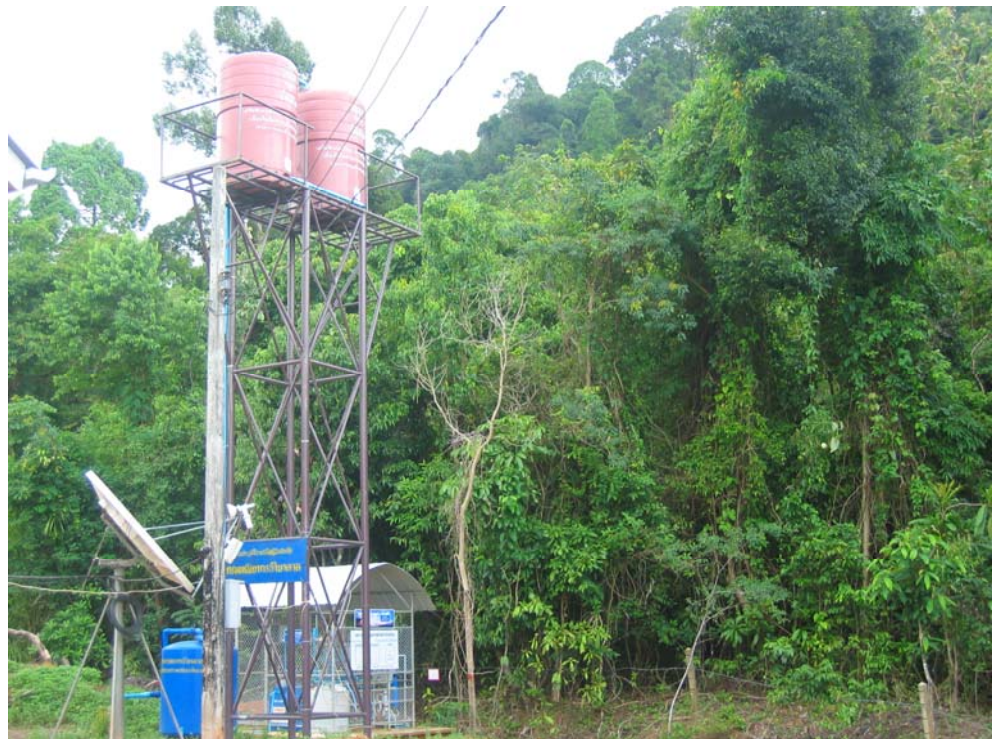
Figure 4. Groundwater supply system at Village no. 1

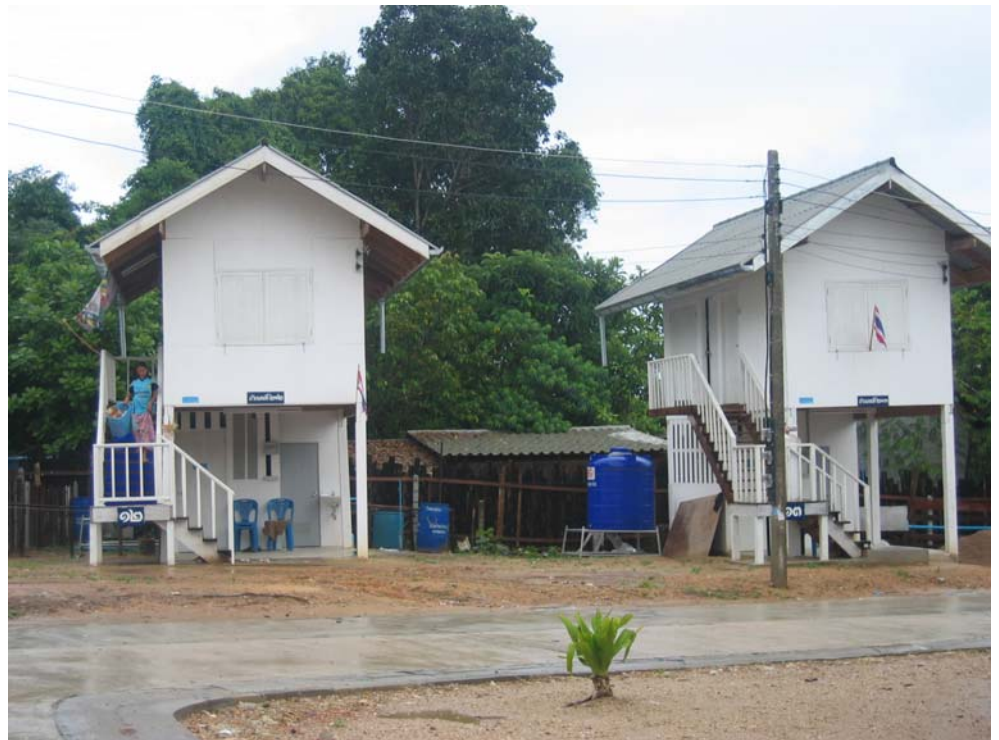
For the newly-built houses, pipes and plumbing systems were adequately installed in individual household, except village no. 2 where groundwater is used as a water supply source, as shown in Figure 5. In addition to groundwater supply system, a 1.5-m³ plastic tank was provided for each household for rainwater collection (see Figure 2). However, probably because local people do not familiar to the uses of rainwater, it was noticed that they would prefer to get the tap water either from either groundwater or surface water sources. Similarly, this behavior is also apparent at Village no. 4 where a 2-m³ concrete jar has been given for each household, but rarely used for rainwater collection (see Figure 6).

Figure 5. A 1.5 m³ plastic tank for rainwater collection

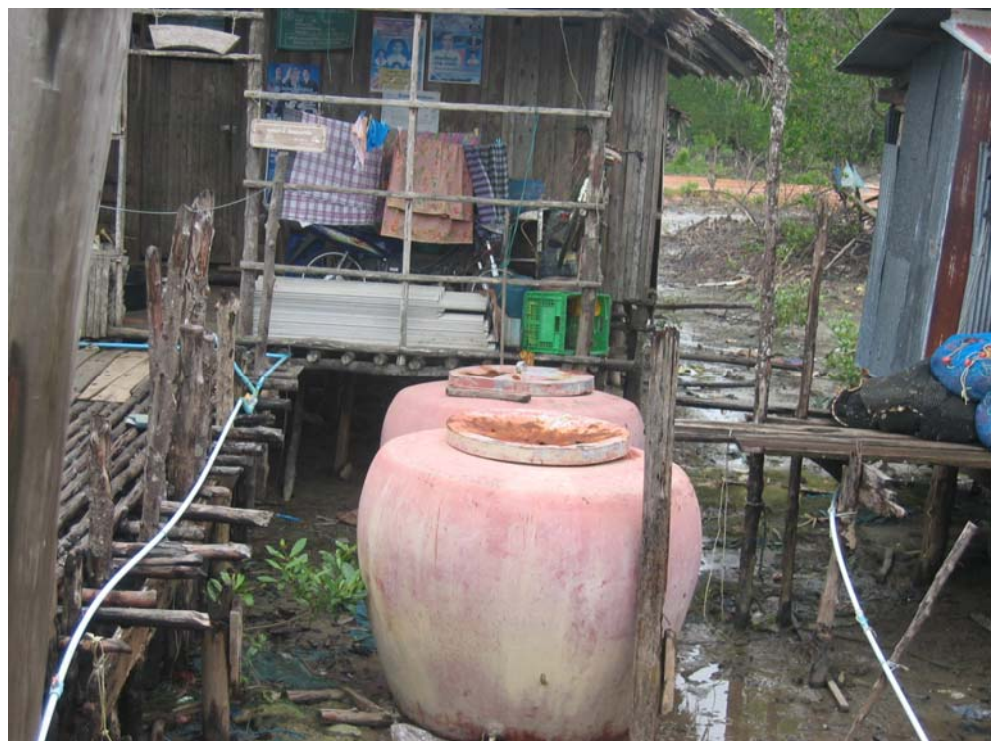
Figure 6. A 2-m³ concrete jar at Village no. 4

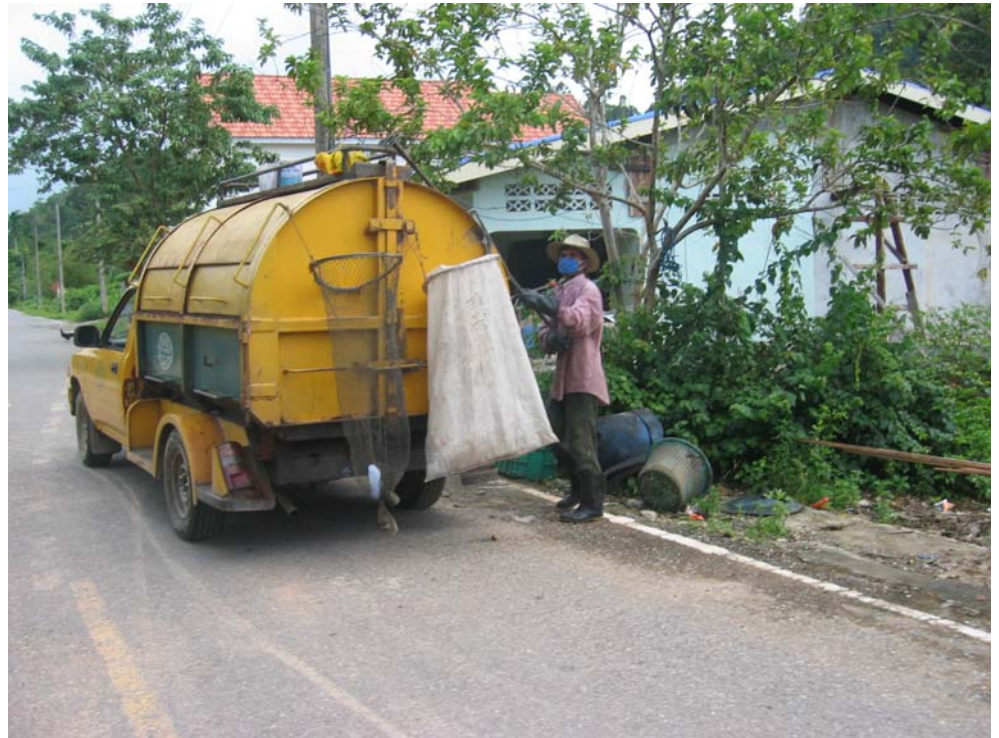
The filed surveys revealed that the solid waste collection and disposal systems in these villages are inadequate to serve the whole communities. There is only one small-scale truck (Figure 7) for solid waste collection in 7 villages and disposing the collected waste at the open dumping site (Figure 8). Because of the limited collection service, there are wastes remaining in the communities, threatening to public hygiene as well as contamination into land and water resources. At the open-dumping site, where appropriate lining and regular soil coverage do not prevail, the leachate from solid wastes piles can cause serious environmental problems such as contamination of toxic compounds in the farmland nearby the dumping site.

Figure 7. A 6-m³ truck for solid waste collection in Tambon Kampuan

- Sort separation at household level – introduction of “Garbage Bank” concept
- Waste reuse and recycling
- Composting of organic wastes
- Improving the dumping site to be sanitary landfill

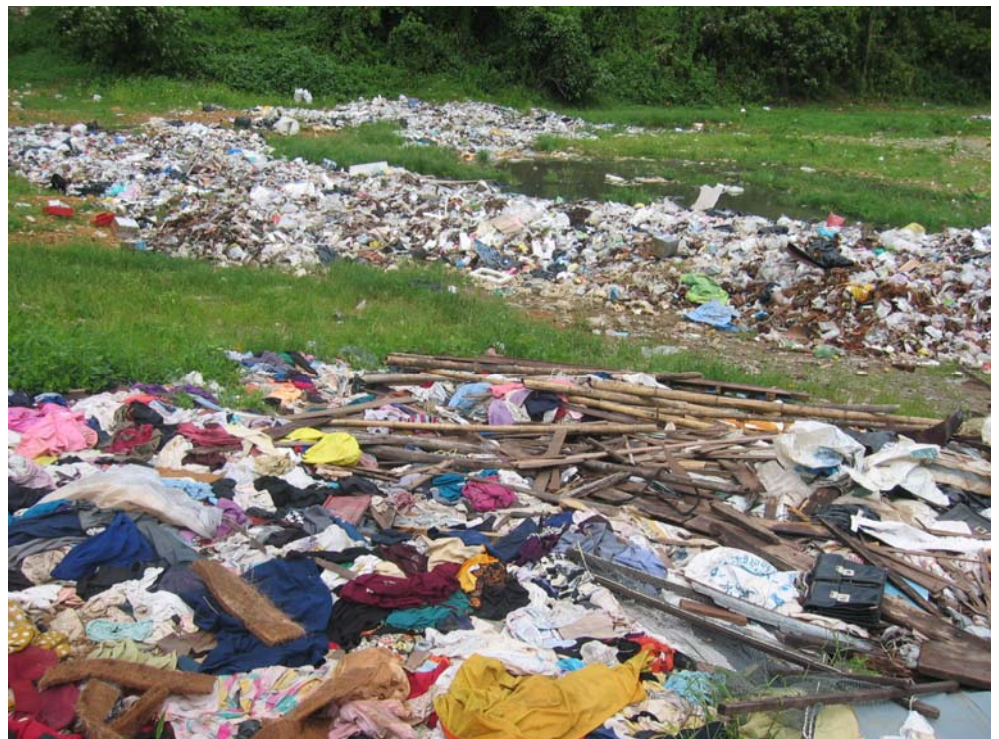
Figure 8. An open-dumping site in Tambon Kampuan, adjacent to rice fields

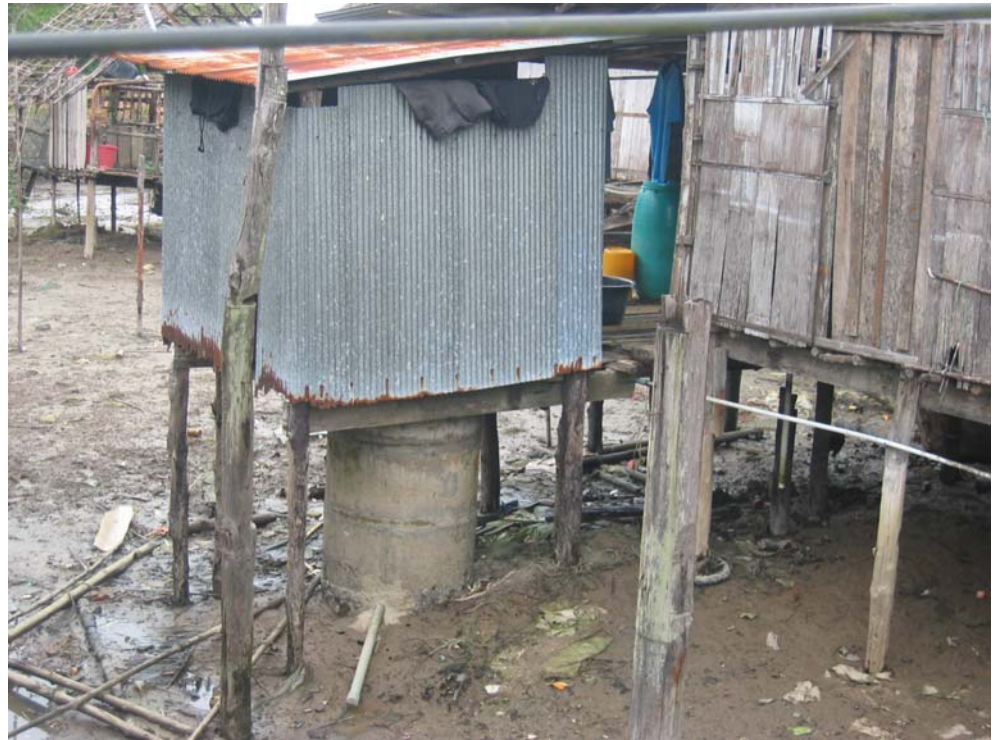
In addition to the solid waste management, it is expected that collection and disposal of septage, an emptying sludge from septic tank or cesspool, be another sanitation concerns. Either in the existing newly-built or existing housing estates, toilet wastewater is connecting to a cement-ring cesspool (Figure 9) or septic tank (Figure 10), which typically require sludge emptying every 1 or 2 years. Inappropriate disposal of this sludge, containing high contaminants and pathogens, could cause severe disease transmissions/outbreaks in the communities. It is suggested that the appropriate sludge collection and disposal system be introduced in these communities which should help relief health burden for the public.

Figure 9. Toilet system at Village No. 4

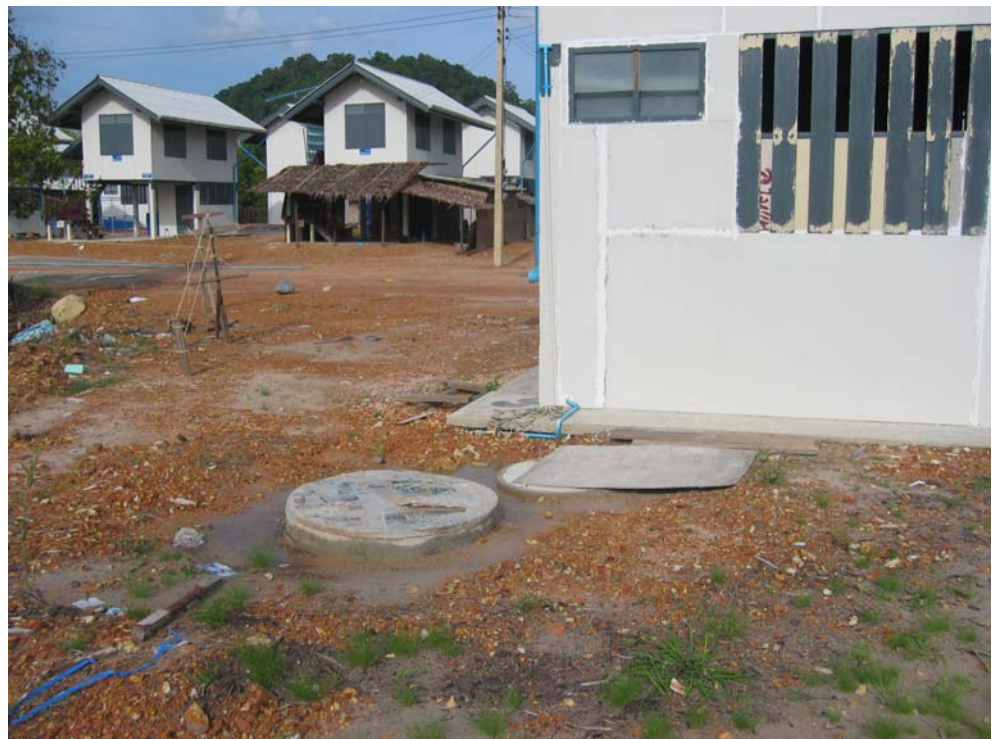
Figure 10. Toilet system at Village No. 7
