# Final Report and Recommendations Resulting from CRC/WIOMSA Volunteer Assignment in Tanzania June 26 to July 10, 2005

## Mariculture Business Development

*Michael A. Rice & Edwin Requentina, Sr.*

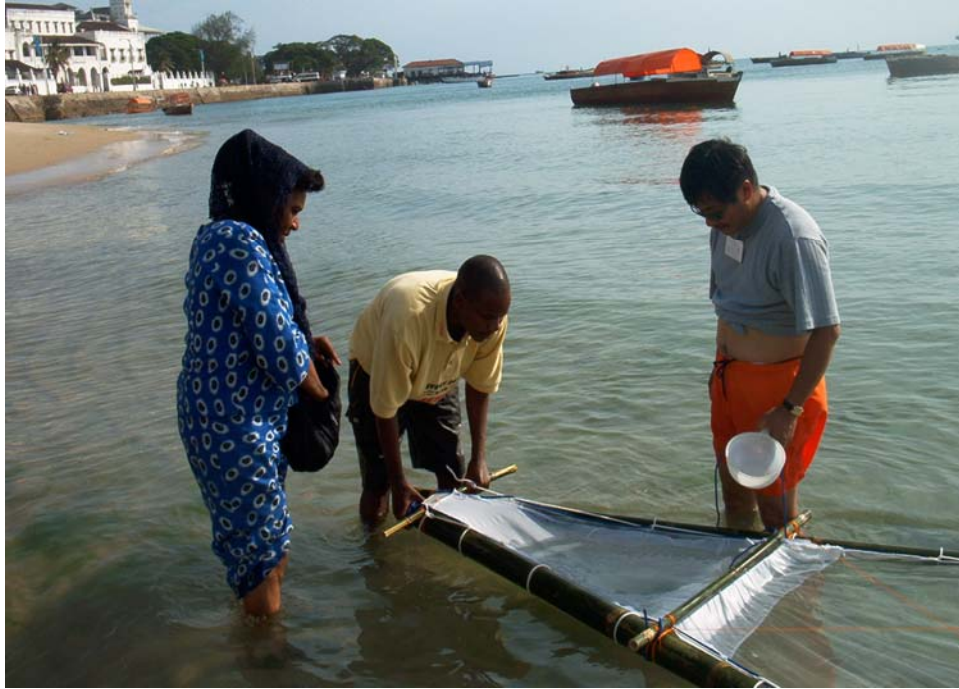
*Volunteer, Edwin Requintina demonstrating milkfish fry collection using a Philippines-style scissors net constructed as a demonstration exercise at the workshop*

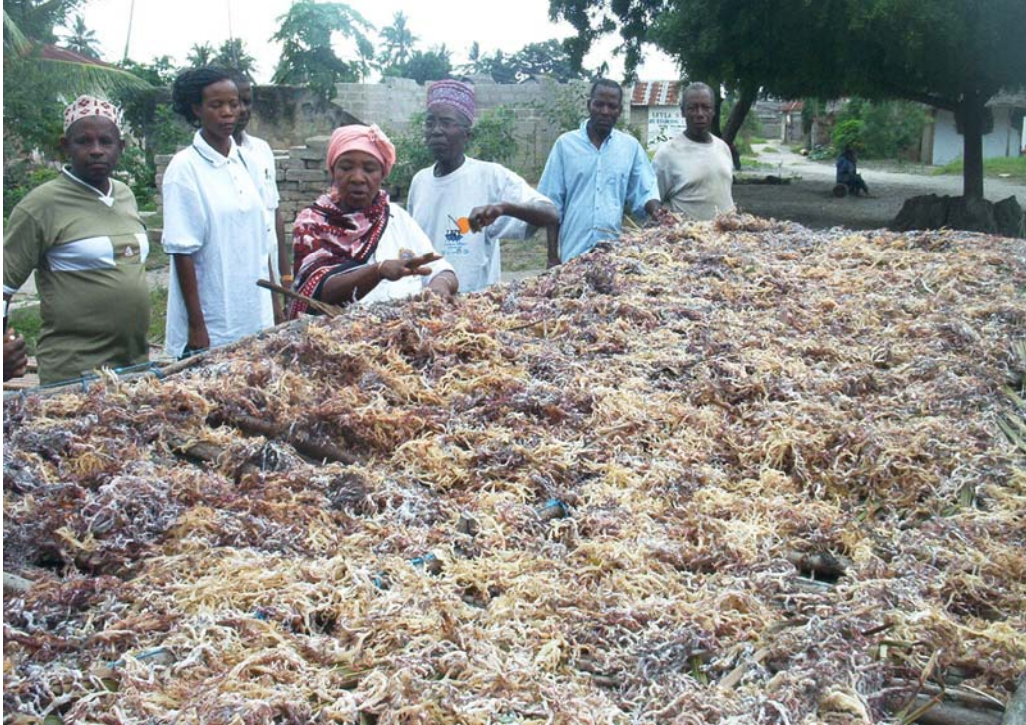
- Production of seaweed is meeting villagers' expectation at this time. They showed us a full storeroom and stated they were awaiting arrival of the seaweed buyers from Zanzibar.
- We observed that some of the seaweed on drying racks in the village was coated by a grayish fungus that might affect the market price. The racks in question were shaded part of the day by trees in the village. We suggested situating the racks in open areas where their exposure to direct sunlight can be maximized.

*Villagers at Bagamoyo showing their seaweed drying racks*

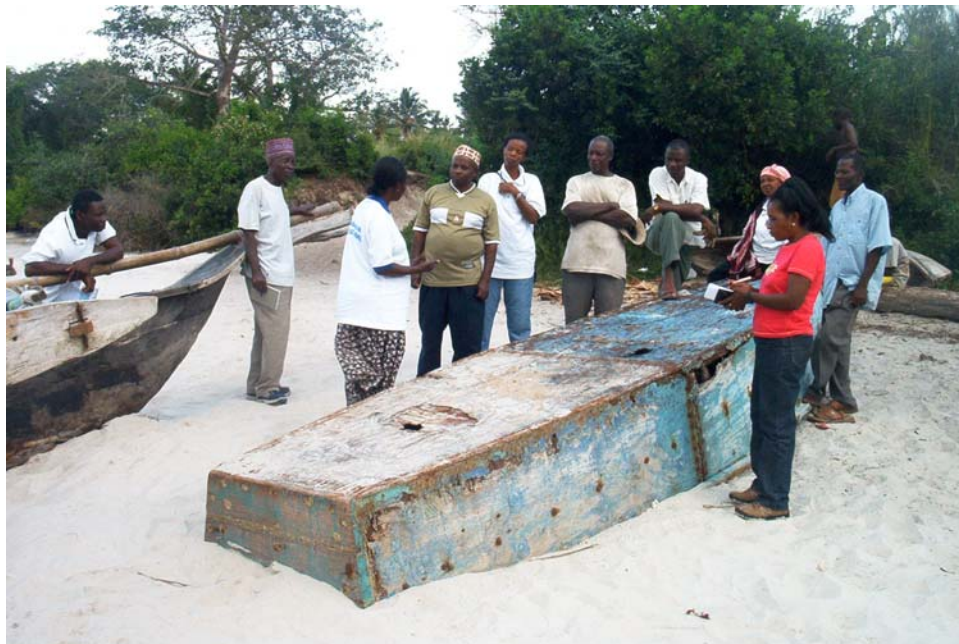
*Marine Scientist Dr. Flower Msuya discusses seaweed farm tender boats with Bagamoyo villagers*

- We suggest the following as the optimum combination of vessels to carry out seaweed farming in Bagamoyo. This is the combination of a raft for use as a work platform (as described above) and a small three meter motorized boat for use in inspecting and tending the farms. At harvest time, the raft could be towed to the work site. It may be wise to introduce the raft to the village first – i.e., before the motorized vessel – i.e., as a step-wise strategy in introducing technology.

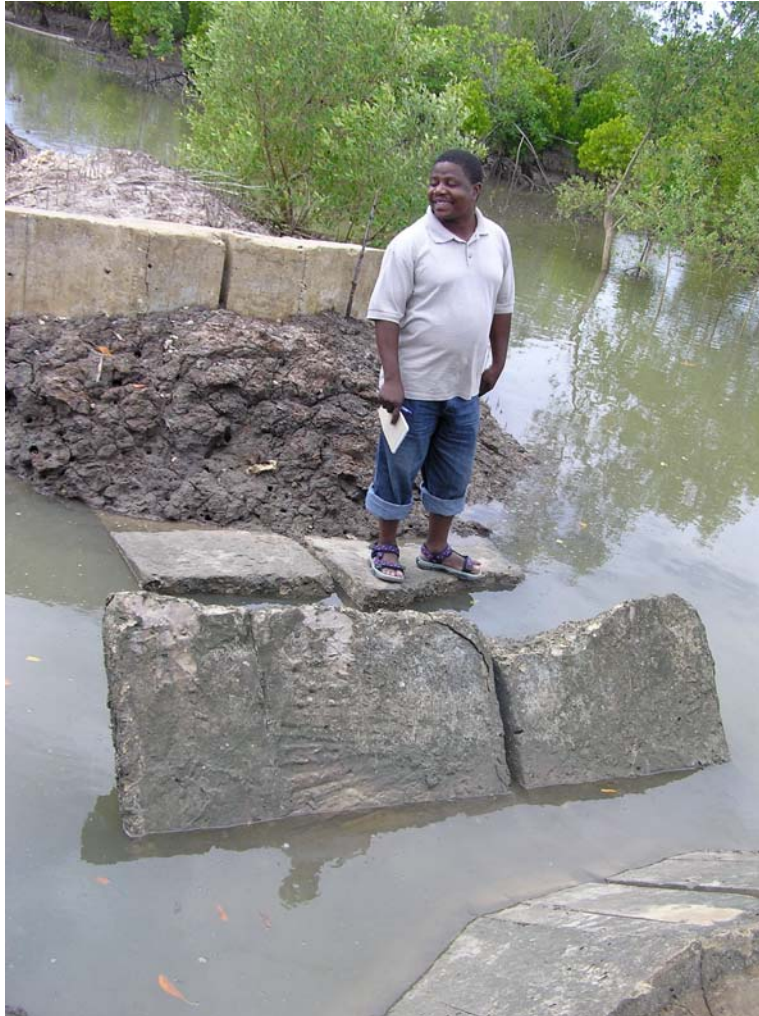
- The Kirago Farm has soils with a high sand content that is sub-optimal for the construction of fishpond dikes. Soil types with higher percentages of clay/loam are better for dike construction.
- The perimeter dikes at the Kirago Farm were constructed at a height below the level of high spring tide, so they were severely damaged as receding spring tides that overflowed the dikes receded back to sea. This error in dike construction destroyed the concrete main water supply gate for the farm.

*Extension Agent Mr. Muganga stands on the ruined main water supply gate of the Kirago Farm caused by high spring tides overflowing the main perimeter dike*

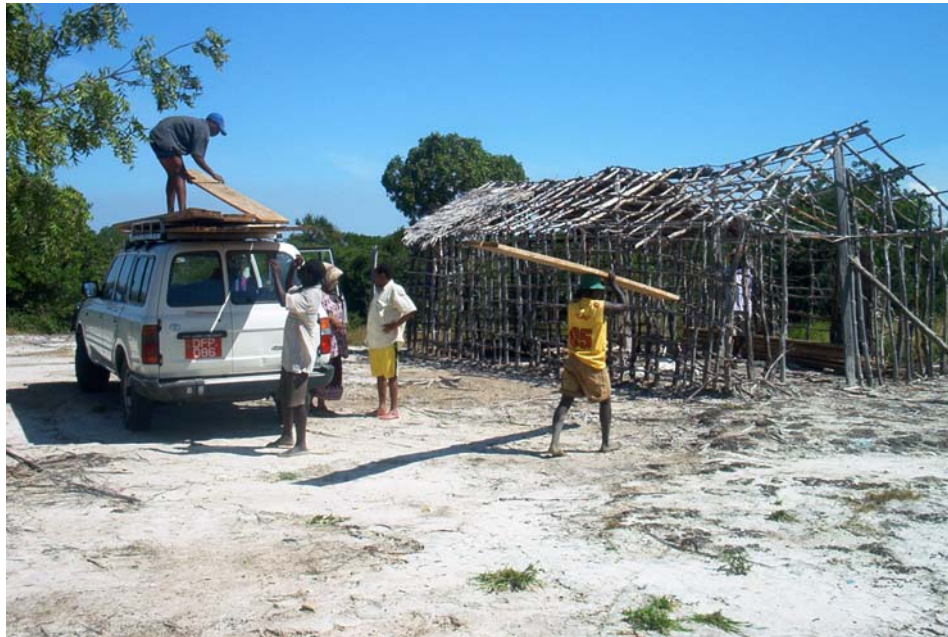
*Moving lumber for wooden gate construction to Mukadam Farm*

- Mr. Kirago lacks some of the qualities desired of an ideal extension cooperater for the SUCCESS project and has unrealistic and unclear expectations concerning what he was being asked to do and provide versus what the project could provide. It is not clear how committed he is to improving the business operations of his current salt operations and converting a portion of his salt ponds to fishponds. He seemed unwilling to contribute labor needed to implement some of our recommendations, including a reconstruction of the water supply gates, in spite of the fact that the project was willing to provide all of the materials for construction. For this and the aforementioned reasons, it was decided that the wooden dike demonstration should be carried out at the nearby Mukadam Farm where there was another willing salt operator interested in converting to milkfish ponds and contributing the labor for dike modifications, gate construction and installation. After considerable discussion, all the lumber was relocated to Mukadam Farm.

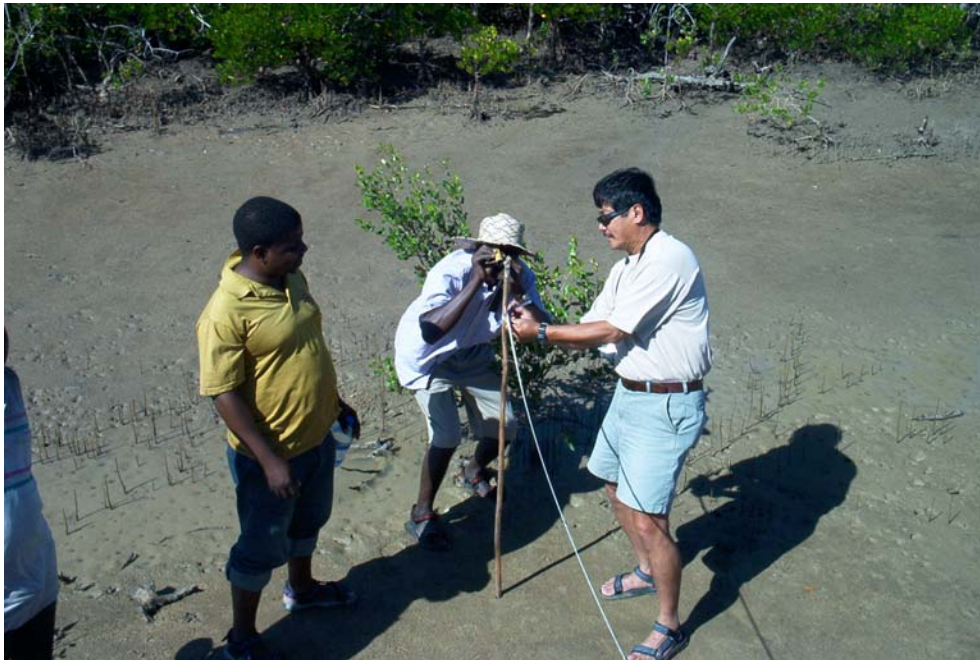
*Volunteer Edwin Requentina demonstrating the method of determining low tide baseline elevation datum, tide range determination, and the method for transferring tide measurements to make proper dike and pond bottom elevations*

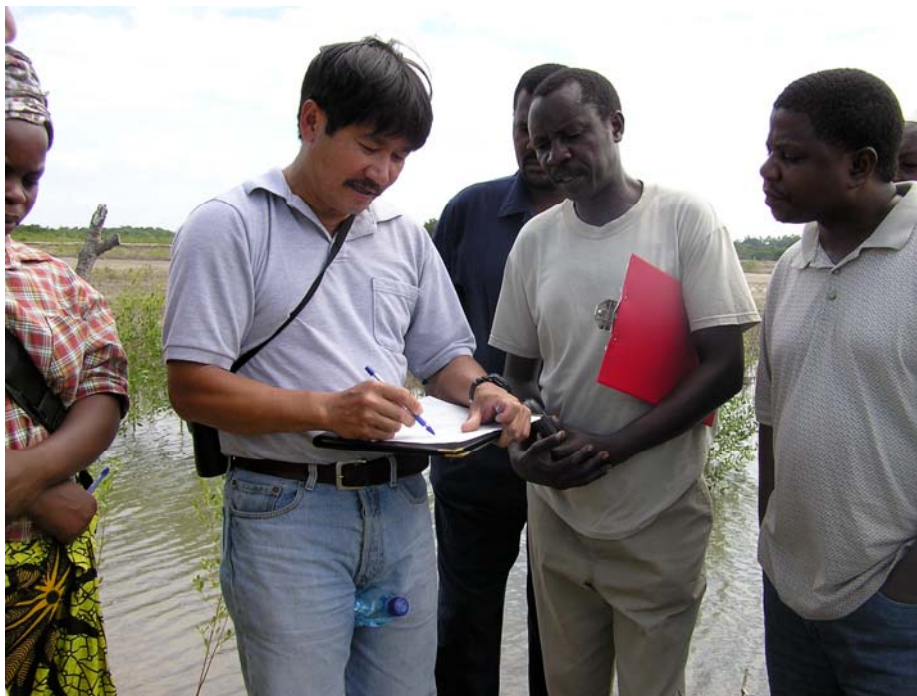
*Edwin Requintina discusses pond layout methodology with extension agents Sandey and Muganga at the Mukadam Farm*

- On the first visit (July 4), the volunteers were provided the dimensions by the cooperators of the dike's perimeter. These provided the basis for an initial dike layout and construction plan. However on the second visit (July 6), the volunteers

measured the dike to verify the dimensions provided and found that all dike measurements were inaccurate by  $\pm 25\%$ . This necessitated a complete rewrite of the layout and construction plan. It is important to emphasize to cooperators that “guesstimates” of area and volume dimensions make business planning and calculation of construction costs difficult if not impossible. Proper planning relies upon accurate information. The revised Mukadam site plan is appended to this report with copies supplied to Mssrs. Muganga and Sandey.

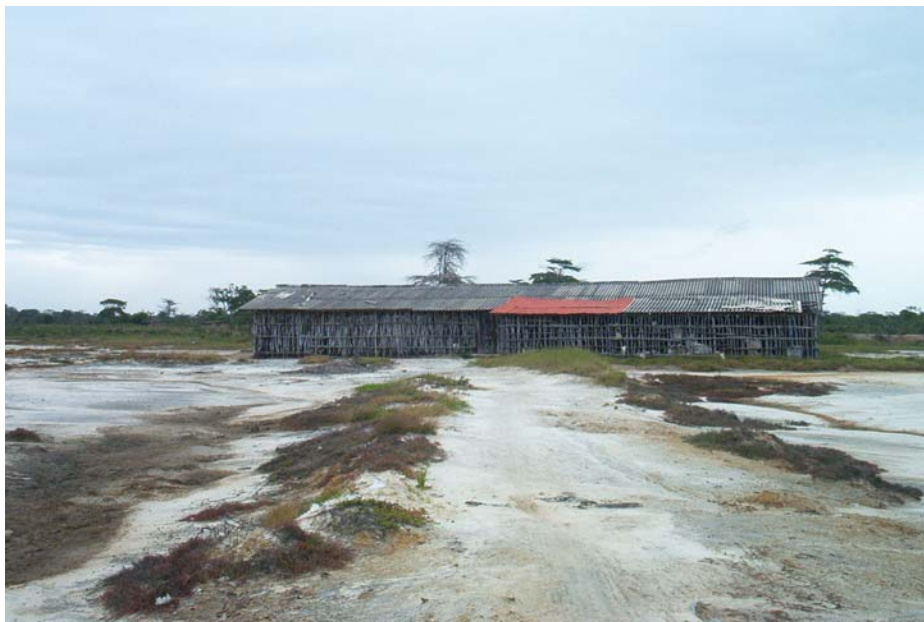
*Salt storage warehouse at the Regent Enterprises salt pans*

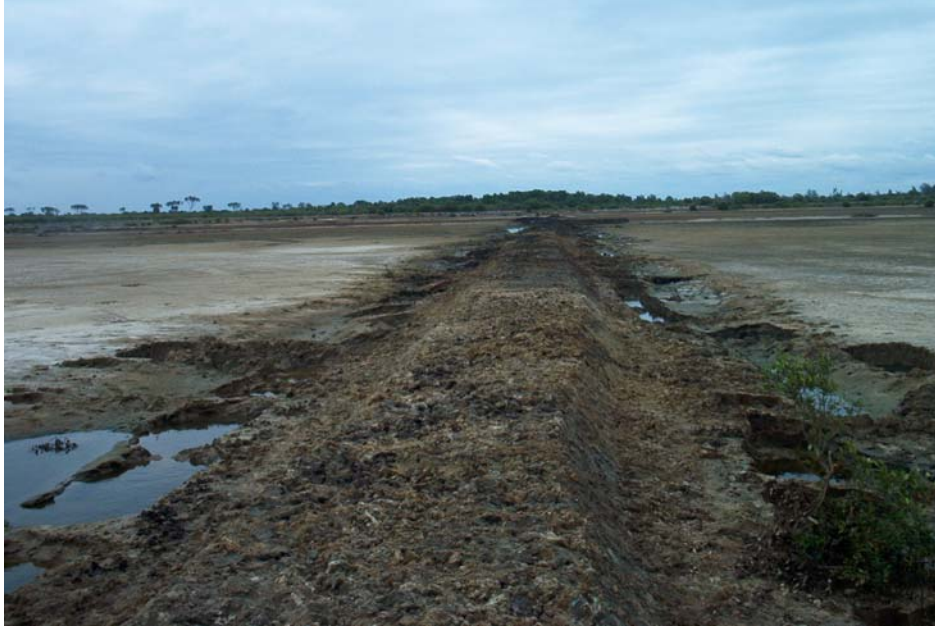
- The soil quality at this site is perfect for construction of fishpond dikes. The subsoil consists of organic clay loam that is overlain by a sandy top layer.
- There is a permanent workforce on site that is knowledgeable of construction techniques for sturdy dikes using the ‘mud-block’ placement system. Furthermore, they use staking methods to guide construction and keep the dikes straight.

*Newly constructed dike at Regent Enterprises site using quality clay-loam blocks and proper slope, base and crown dimensions*

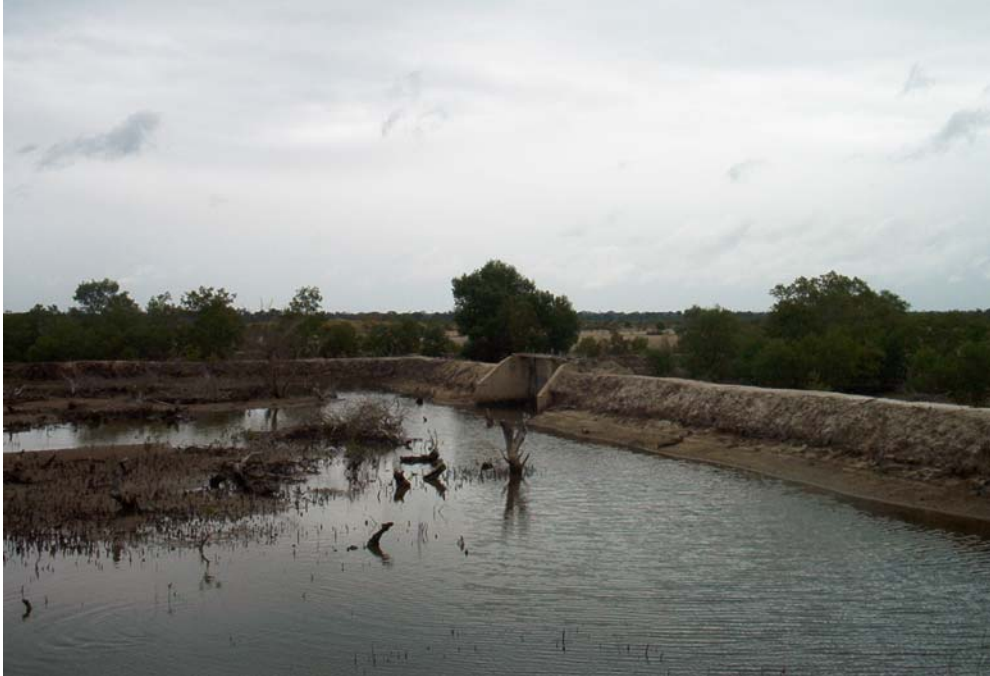
- There is a site manager living on-site who is knowledgeable about all operations.
- The tidal range exterior to the perimeter dikes is 1.0 to 1.5 meters, which is optimum for milkfish pond construction.
- The existing main gate of the farm is approximately 3 meters in width with single planking to form the gate closure. This design is exceptionally leaky in that water cannot be retained by the board joints. The recommendation is that the gates be modified with double doors so that the median space can be packed with mud to make the gates more effective in retaining water. The cooperater liked the idea and stated he would try it out.

*Main water gate at Regent Enterprises salt pans in Bagamoyo*

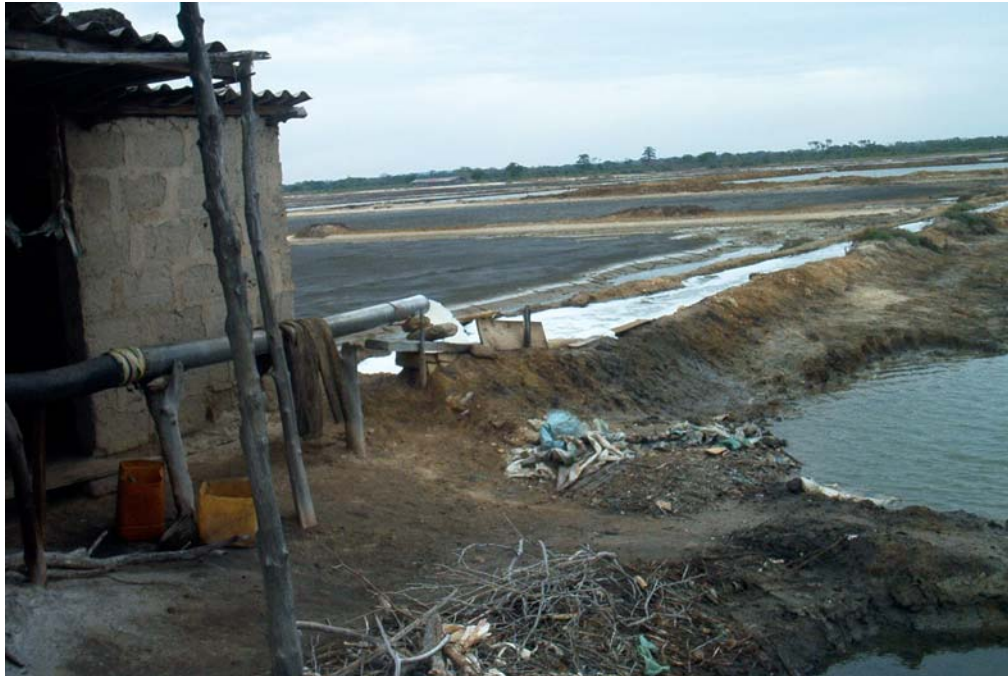
- The site already has in place seawater pumps that can be operated to top off ponds during emergency situations, giving the operator good management options if water quality suddenly goes bad.

*Water is pumped into high salt pans by diesel engine driven centrifugal pump at Regent Enterprises salt pans*

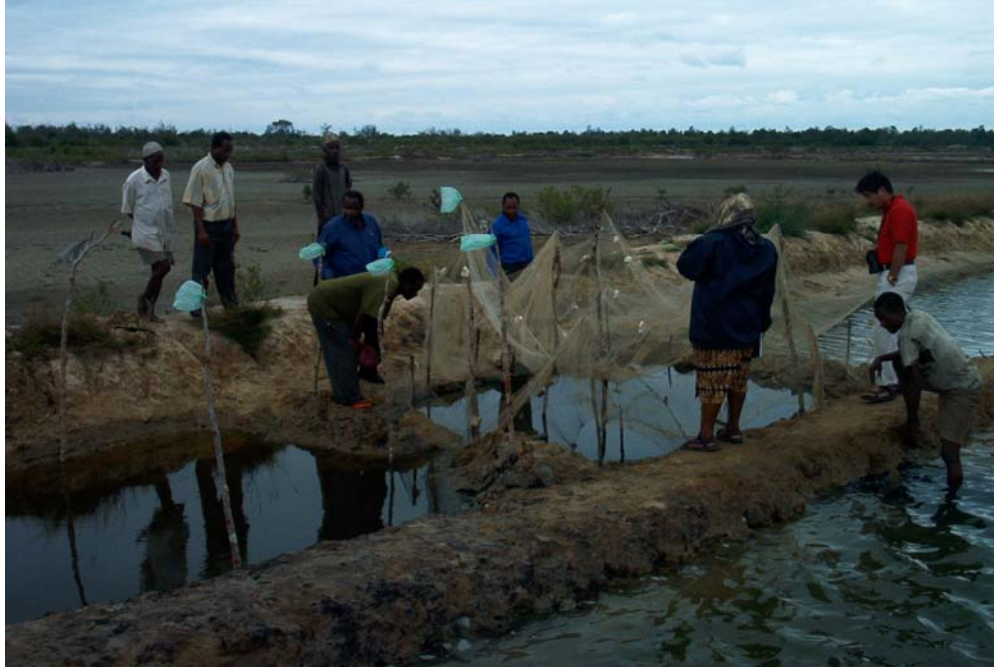
*Experimental fry rearing ponds built by owner of Regent Enterprises salt pans without any prior technical assistance. Netting on one pond is an experiment to exclude bird predators.*

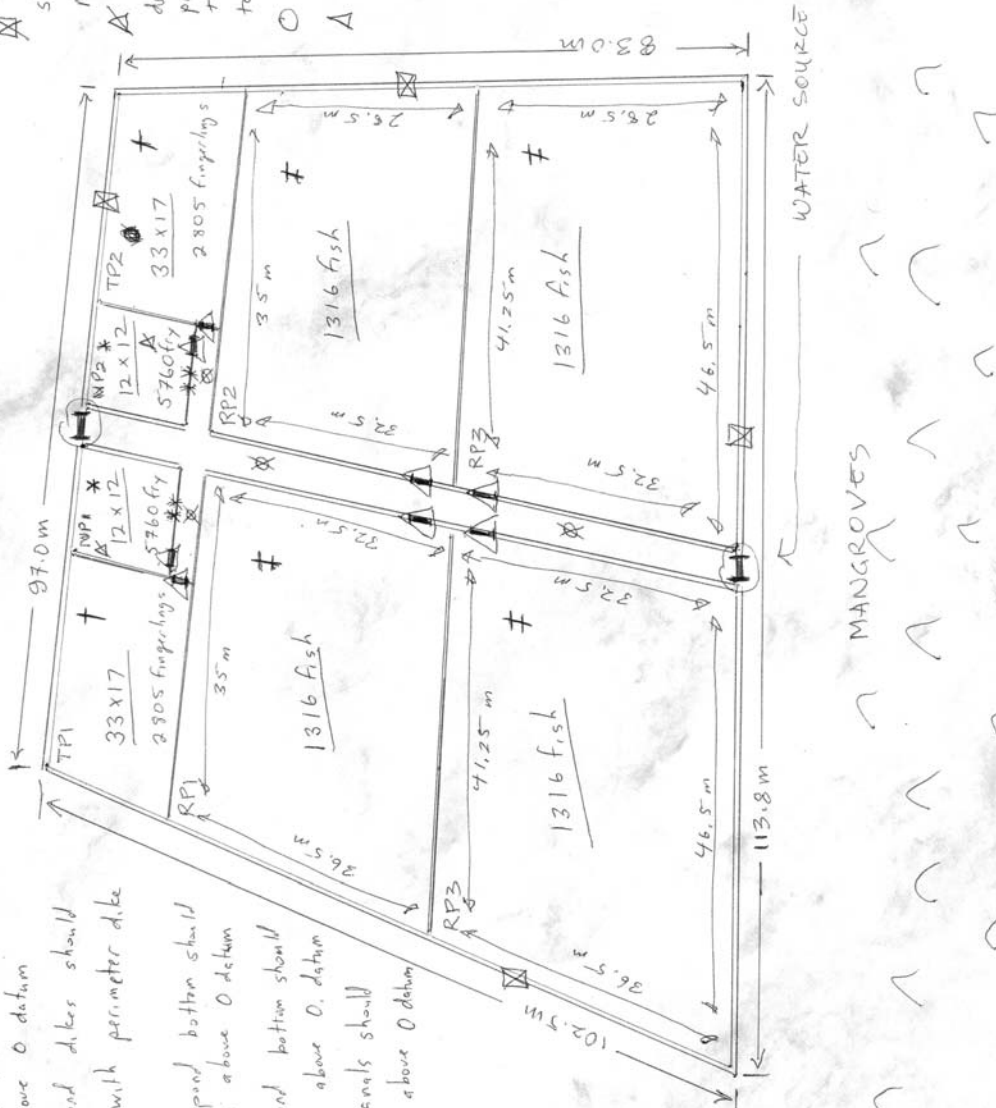
Mukadam Site at Mpafu

- Nursery pond bottoms 0.5 m above 0 datum
- Nursery pond dikes should be even with perimeter dike crown
- Transition pond bottom should be 0.3 m above 0 datum
- Rearing pond bottom should be 0.2 m above 0 datum
- Supply canals should be 0.1 m above 0 datum

- Perimeter dikes should be 1.5 m above Datum
- Nursery ponds are designed with excess production capacity to supply fingerlings to other farms.
- Main gates
- Secondary gates
